AGENDA

COMMITTEE OF THE WHOLE MEETING OF COUNCIL

MONDAY, JANUARY 21, 2019 AT 3:30 PM
IN THE CITY HALL COUNCIL CHAMBERS

- Cost Sharing Agreement for McLean Mill National Historic Site (outlining City's obligations) dated July 23, 1996 - Page 10
- McLean Mill Society (MMS) Constitution dated December 8, 2016 - Page 22
- Operation and Management Agreement between City and MMS dated January 1, 2017 - Page 23
- McLean Mill Site Assessment prepared by John Dam & Associates Inc. dated July 3, 2018 - Page 36

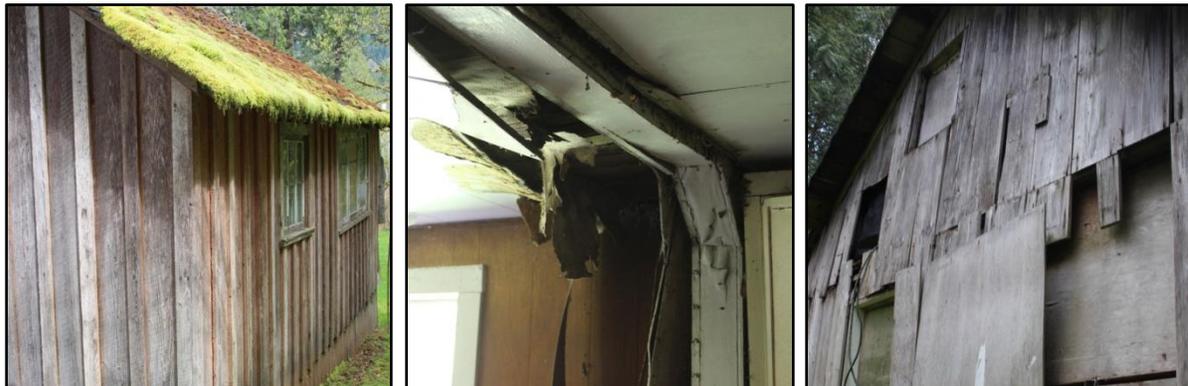
Currently, the asphalt shingle roof is supporting significant moss growth on both the north and east elevations while moisture ingress through the attic has occurred, deteriorating the ceiling finishes. The discontinuous roof line at the south-east corner would suggest a previous addition on the east elevation has been removed.

Photographs 5 - 7 – (left to right) moss growth on the north eaves, ceiling damage associated with building displacement and moisture ingress, damaged and deteriorated east wall

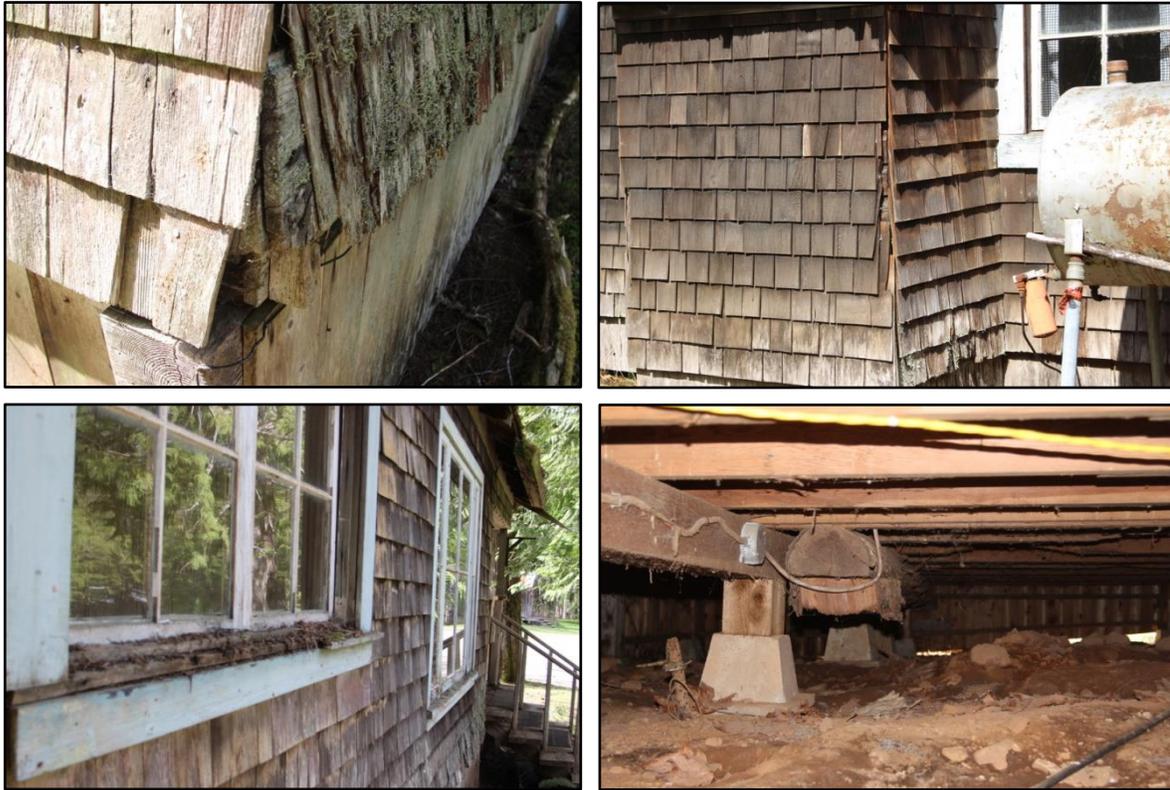
Photographs 13 - 16 – (clockwise from top left) deteriorated wall cladding, sound building frame and footings, debris on the window sills

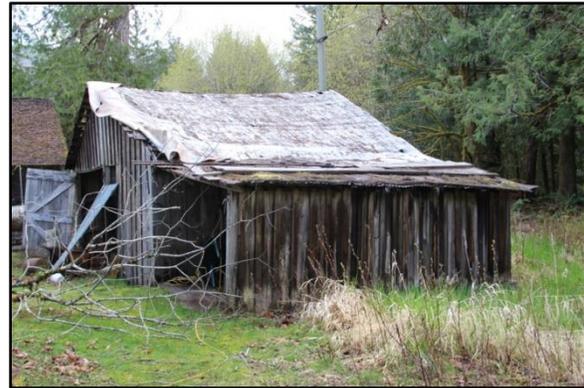
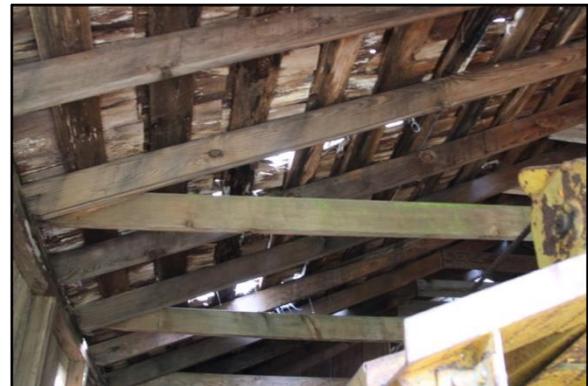
Currently the building is in a state of advanced deterioration and close to structural collapse. The roof structure is exposed to the elements while the south-west corner of the building is submersed in standing water.

The cedar shingle roof over the main garage has been protected with a tarp that is loosely held in place and heavily damaged. With the severe deterioration of the shingles and the damaged tarp, the roof structure is exposed to moisture ingress and the associated deterioration. The lean-to on the west side is protected with sheet metal cladding held down with timber scraps and debris. Given the low-slop and accumulation of debris, the onset of deterioration of the sheet metal is unavoidable with a number of holes already observed.

Photograph 18 - 20 – (clockwise from top left) damaged roof tarp, holes through the main, cedar shingle roof and the lean-to, sheet metal roof

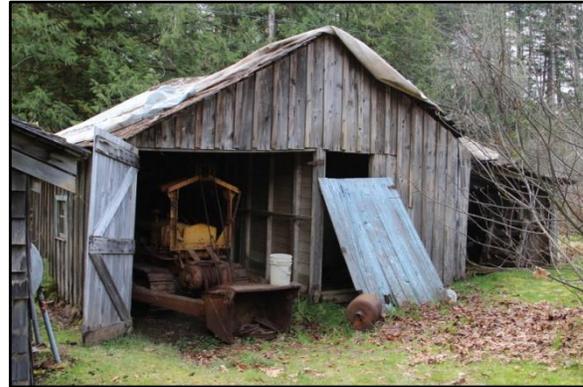
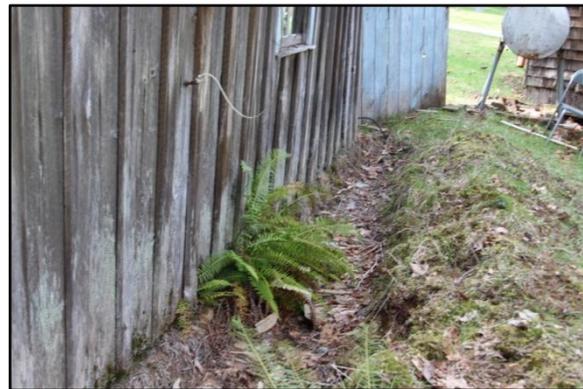
The condition of the A. McLean Garage is critical with potential assembly failure imminent. As with all buildings, it is important that the garage stay dry and have the capacity to dry out to best minimize moisture related deterioration. The primary recommendation is to reset the building on a new foundation assembly, out of the encroaching water, and if necessary, drain the adjacent accumulation of water away from the area. The deteriorated roof assembly must also be addressed with the renewal of the original assembly using new materials or with the installation of temporary, protective cladding. Tarps must only be considered a short term, seasonal measure, understanding that once moisture gains access beneath them, it cannot easily escape and the tarp can actually make conditions worse. Simultaneously with the restoration of the foundation and the roof, the building structure should be reviewed and addressed as necessary to ensure that it remains stable and safe to enter. Following these efforts, conservation works can be completed including the restoration of the original doors and the repair of any localized wall and window deterioration that may be affecting the integrity of the building structure. The open concept of the garage building allows it to constantly vent the interior space.

Photograph 21 & 22 – (top to bottom) the north elevation with a tractor in the east bay and the displaced doors, a ditch along the east elevation

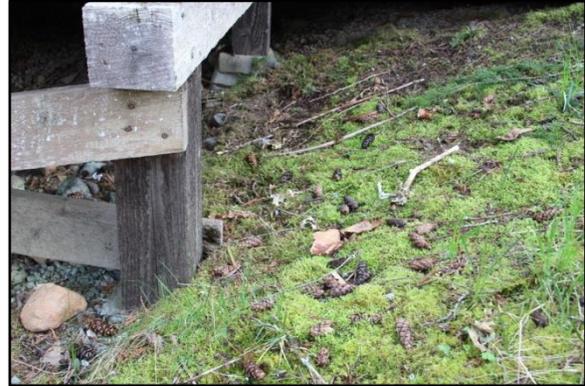
With the extensive restoration work completed in 2011, the Office generally appears to be in good condition. Organic debris accumulation on the roof and the encroachment of grade at the north-west corner are the only noteworthy items of concern. It is recommended that these two circumstances be addressed and integrated into the regular management of the building to prevent the onset of serious deterioration.

Photograph 27 –grade encroaching on a foundation post.

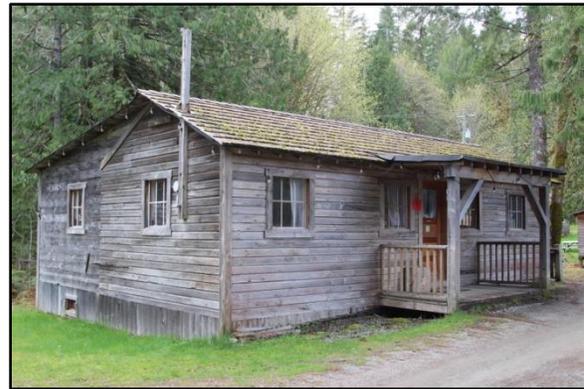
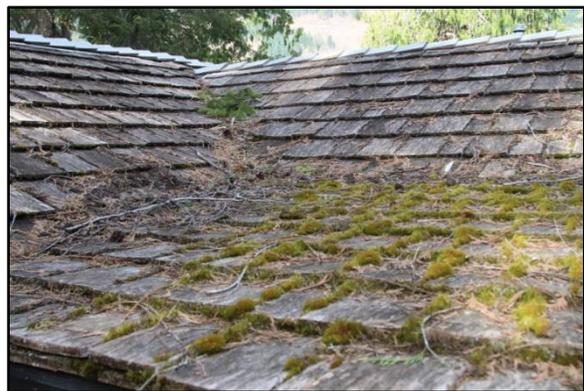
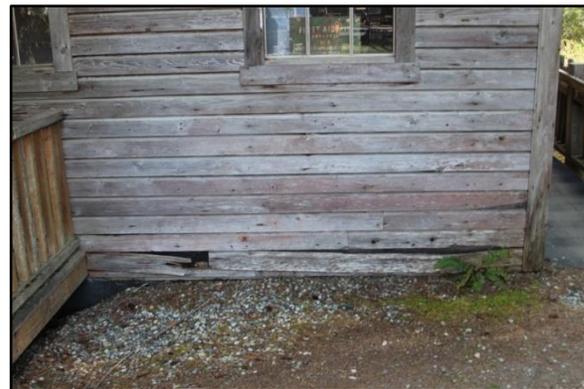
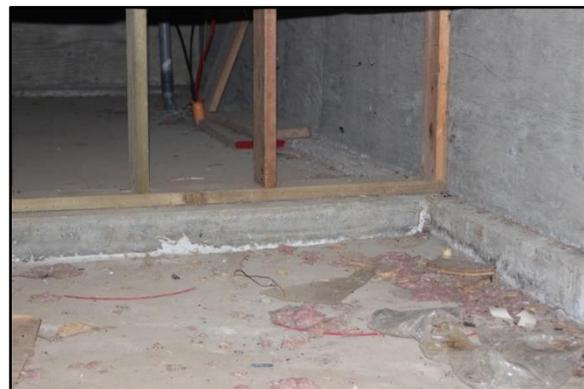
Photographs 29 - 31 – (top to bottom)
debris accumulation on the low-sloped cedar shingle roof, damaged wood cladding, concrete foundation and crawlspace slab.

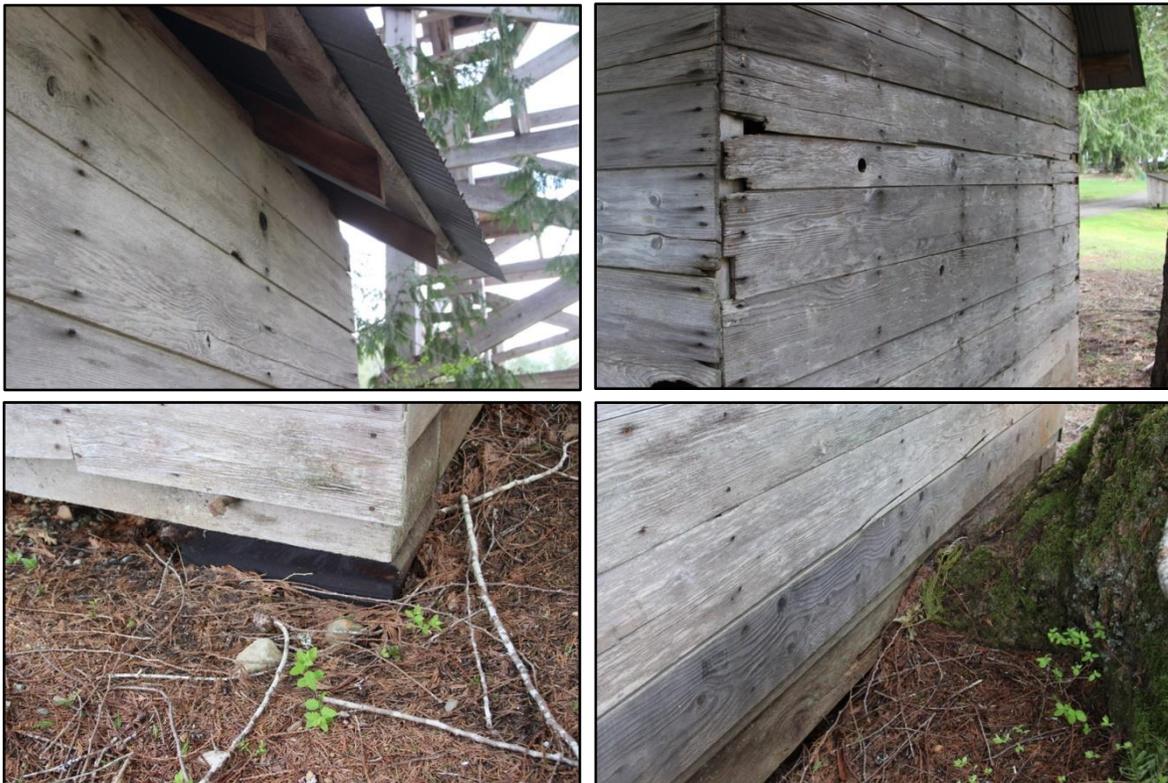
Photographs 33 - 36 – (clockwise from top left) sheet metal roof cladding overhang, deteriorated siding, building base constructed over a tree root, a creosote block footing

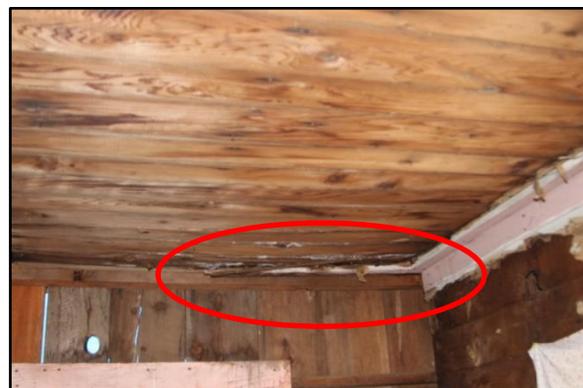
Photographs 38 - 40 – (clockwise from top right) loose roof tarps, deteriorated wood and donna conna ceilings

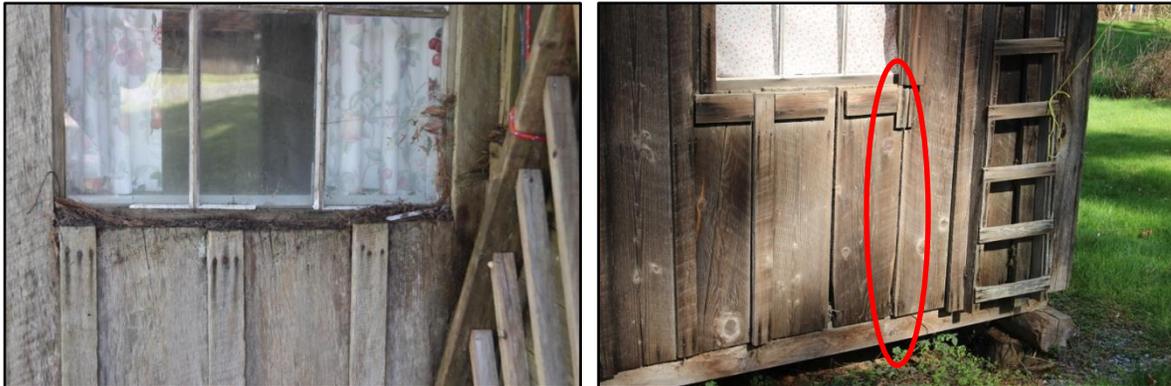
Photographs 41 - 42 – (left to right) missing window trim and debris accumulation at the base, missing batten

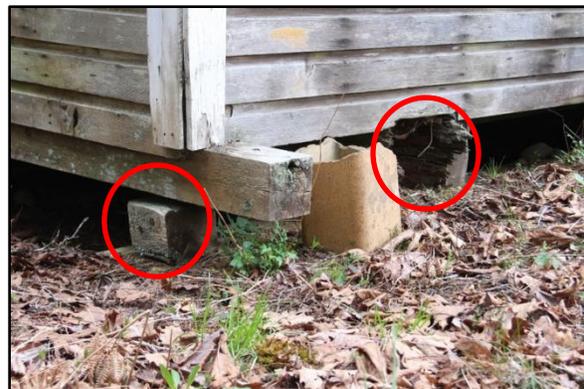
Photographs 44 - 46 – (clockwise from top left) lifting and buckling sheet metal roof, settled and deteriorating timber footing assembly

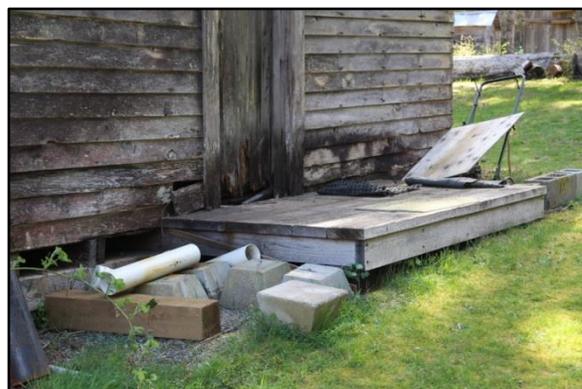
Photographs 48 - 50 – (clockwise from top right) deteriorated timber roof structure, north porch with adjacent door and cladding deterioration, perimeter growth

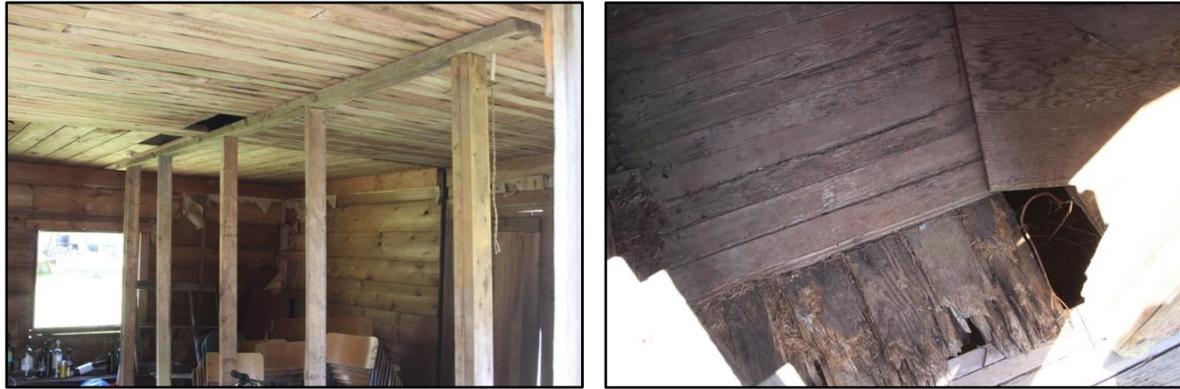
Photographs 51 & 52 – (left to right) interior stud wall, overlaid, deteriorating floor planks

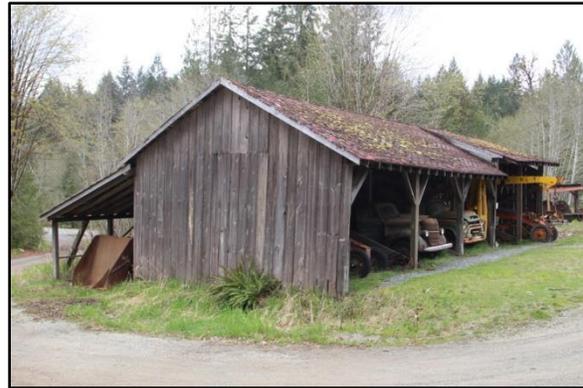
Photographs 58 - 60 – (clockwise from top left) deteriorated asphalt shingles, unconventional roof framing, moisture staining on the structural assembly

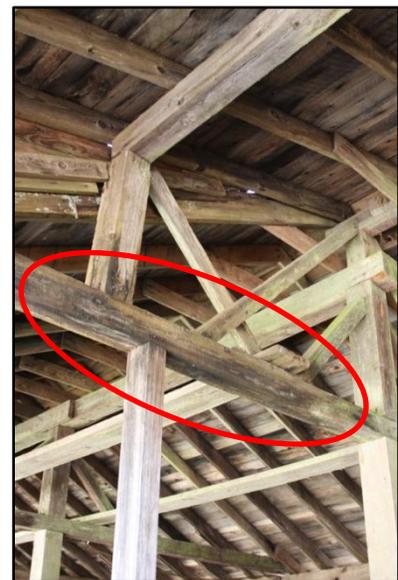
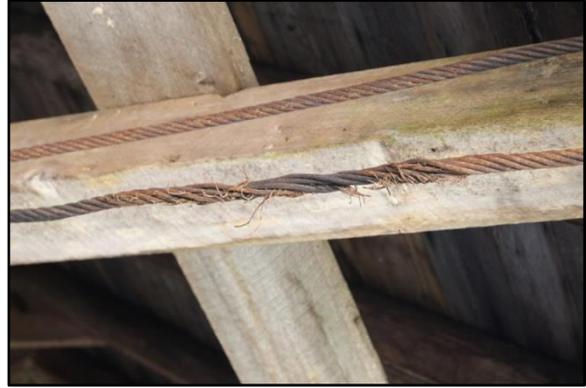
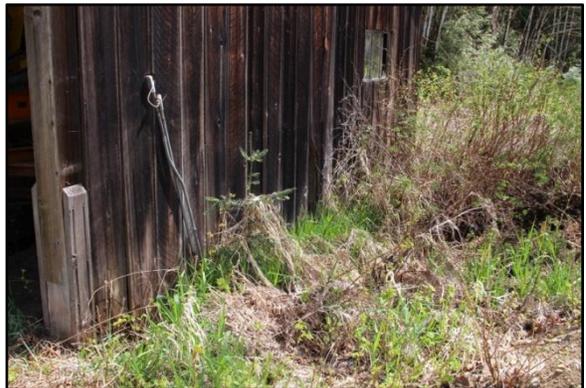
Photographs 61 - 68 –
(clockwise from top left)
failed roof cladding,
frayed tension cable,
unabated growth along
the east elevation,
localized siding failure,
displaced and collapsed
floor planks, post base
failure, overgrown,
braced lean-to
structure

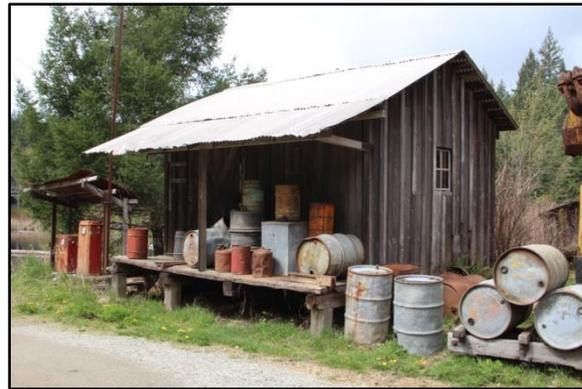
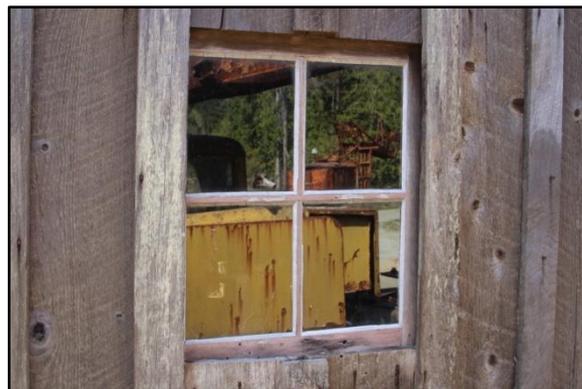
The south wall is in good condition, protected by the porch roof while the remaining walls, without this protection, are significantly weathered with localized damage and organic growth and debris encroaching at the base. The windows, without sill plates or trim, allow water to pass in between the sash and wall assembly.

Photographs 70 - 73 – (clockwise from top left) Loose corrugated roofing, encroachment of growth and debris, a window pane set in the wall, the front porch with a missing support post

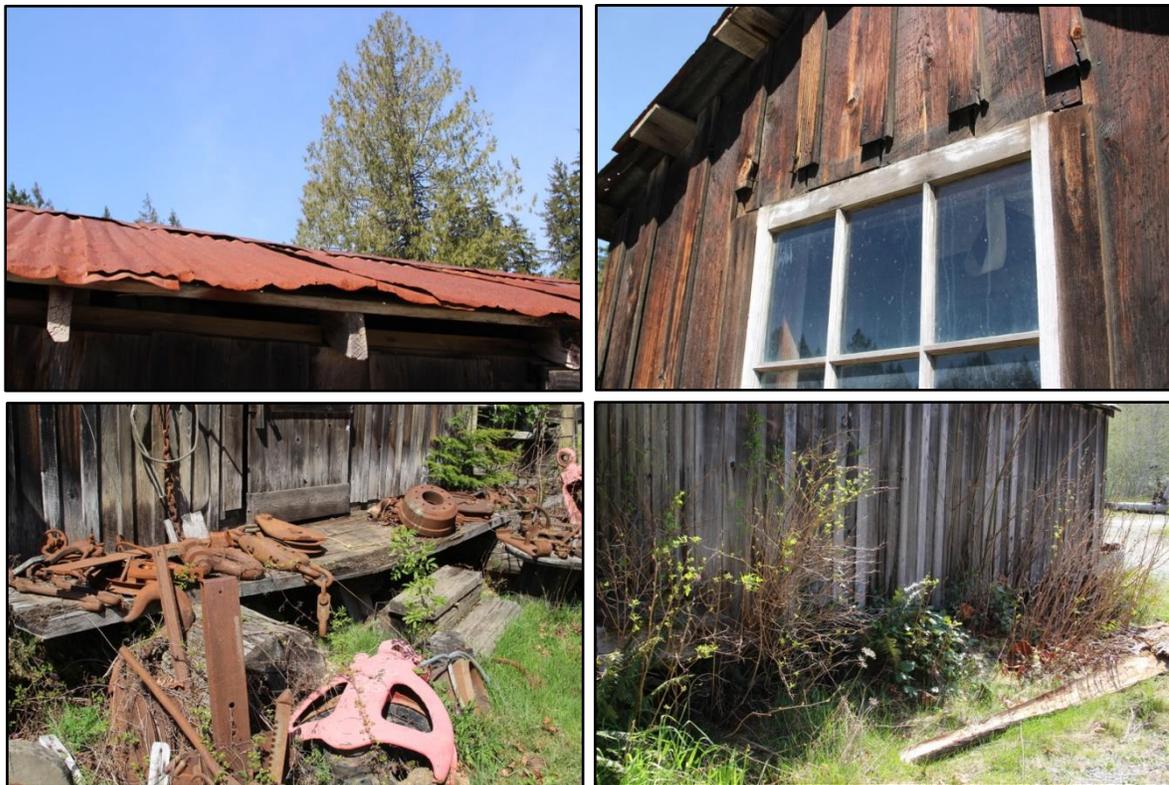
Photographs 79 - 82 – (clockwise from top left) corroded and loose corrugated roofing, missing window trim, organic growth and the building perimeter, misc. parts stored on buckling planks

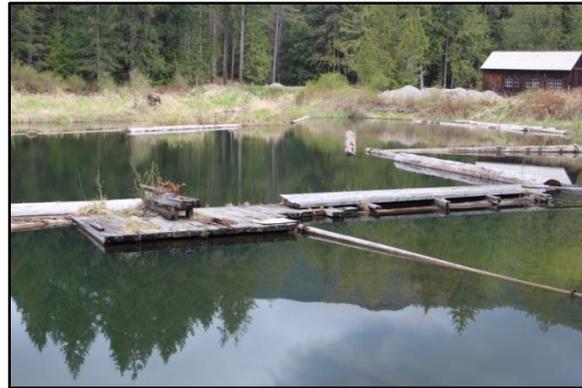
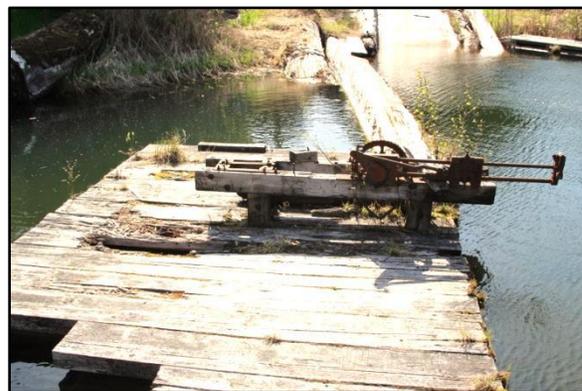
Photographs 84 & 85 – (left to right) Deteriorating wood planks, corroding piece of mechanical equipment

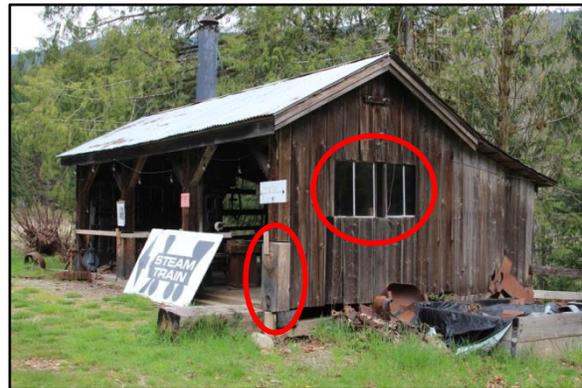
Photographs 87 & 88 – (left to right) organic debris accumulation on the sheet metal roof, unsympathetic post repair and sliding sash

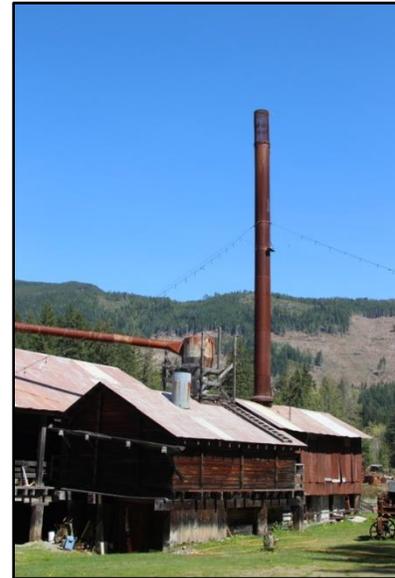
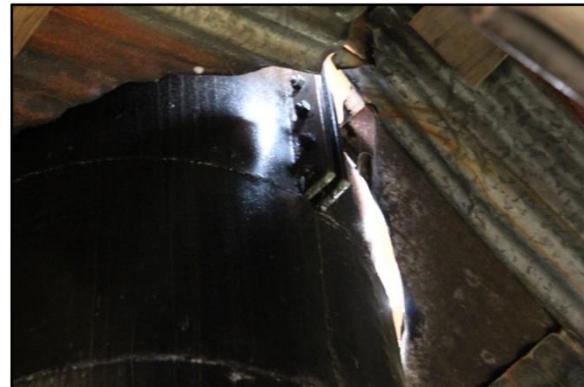
Photographs 92 - 94 – (clockwise from top left) Double layer roof assembly over the east building, gaps between the roof cladding and chimney, sheet rubber lined, wood frame gutters

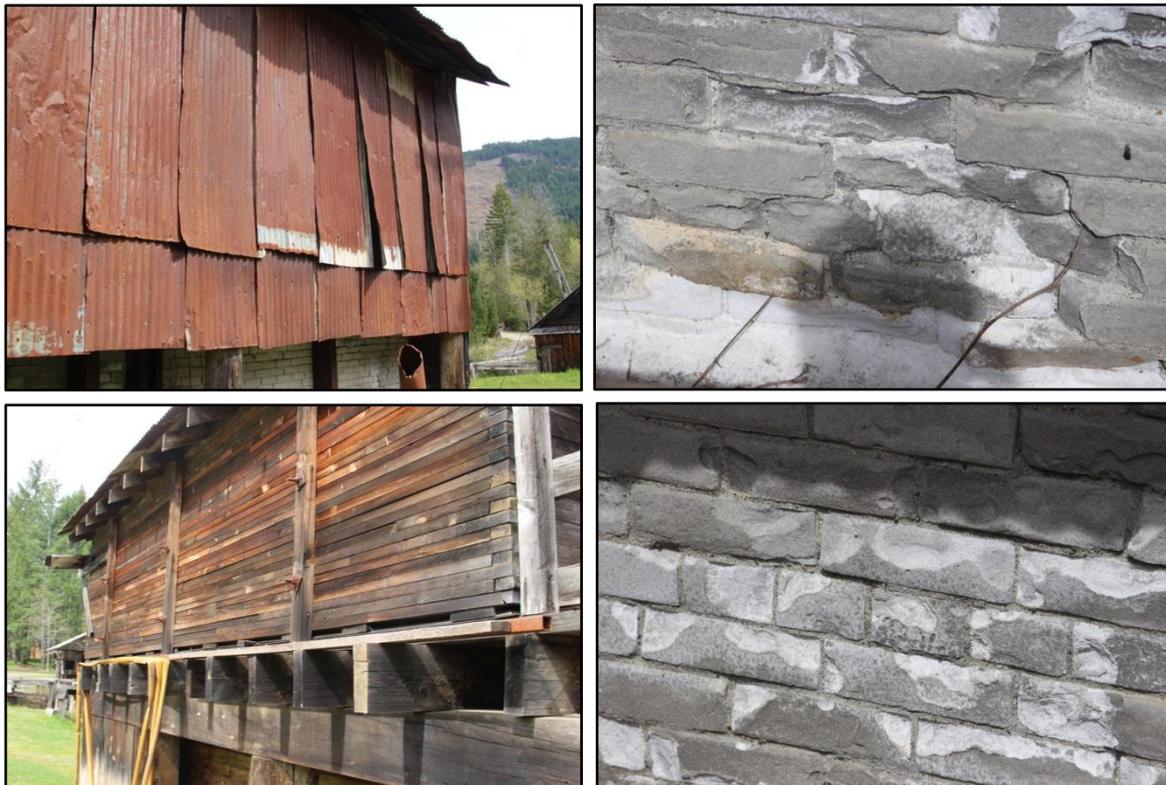
Photographs 95 - 98 – (clockwise from top left) corroding sheet metal wall cladding, spalling and eroding brick foundation, laminated timber walls

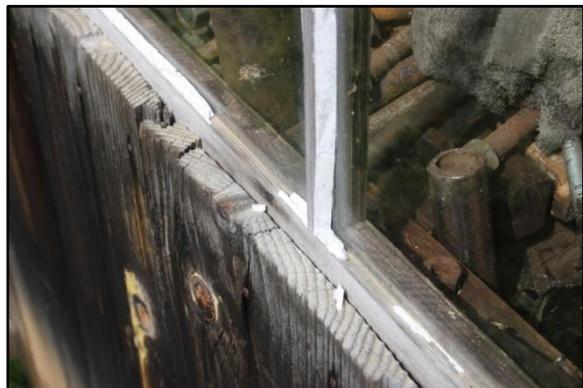
Photographs 100 - 102 – (clockwise from top left) material debris and organic growth against the north elevation, deteriorating glazing putty and gap between the sash and cladding, timber post set on rubber pad on concrete footing

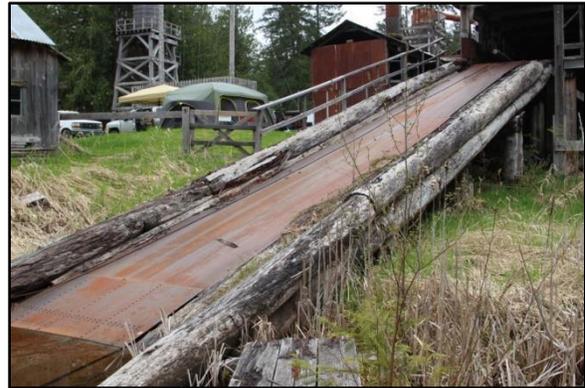
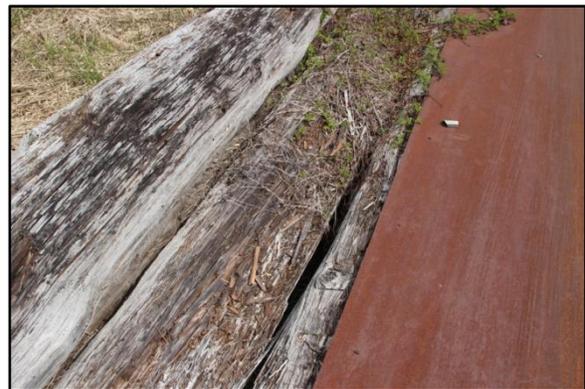
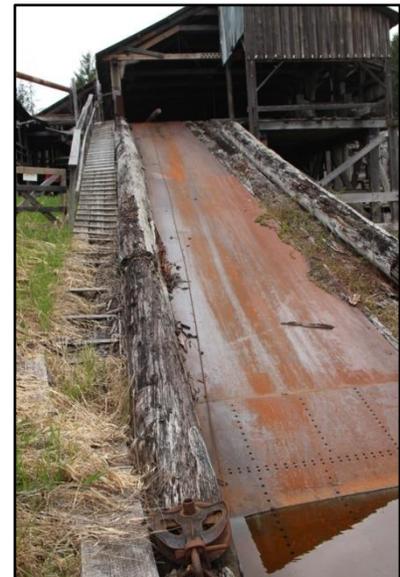
Photographs 104 - 107 – (clockwise from top left) corroding steel plate and deteriorating side timber, deteriorating side timbers with encroaching organic growth, deteriorating side timber and organic growth over walkway, severely deteriorated walkway

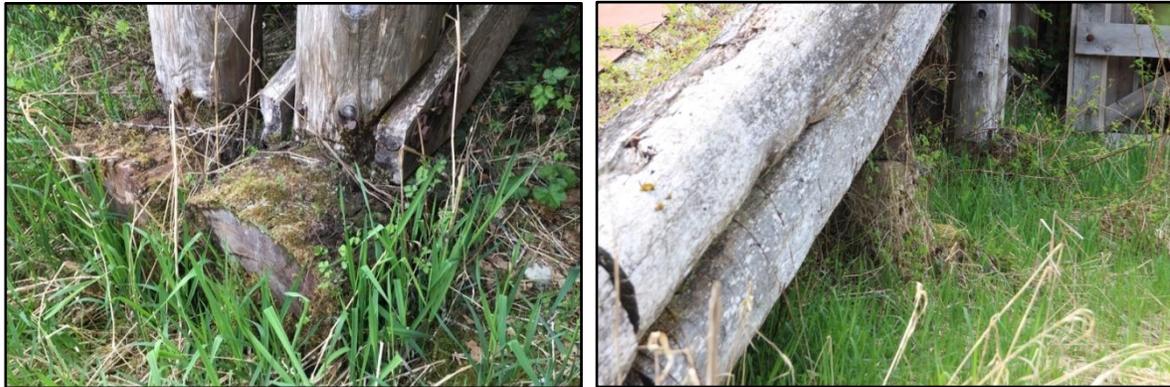
Photographs 108 & 109 – (left to right) timber footings set on grade being overgrown and deteriorating

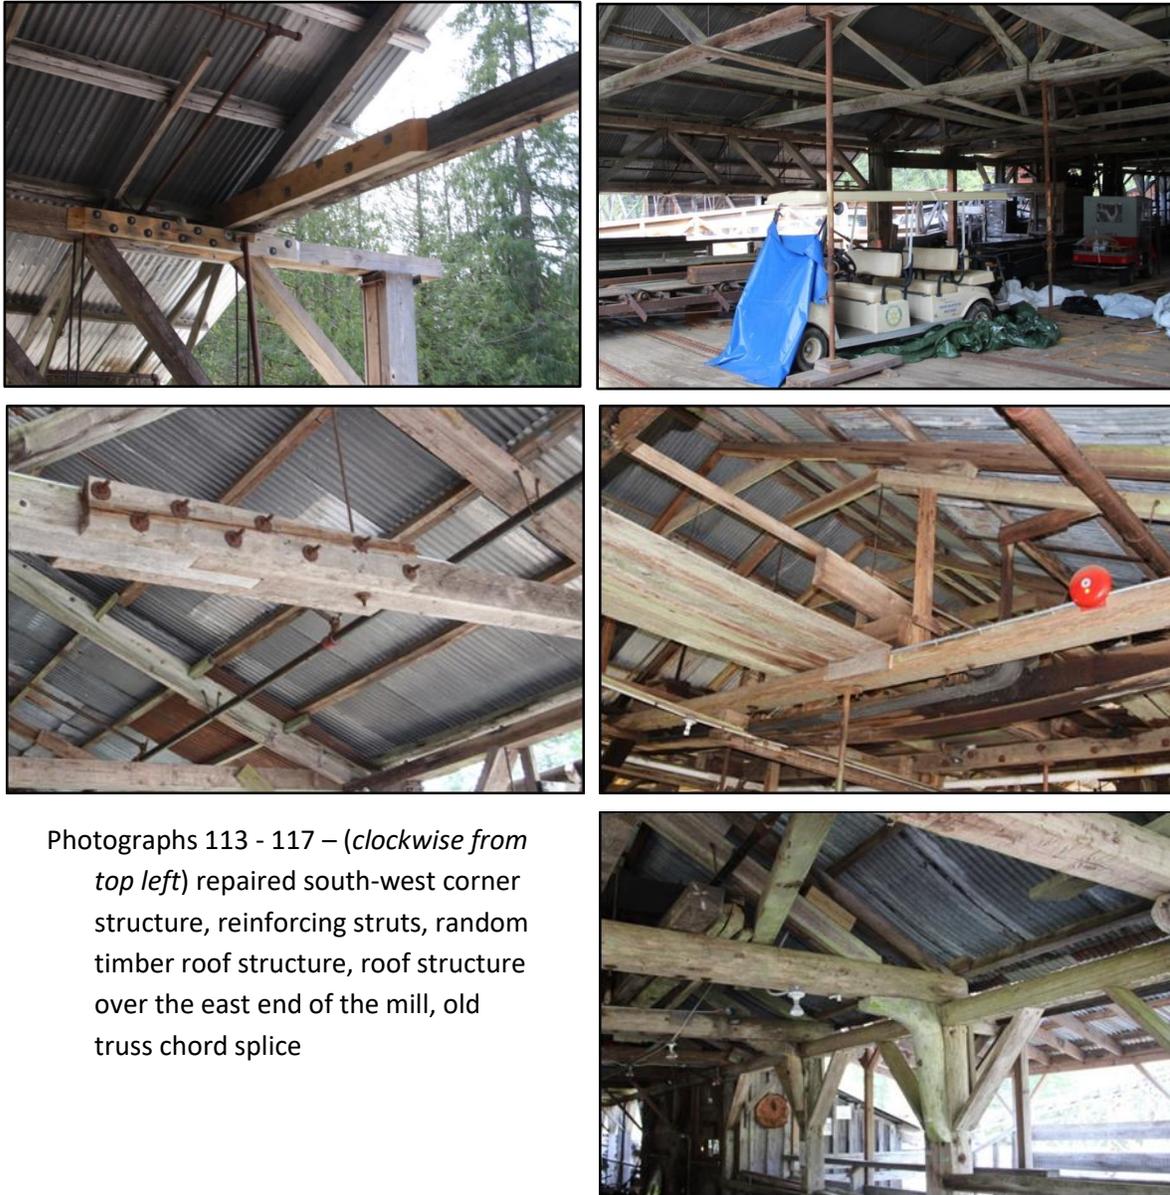
Photographs 113 - 117 – (clockwise from top left) repaired south-west corner structure, reinforcing struts, random timber roof structure, roof structure over the east end of the mill, old truss chord splice

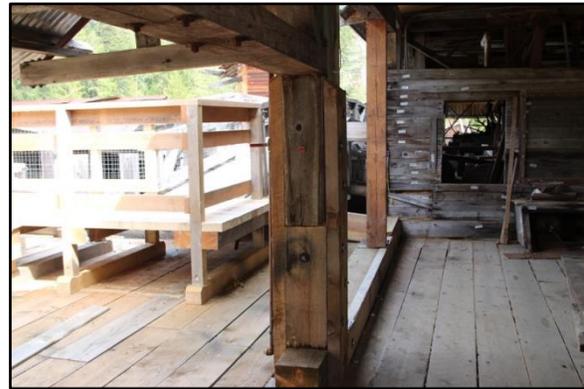
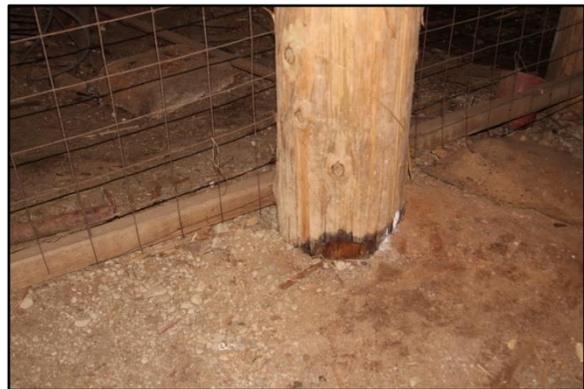
Photographs 118 & 119 – (top to bottom) repaired wall post, deteriorating foundation post base

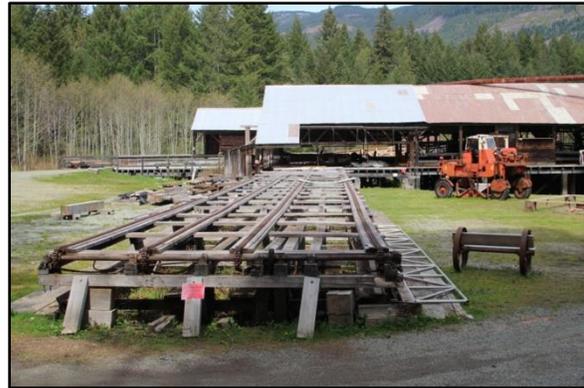
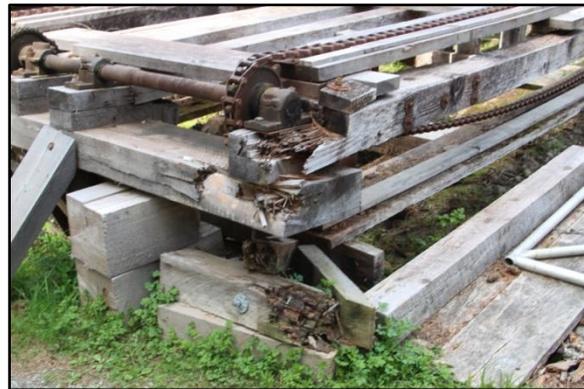
Photographs 122 & 123 – (left to right) failed timber joints

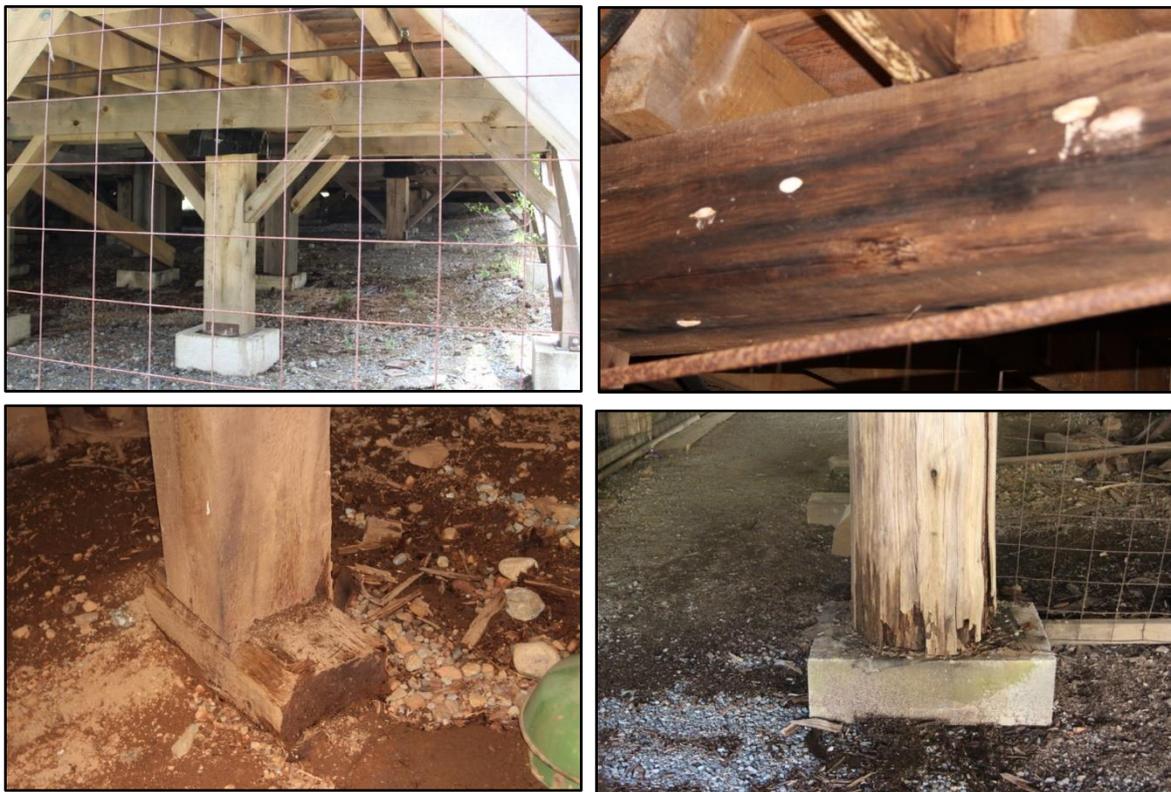
Photographs 125 - 128 – (clockwise from top left) renewed timber deck structure, organic growth on original timber beam, deteriorating post base, , deteriorating timber footing

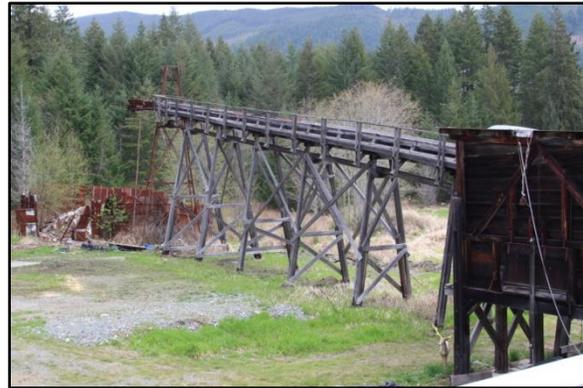
Photographs 130 - 132 – (clockwise from top left) Corroded, corrugated metal roof with flipped panel, spliced posts supporting the Waste Sheds

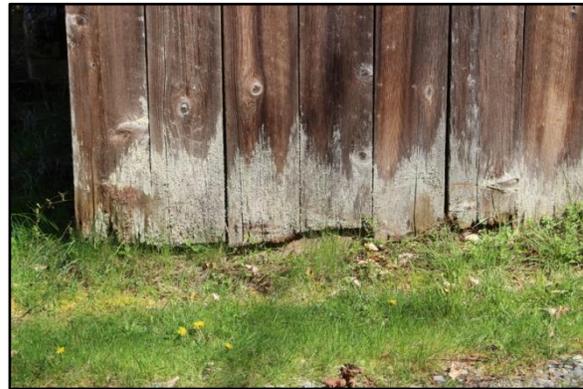
Photographs 137 - 139 – (clockwise from top left) timber roof structure, deteriorated wall planks, organic growth along the east wall

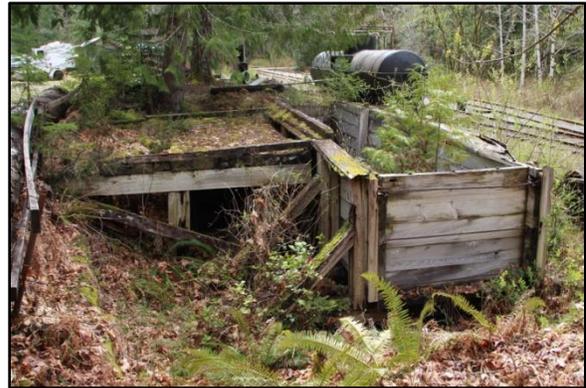
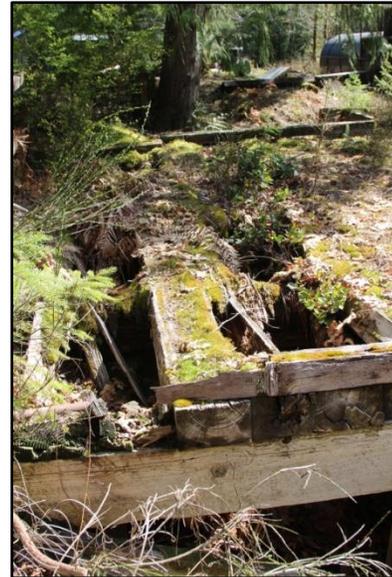
Photographs 141 - 144 – (clockwise from top left)
Overgrown and deteriorated tank wall and adjacent deck, completely deteriorated and failed support beams

It is recommended that if there is an interest to conserve this structure, all organic growth and debris be removed from within and around it, all deteriorated timber elements be replaced with new timbers, and, if necessary, the support structure be set on new concrete footings. Once the conservation work is complete, the deck and tank should be regularly maintained, eliminating organic growth and debris accumulation.

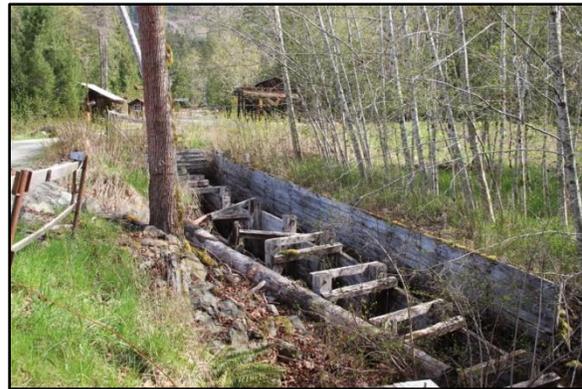
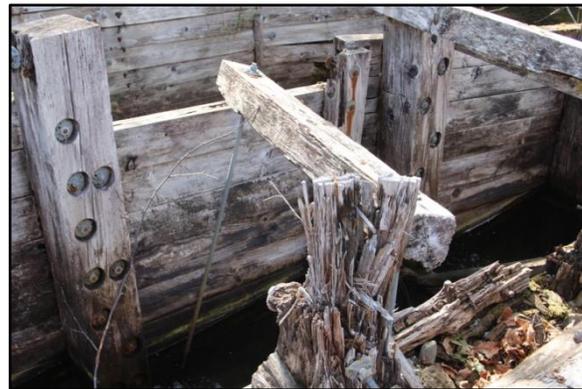
Photographs 146 & 147 – (left to right) structural deterioration of the planks and timbers

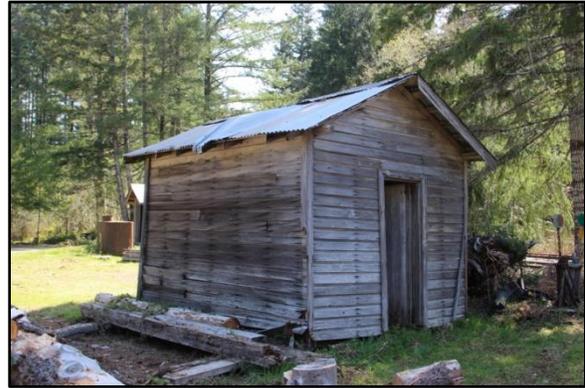
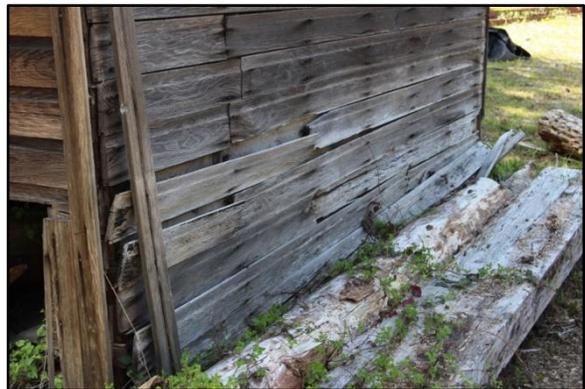
The nailed in place corrugated roof appeared to be in fair condition with a panel bent down at the eaves and buckled mid-span. It would appear that an object fell against the edge of the roof to create this condition. Many of the roofing nails also appeared to be popping leaving a number of the panels loosely held in place. Half of the trim at both roof gables was noted to be missing.

Photographs 149 - 151 – (clockwise from top left) buckled corrugated roof panel, damaged wall siding, missing trim on the north window

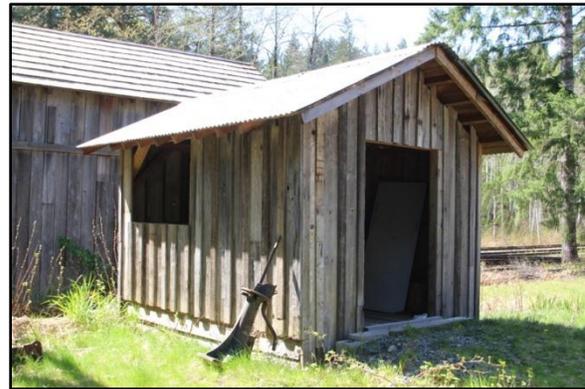
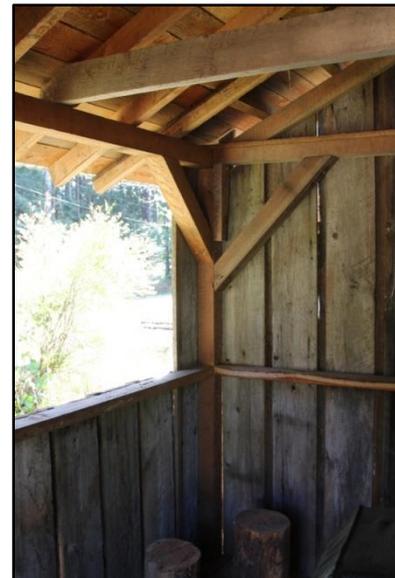
Photographs 153 - 155 – (clockwise from top left) Cracked truss chord, braced frame wall structure, log timber on concrete footings
