# HAZARDOUS MATERIALS SURVEY REPORT

Somass Silo

3500 Harbour Road

November 2025

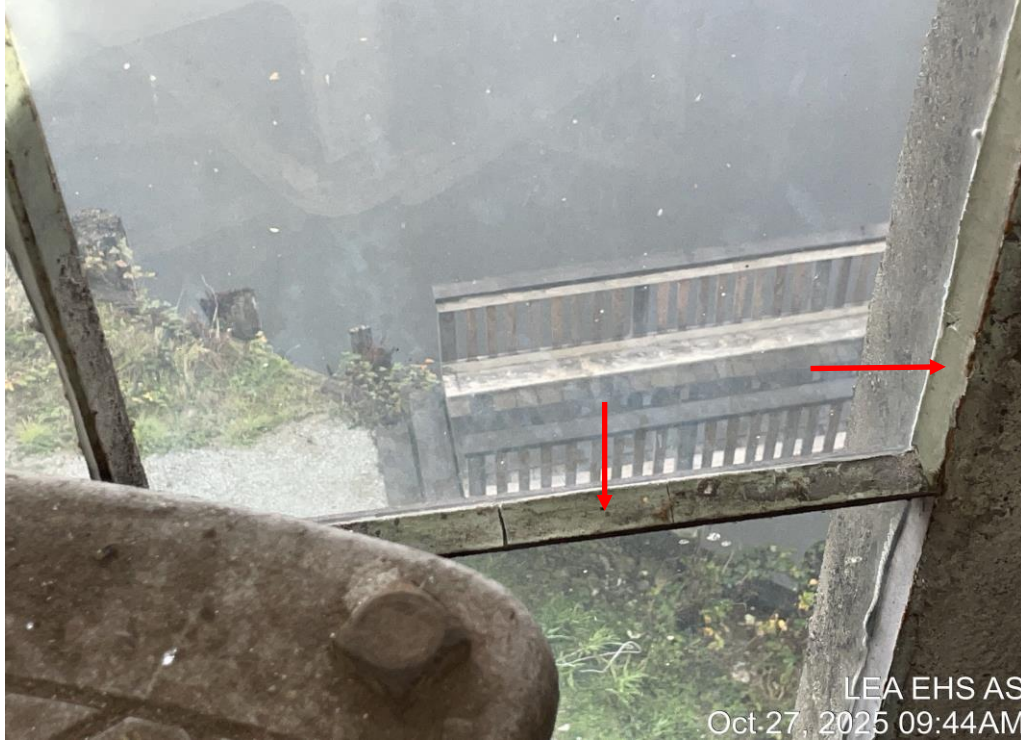
| Sample No. | Sample Description | Sample Location | Asbestos Content | Quantity <sup>1</sup> |
|---|---|---|---|---|
| E0434-372.9-1a, b, c | Off-White Window Putty | Silo Interior Window | Chrysotile 1-3% | 3 Windows |

**Figure 1.** Asbestos-Containing Off-White Window Putty - Interior.

**6.1 Asbestos-Containing Materials:** The materials described as Asbestos-containing in Section 5.1 must be removed or safely contained by a WorkSafeBC Certified Asbestos Abatement contractor prior to general demolition. 'Moderate Risk' procedures as described in the WorkSafeBC publication Safe Work Practices for Handling Asbestos (BK27), must be followed for removal of all putties and mastics. Suspect mechanical gaskets, ropes, and belts, incandescent light insulation, electrical wire casing, brakes and cement pipes may also be removed following Moderate procedures if encountered. (Occupational safety hazard – Moderate)

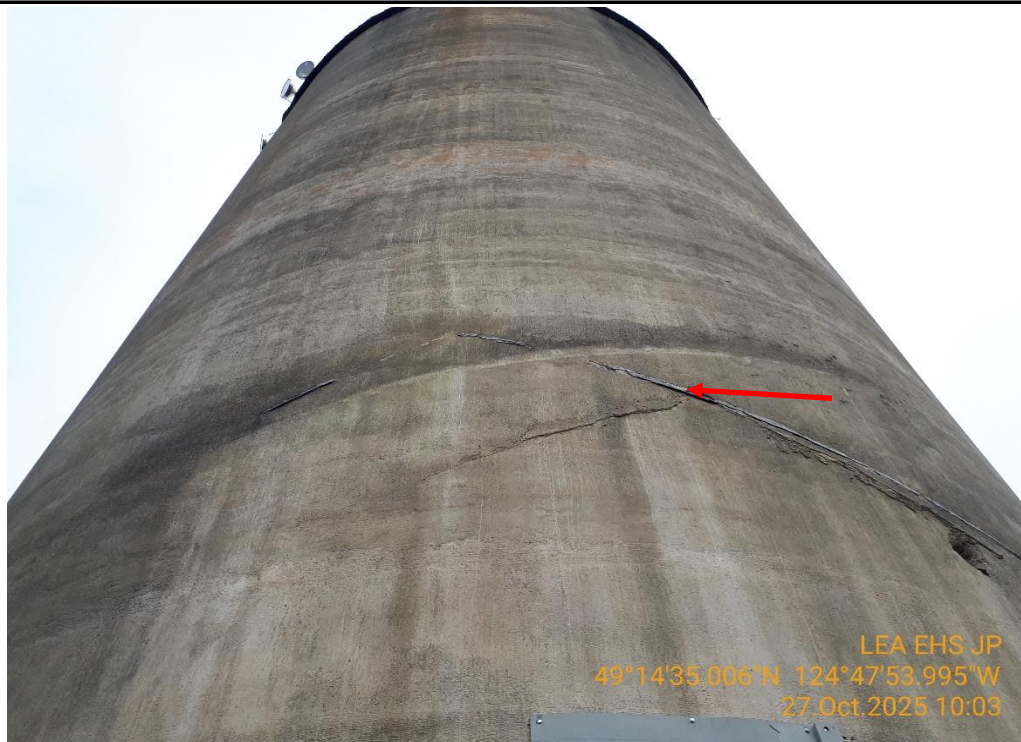
| Sample No. | Sample Description | Sample Location | Asbestos Content | Quantity <sup>1</sup> |
|---|---|---|---|---|
| E0434-372.9-3a, b, c | Black Mastic | Silo Exterior | Chrysotile 15-30% | Throughout |

**Figure 2.** Asbestos-Containing Black Mastic on Exterior Concrete Wall of Silo.

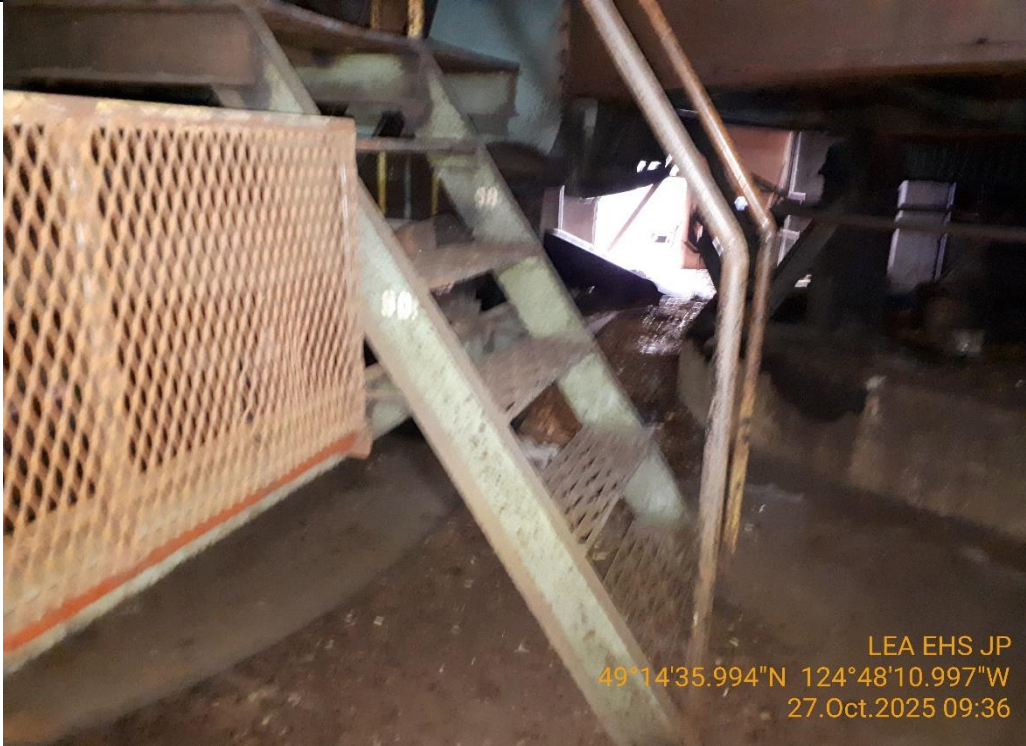
| Test No. | Sample Description | Sample Location | Lead Content | Quantity <sup>1</sup> |
|---|---|---|---|---|
| #2 | Blue/green paint on metal stairs | Silo Interior | > 5 % | All Metal |
| #3 | Red paint on metal safety cage | Silo Interior | 5000-10000 ppm | All Metal |
| #4 | Yellow paint on metal safety railing | Silo Interior | > 5 % | All Metal |

**Figure 3.** Lead-Containing Coatings/Metal on Interior Structures

**6.2 Lead-Containing Materials:** The materials described as lead-containing in Section 5.2 must be removed or safely contained by a qualified contractor who is experienced with safe practices for handling lead prior to general demolition. Although Lead content may be reported as <90 ppm, any level of Lead in these materials may present a significant exposure risk to workers, depending on the type and condition of the material(s) & upon the method(s) of removal and handling. If work disturbing lead-containing materials is undertaken, a Risk Assessment, Exposure Control Plan and related Safe Work Procedures will be required to ensure exposure is kept to levels 'As Low as Reasonably Achievable'. For more information see WorkSafeBC publication BK 159 "Safe Work Practices for Handling Lead". (Occupational safety hazard assuming no dry stripping – Low to Moderate)

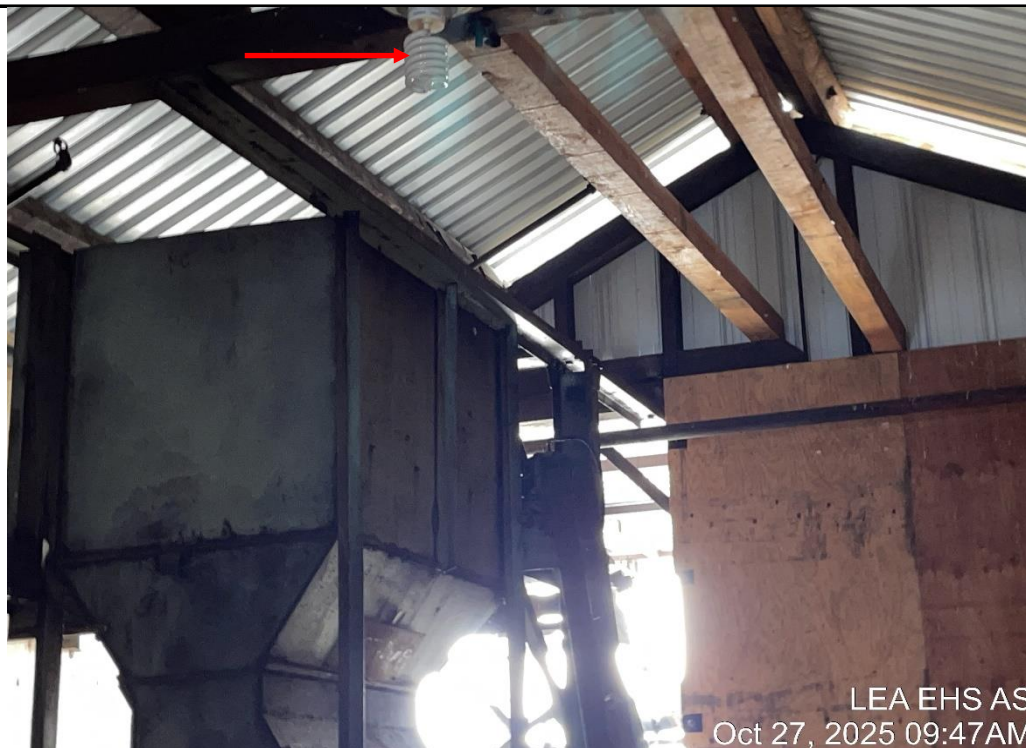
**5.5 Mercury-Containing Products:** Mercury-containing compact fluorescent lights (CFL) bulbs were observed.

**Figure 4.** Mercury-Containing Compact Fluorescent Light

**6.4 Mercury-Containing Electrical Apparatus:** Mercury containing Compact Fluorescent Light (CFL) bulbs should be removed intact for re-use or for disposal at an approved receiving facility. (Occupational safety hazard – Low)

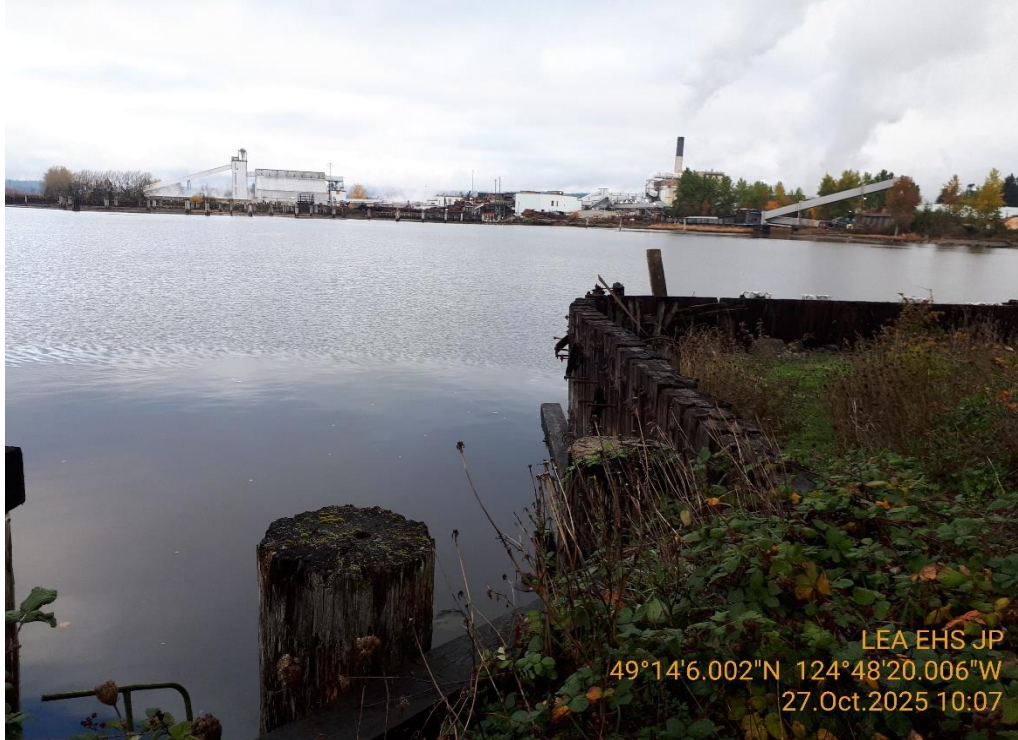
**5.7 Bulk Petroleum and Hazardous Products:** Bulk Petroleum was not observed. Pressure-treated lumber with creosote and/or other chemical preservatives were observed outside the silo structure.

**Figure 5.** Pressure-Treated Lumber Containing Chemical Preservatives

**6.6 Bulk Petroleum and Hazardous Products:** Pressure-treated lumber containing chemical preservatives should be removed intact and separated from general waste for proper disposal. (Occupational safety hazard assuming no dry stripping – Low)

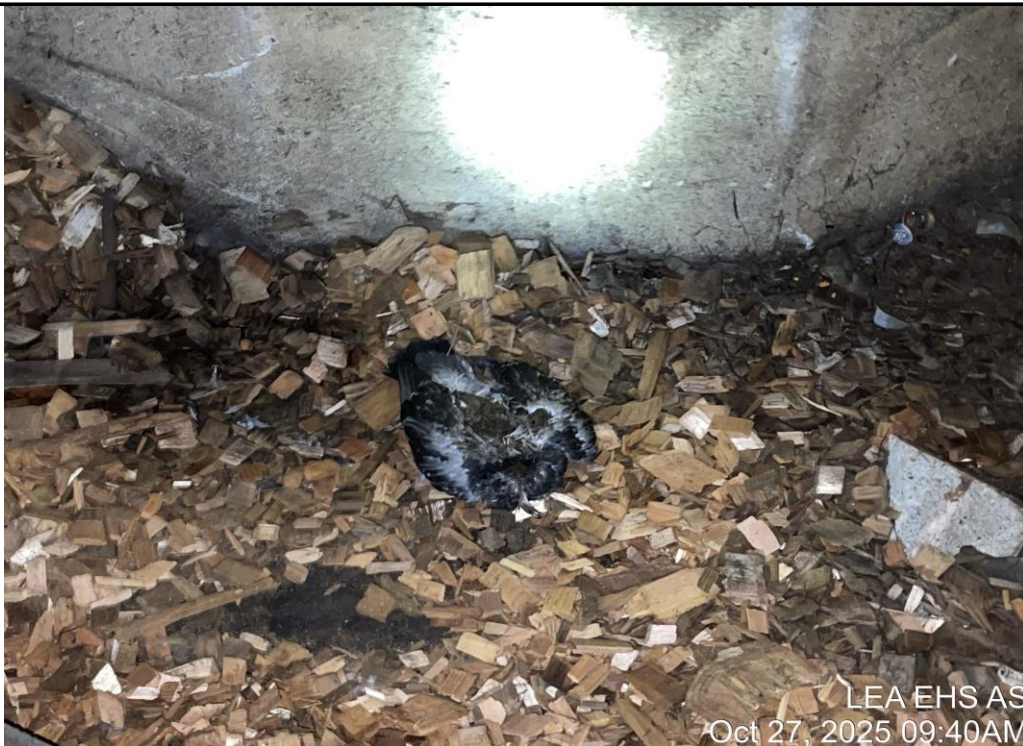
Other bio-hazardous materials were observed including rodent droppings, bird carcasses and human feces.

**Figure 6.** Bio-Hazardous Bird Carcass and Droppings

**6.7 Biohazardous Materials:** Personal protective equipment including gloves and a respirator should be worn where workers are exposed to bird carcasses, rodent droppings and/or human feces. (Occupational safety hazard - Low)
