AGENDA - COMMITTEE OF THE WHOLE

Monday, June 16, 2025 @ 6:00 PM

4850 Argyle Street, Port Alberni, BC

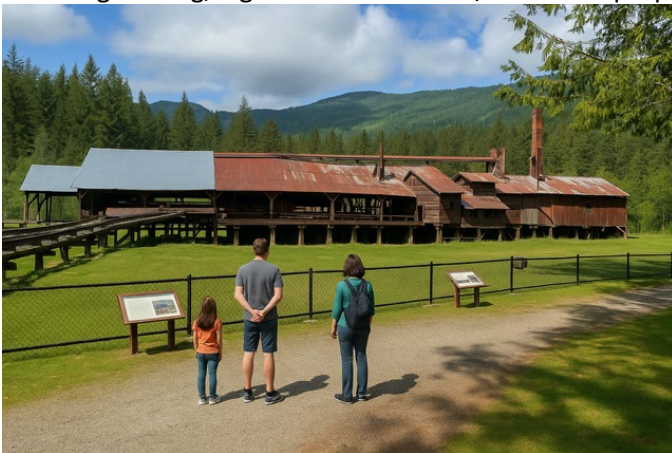
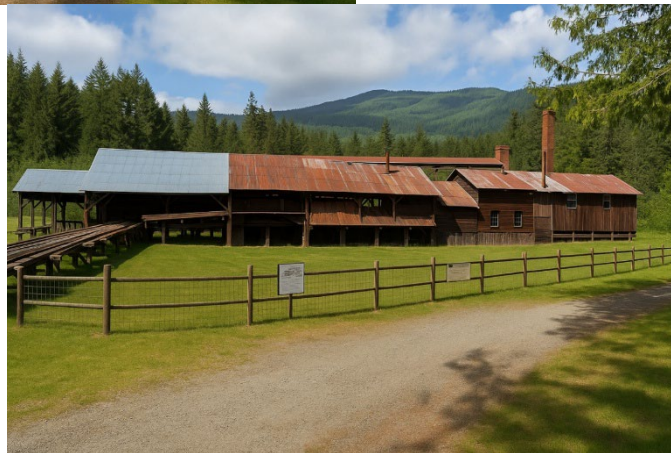
Both the McLean House and Worker House have the presence of hazardous materials and access to them should be restricted. While this can be achieved with a new set of locks but abatement is recommended to make the asset safe for access and to preserve the asset. Signage is recommended to prevent any access. Volunteers for the Chamber of Commerce will be notified that the structure is no longer accessible.

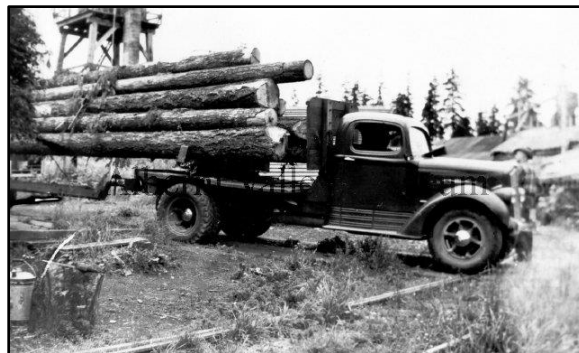
Photograph 1 – Gas powered logging truck

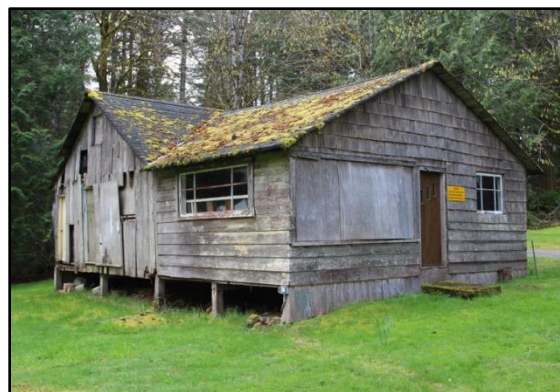
Currently, the asphalt shingle roof is supporting significant moss growth on both the north and east elevations while moisture ingress through the attic has occurred, deteriorating the ceiling finishes. The discontinuous roof line at the south-east corner would suggest a previous addition on the east elevation has been removed.

The Workers House was generally found to be in fair condition though in need of remediation work. It is recommended that if the roof is found to be currently leaking, it be addressed with the installation of temporary sheet metal or the renewal of the asphalt shingles to eliminate persistent moisture ingress and related deterioration. The east elevation should be repaired to close up the damaged and exposed wall assembly and prevent moisture ingress into the building. The window sills should be restored where signs of moisture ingress into the wall assembly are evident. The damaged floor joists should also be replaced to prevent further building displacement and the possibility of progressive failure. If material is to be stored in this building, it is important that it be organized and well-spaced to facilitate airflow, reduced moisture storage, and allow for the onset of assembly deterioration and displacement to be readily observed.

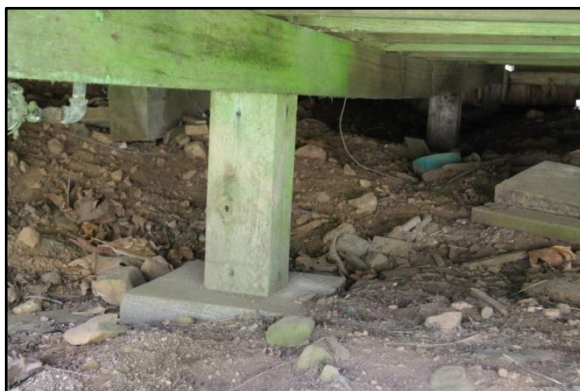
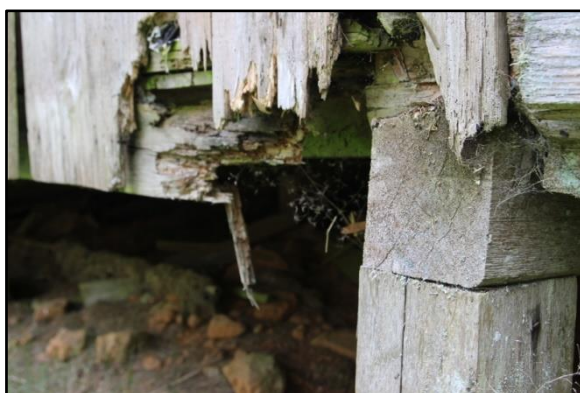
The interior was observed to be haphazardly filled with random materials and debris exacerbating building deterioration and compromising interior air flow and drying.

Photographs 8 - 10 – (clockwise from top left) renewed timber foundation structure on concrete pad footings, deteriorated exterior joists resulting in building displacement

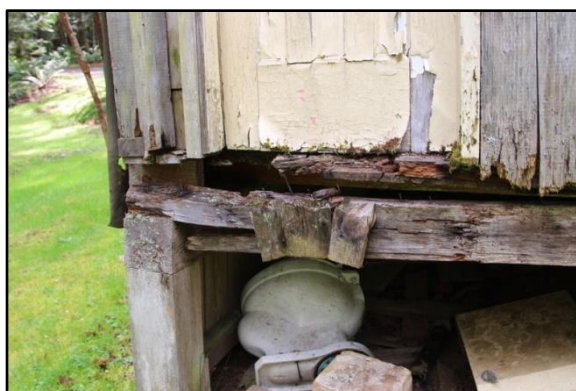
The supporting timber structure appears in good condition except at the south end of the east elevation where the outer joist has failed, resulting in differential settlement.

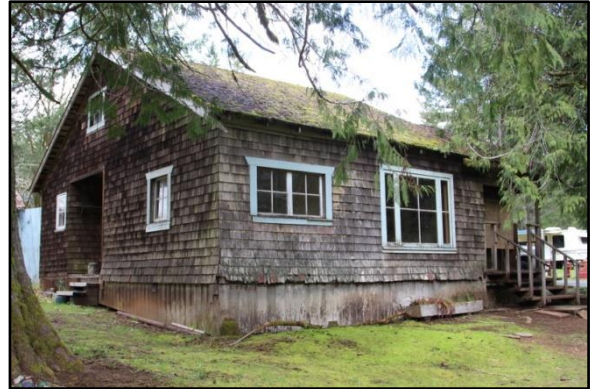
Built adjacent to a couple of large trees, Organic debris and growth is accumulating on the cedar shingle roof and filling the gutter over the front door. At least one branch was observed to be resting on the roof. Despite this, the roof appeared to be performing as required with no observed interior moisture ingress and related deterioration.

Photograph 12 – debris accumulation on the roof and in the gutter

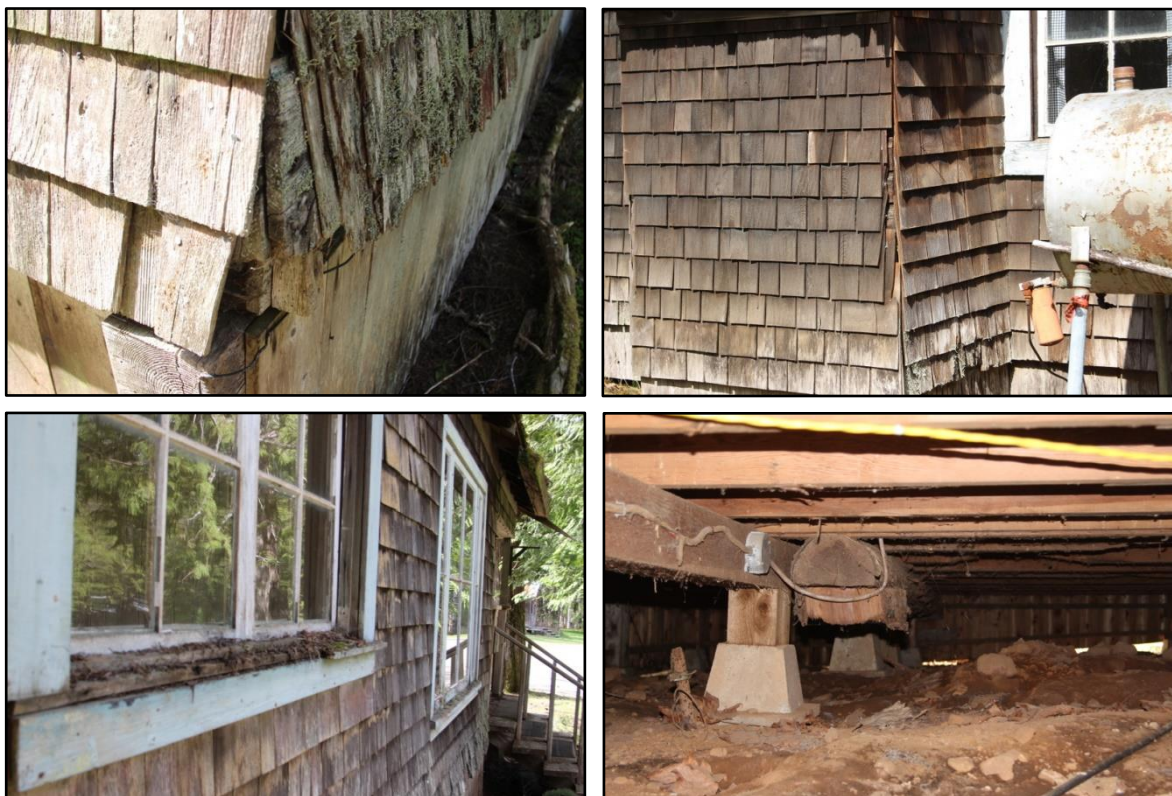
Photographs 13 - 16 – (clockwise from top left) deteriorated wall cladding, sound building frame and footings, debris on the window sills

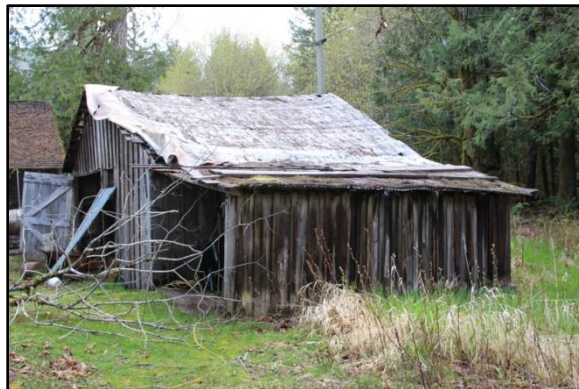
Currently the building is in a state of advanced deterioration and close to structural collapse. The roof structure is exposed to the elements while the south-west corner of the building is submersed in standing water.

The condition of the A. McLean Garage is critical with potential assembly failure imminent. As with all buildings, it is important that the garage stay dry and have the capacity to dry out to best minimize moisture related deterioration. The primary recommendation is to reset the building on a new foundation assembly, out of the encroaching water, and if necessary, drain the adjacent accumulation of water away from the area. The deteriorated roof assembly must also be addressed with the renewal of the original assembly using new materials or with the installation of temporary, protective cladding. Tarps must only be considered a short term, seasonal measure, understanding that once moisture gains access beneath them, it cannot easily escape and the tarp can actually make conditions worse. Simultaneously with the restoration of the foundation and the roof, the building structure should be reviewed and addressed as necessary to ensure that it remains stable and safe to enter. Following these efforts, conservation works can be completed including the restoration of the original doors and the repair of any localized wall and window deterioration that may be affecting the integrity of the building structure. The open concept of the garage building allows it to constantly vent the interior space.

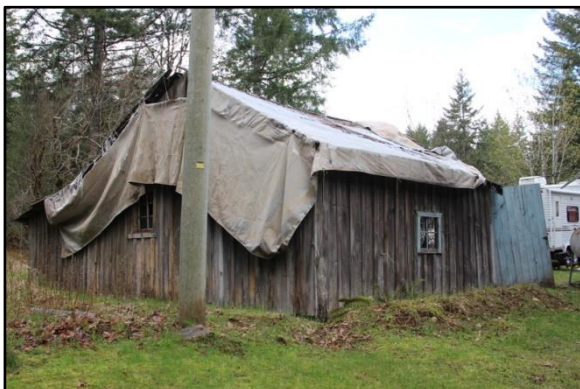
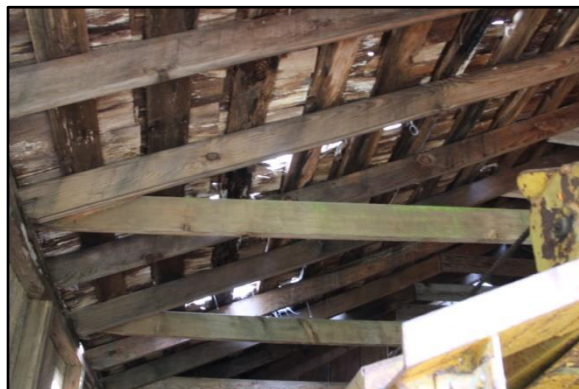
The cedar shingle roof over the main garage has been protected with a tarp that is loosely held in place and heavily damaged. With the severe deterioration of the shingles and the damaged tarp, the roof structure is exposed to moisture ingress and the associated deterioration. The lean-to on the west side is protected with sheet metal cladding held down with timber scraps and debris. Given the low-slop and accumulation of debris, the onset of deterioration of the sheet metal is unavoidable with a number of holes already observed.

Photograph 18 - 20 – (clockwise from top left) damaged roof tarp, holes through the main, cedar shingle roof and the lean-to, sheet metal roof

Table 3 – Arnold McLean Garage - Renewal Recommendations		
9	Renew the roof cladding and address any roof structure deterioration	Critical
10	Reset the building on a new foundation out of accumulating water.	Critical
11	Complete a structural review of the building and address any necessary upgrades	Critical
12	Restore the garage doors	Low

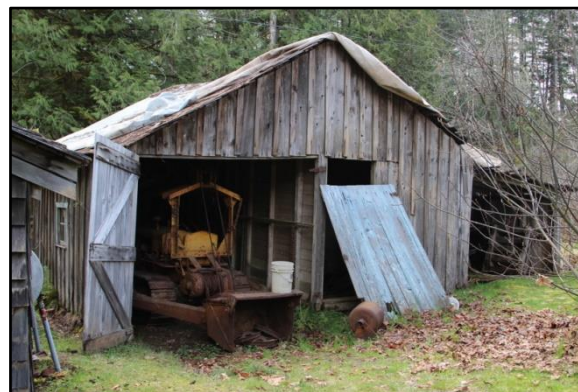
The board and batten wall cladding and the windows both appear to be in fair condition with only minor localized deterioration, particularly along the base of the wall. The garage doors to the east bay were observed to be off their hinges, one leaning against the building and the other haphazardly hanging.

Photograph 21 & 22 – (top to bottom) the north elevation with a tractor in the east bay and the displaced doors, a ditch along the east elevation

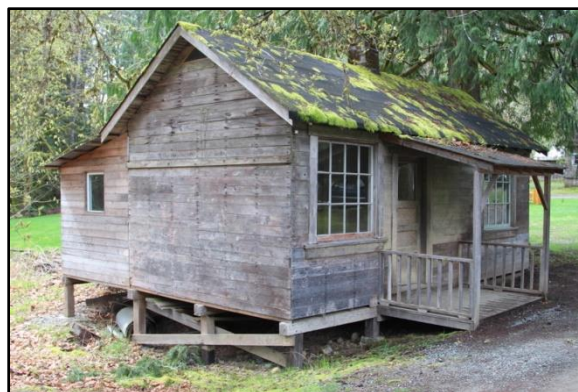
The main and entrance porch roofs are currently protected with a modified bitumen sheet membrane while the rear addition is covered with sheet metal. Both roofs are supporting organic growth and debris but otherwise appear to be performing as expected. The exposed rafter ends were observed to be deteriorating suggesting that the overhang of the roof is not sufficient to prevent moisture drainage onto them. The chimney appears in fair condition but could be cleaned and repointed to reduced accumulating organic growth and associated deterioration.

Table 4 – Office - Renewal Recommendations		
13	Remove organic growth and debris from the roof and repoint the chimney.	Medium
14	Pull back grade from the north-west corner of the building and monitor the encroachment of tree roots	Low

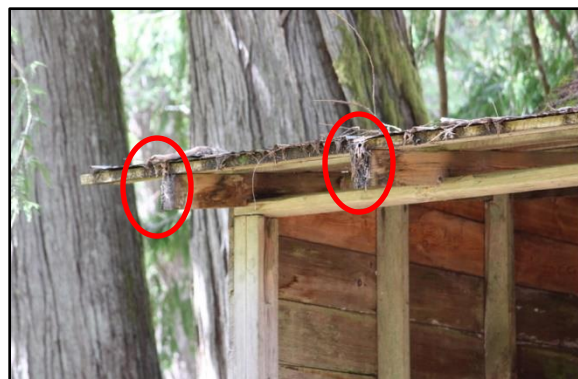
Photograph 24 – debris runoff on the rafter tails

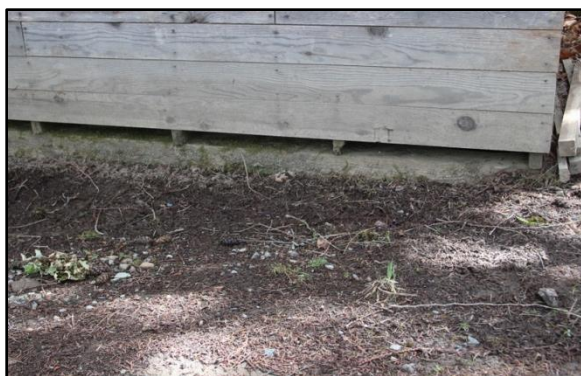
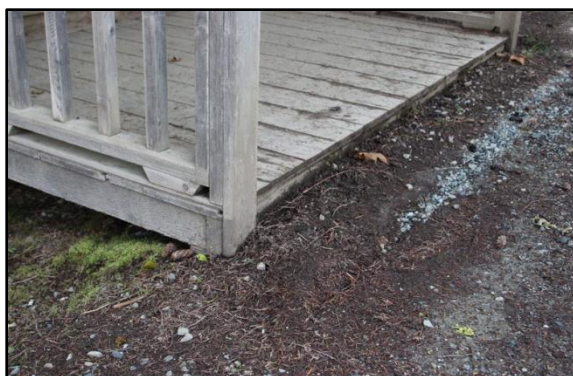
The restored foundation posts and concrete footings appeared to be in good condition. Lacking the perimeter skirting, there is positive ventilation beneath the building. Grade is however starting to accumulate at the north-west corner and along the west and north edges of the entrance porch putting the base timber at risk of moisture related deterioration. A large tree is also growing in close proximity to the west elevation, exacerbating the impact of the accumulating grade. Material debris was also observed to be stored beneath the building.

Photograph 25 & 26 – (left to right) grade accumulation along the north elevation

With the extensive restoration work completed in 2011, the Office generally appears to be in good condition. Organic debris accumulation on the roof and the encroachment of grade at the north-west corner are the only noteworthy items of concern. It is recommended that these two circumstances be addressed and integrated into the regular management of the building to prevent the onset of serious deterioration.

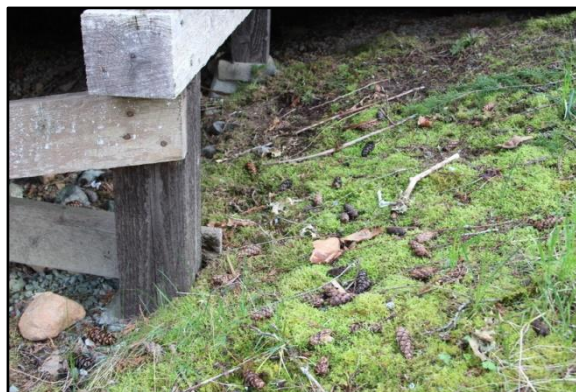
Photograph 27 –grade encroaching on a foundation post.

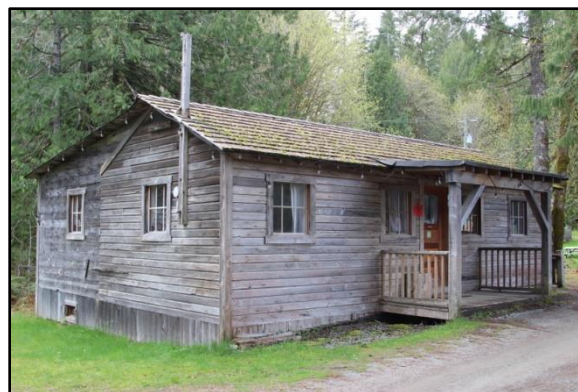
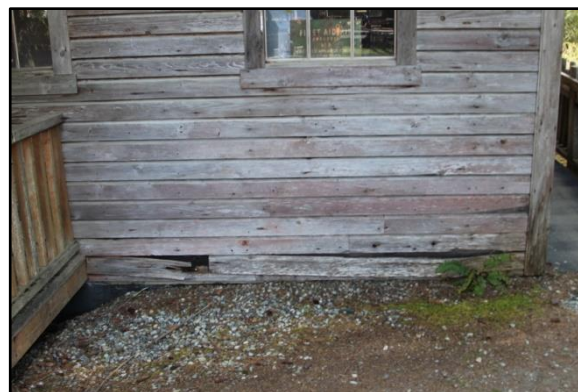
Concrete foundation walls and a central pony wall on strip footings support the building while a concrete slab finishes the crawlspace floor. Timber skirting maintains the historic appearance on the exterior. The crawlspace is ventilated with several openings. The supporting structure appeared to be in good condition.

Photographs 29 - 31 – (*top to bottom*)
debris accumulation on the low-sloped
cedar shingle roof, damaged wood
cladding, concrete foundation and
crawlspace slab.

Having been reconstructed to form a contemporary office space on site, the R.B. McLean House is in good condition with no signs of serious deterioration. The low-sloped roofs and gutter collect organic debris that should be regularly removed. The cedar shingles on the low-sloped roof should also be replaced with the more appropriate modified bitumen membrane. The damaged siding could also be repaired.

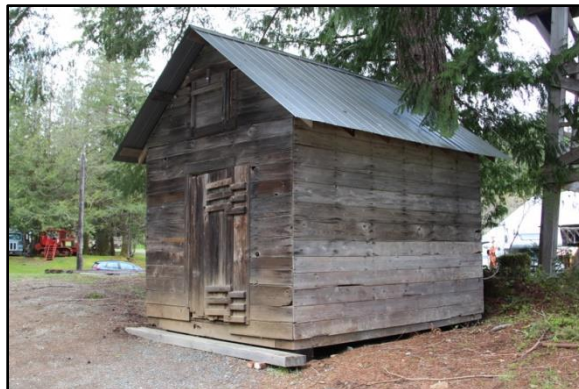
Currently a steeply sloped, sheet metal roof with generous eaves and overhangs protects the wood frame structure. The roof structure supporting the sheet metal appeared to be in good condition.

The wood clad walls appeared in good condition with only a few pieces of siding showing minor edge and end damage and deterioration. The door appeared to be original, at least in design, with dimensional lumber hinges. The building is without any windows.

Creosote blocks at the building corners were observed to be providing foundational support. They appeared to be in good condition from what could be seen. Beyond this, little could be observed of the footings. The building appeared level indicating the footings have not failed. It was noted that the building was constructed over a tree root that will likely, over time, impact its slope and stability.

Photographs 33 - 36 – (clockwise from top left) sheet metal roof cladding overhang, deteriorated siding, building base constructed over a tree root, a creosote block footing

Having been extensively restored, the Root House appears to be in good condition with no signs of damage or deterioration. It is simply recommended that the building be monitored over time to prevent undue impact from the tree root and the encroachment of grade at the perimeter.

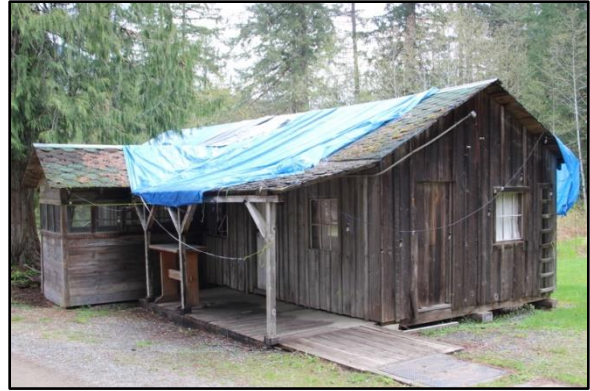
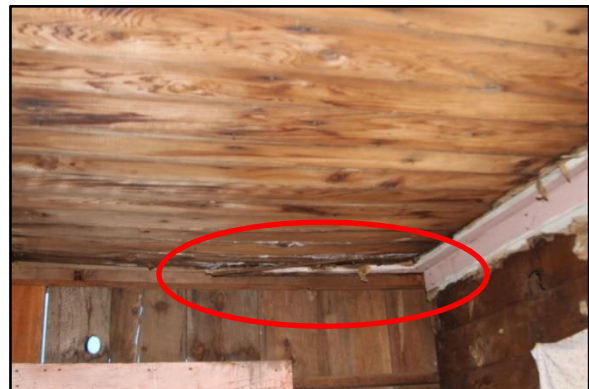
Currently, the asphalt shingle roof is noteworthy deteriorated and protected with haphazardly secured tarps. A large tree remains in close proximity with its lower branches resting on the roof. Roof plank deterioration was observed at the south-east corner while the donna conna ceiling finish of the dining room, and the wood ceiling of the bedroom are supporting organic growth and failing.

Photographs 38 - 40 – (clockwise from top right) loose roof tarps, deteriorated wood and donna conna ceilings

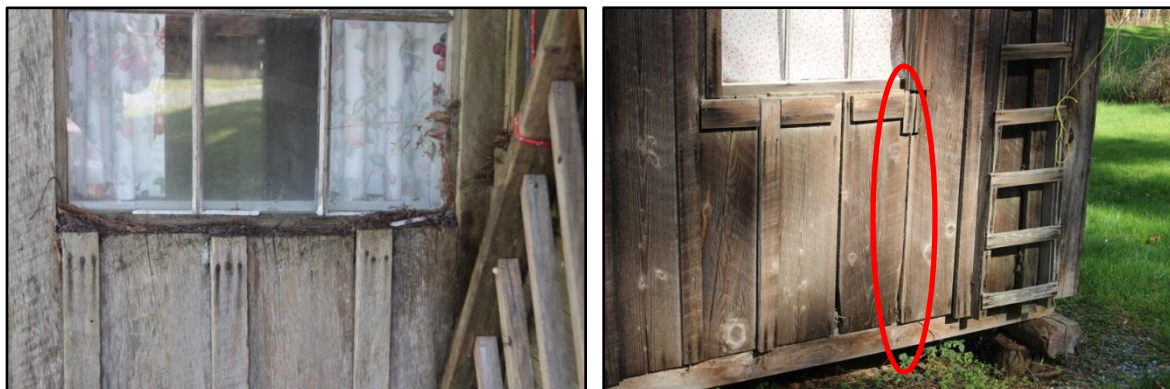
Photographs 41 - 42 – (left to right) missing window trim and debris accumulation at the base, missing batten

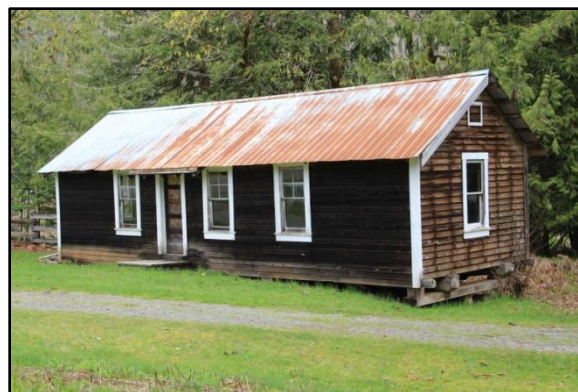
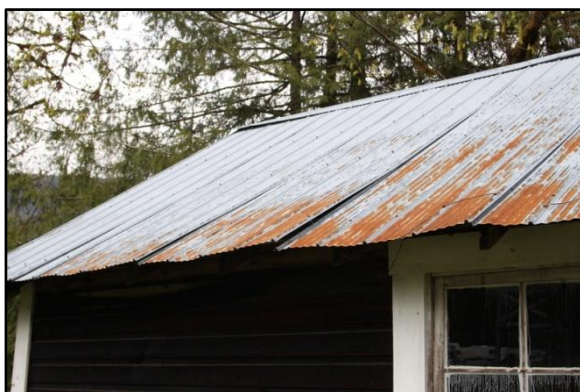
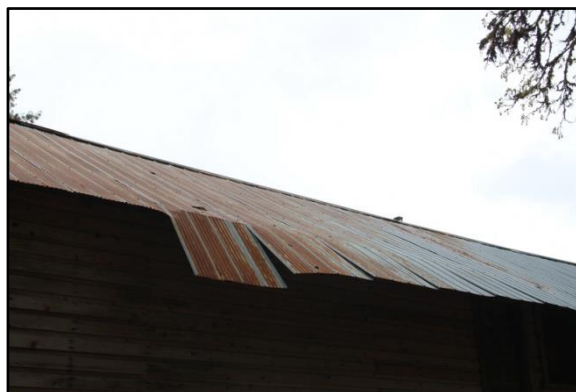
Photographs 44 - 46 – (clockwise from top left) lifting and buckling sheet metal roof, settled and deteriorating timber footing assembly

The 'temporary' sheet metal roof is now starting to corrode and a number of panels were observed to be loose. Along the back elevation, the sheet metal was installed with excessive overhang and one panel has buckled. An abridged gutter, determined to not be original to the building, has been installed over the front door.

The building is supported on a timber structure set on heavy timber footings. A deteriorated and loose footing assembly was observed at the north-east corner.

The Bunkhouse is in fair to good condition with observed deterioration limited to the NE footing and a missing back door and window. It is recommended that the roof be fastened down and that the excessive overhang be cut back from the rear elevation. The deteriorating footing should also be renewed or addition material installed to provide the necessary support. At some future time, the rear window and door could be restored.

Table 8 – Bunkhouse - Renewal Recommendations		
20	Fasten down the sheet metal roof and cut back the excessive overhang	Medium
21	Renew the deteriorating NE footing	Medium
22	Restore the rear window and door	Low

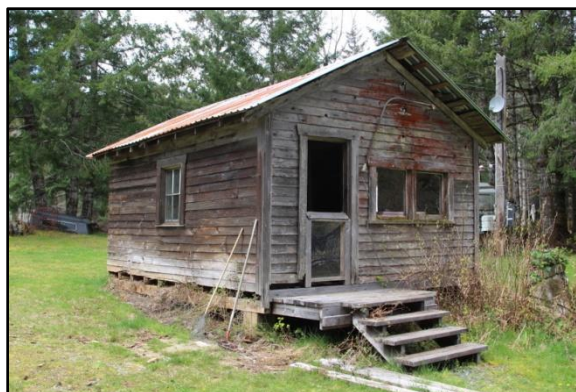
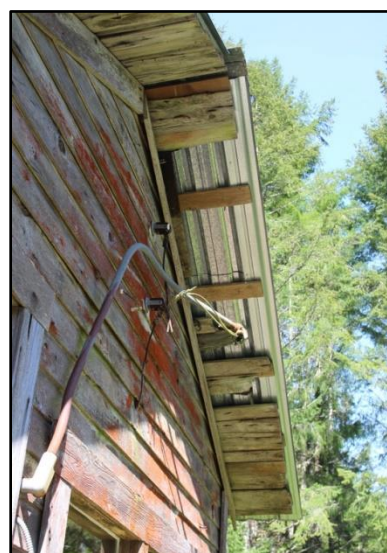
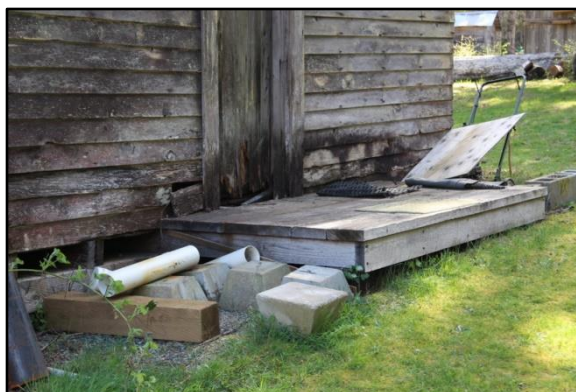
Photographs 48 - 50 – (clockwise from top right) deteriorated timber roof structure, north porch with adjacent door and cladding deterioration, perimeter growth

The sheet metal roof appeared to be in fair condition with the onset of surface corrosion and some flashing repairs completed along the ridge. The wood structure supporting the roof had some noteworthy deterioration but the interior of the building appeared to be dry and free of moisture related deterioration.

The wood siding appeared to be in good condition accepting along the base of the building, particularly adjacent to the north porch, where deterioration was evident. The window is missing in the west elevation while the east window is supporting moss growth. The east door was found to be off its hinges, inside the building while the north door, adjacent to the porch, is significantly deteriorated along the base.

The building is supported by a timber foundation and treated timber and concrete blocks. The foundation structure appeared to be in good condition though organic growth is not managed along the perimeter. The front porch is in good condition but the side porch appears to be sloping towards the building, exacerbating the deterioration of the adjacent door and siding.

Having been relocated at least once, the Teacherage currently appears to be in good condition on a sound foundation with limited, observed deterioration. It is recommended that the north porch be addressed, sloping it away from the building to reduce backsplash against the base of the building. Organic growth around the perimeter should be cut back to allow the base of the building to vent and dry while the east window sill should be cleaned of organic growth to prevent deterioration. Consideration for future conservation works would include the renewal of the doors and windows to reduce moisture ingress into the building, and a further investigation of the roof structure.

Table 9 – Teacherage - Renewal Recommendations		
23	Slope north porch away from building	Medium

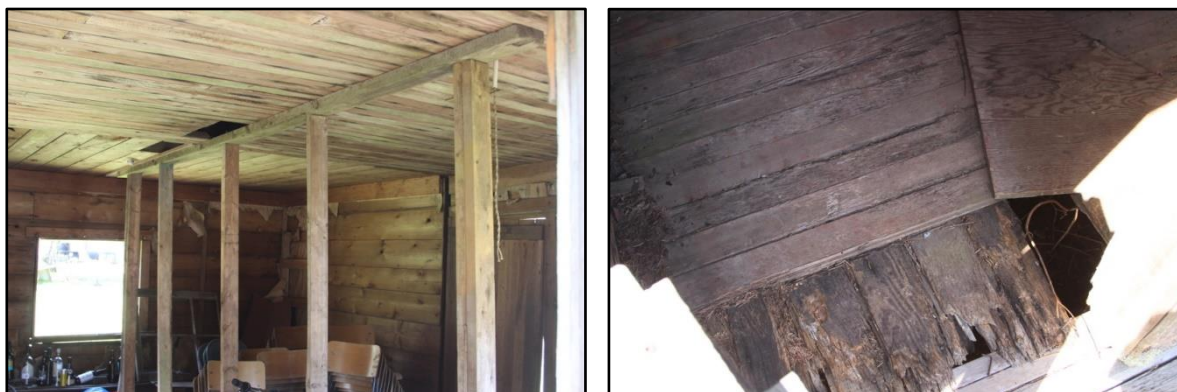
Photographs 51 & 52 – (left to right) interior stud wall, overlaid, deteriorating floor planks

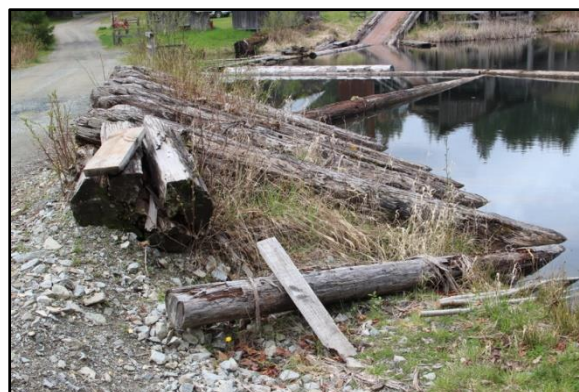
There are currently 6 sloping logs set on a notched base log. The sloping logs, despite the accumulation of debris between them, are in fair condition with the expected level of exposure related deterioration. The base log is significantly decayed at the ends and splitting apart.

Given its exposure and positioning into the edge of the pond, the Log Dump is a feature that will continue to deteriorate over time. This will necessitate the eventual and continual, replacement of the timber members. When it was last restored, the slope was reduced to accommodate current concerns pertaining to the fish in the pond. If possible, consideration should be given to restore the original geometry of the structure.

24	Monitor the timber members, removing debris and growth between them to reduce the rate of decay and replacing them when they become unstable	Low
----	--	-----

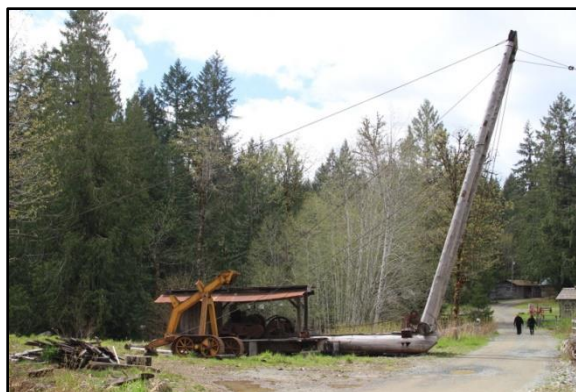
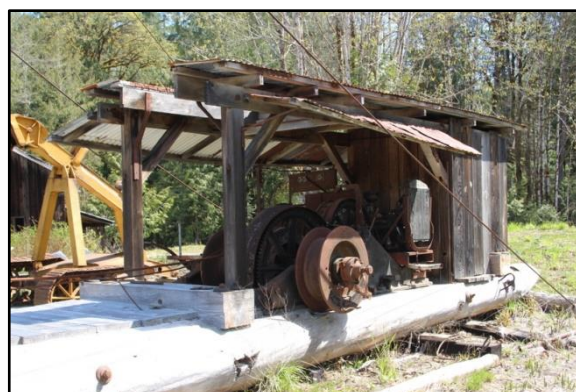
Photographs 55 & 56 – (left to right) The cabin of the A-Frame with the wing roofs

The assembly, set on treated timbers, appeared to generally be in good condition with no significant deterioration observed beyond the ongoing corrosion of the mechanical equipment. The two side roofs, providing protective cover for the operators, are sagging under their own dead load suggesting inadequate structural support. This is likely exacerbated under snow loads conditions.

Ongoing use and maintenance of the A-Frame would enhance the durability and life expectancy of this structure. Alternatively, a contemporary roof structure could be erected over the mechanical end to protect it from exposure to the weather and associated corrosion. It is likely that the structure of the wing roofs is original and that the angled position is what they originally looked like. Regular monitoring and maintenance of these roofs will keep them in place while modest structural upgrades would reduce maintenance requirements and possible failure.

Table 11 – A-Frame - Renewal Recommendations		
25	Monitor the mechanical assembly and protective structure, completing maintenance and renewal work when necessary.	Low

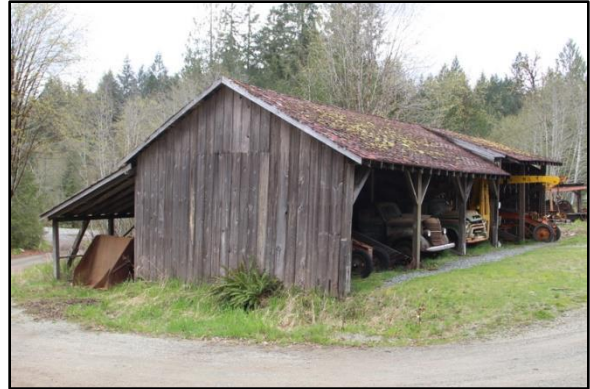
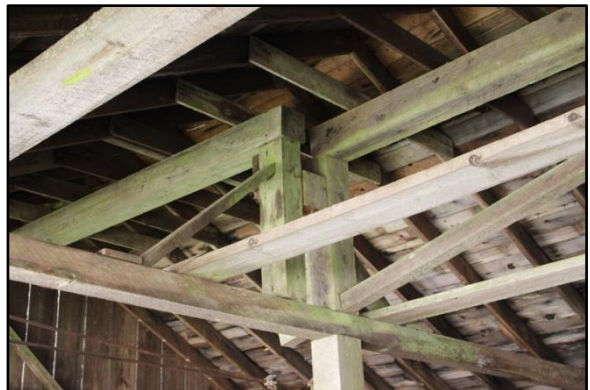
Photographs 58 - 60 – (clockwise from top left) deteriorated asphalt shingles, unconventional roof framing, moisture staining on the structural assembly

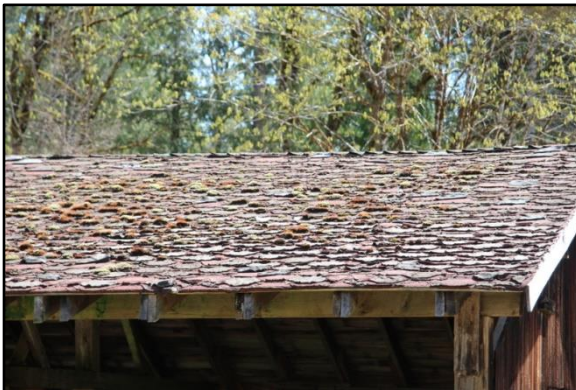
The renewed asphalt shingles are now beyond their expected service life with extensive deterioration and organic growth observed.

The cedar shingles on the rear lean-to roof are also covered with moss and organic debris. The main roof structure is unconventionally framed with discontinuous members and seemingly random bracing. Moisture ingress is occurring in a number of locations, most notably where the raised roof transitions to the main roof. A number of material and assembly failures were observed including a significant hole in the roof, fraying tension cables, and deteriorating post bases.

Despite the renewal work completed in the 90's when the building was found to be near collapse, the Garage is once again in very poor condition with signs of structural settlement, moisture ingress and related deterioration. The unconventional framing and bracing along with the settlement indicates that the building may not be stable. It is recommended that a comprehensive structural review of the building be undertaken to ensure its safety and stability and to determine what structural renewal work may be required. In addition, the roof should be replaced to eliminate moisture ingress into the building and reduce further member deterioration while the surround grade and organic growth should be pulled back from the building to allow the base assemblies to dry out and reduce their rate of deterioration.

Table 12 – Garage - Renewal Recommendations		
26	Complete a structural review of the building to determine any necessary renewal and reinforcing works that may be required	High
27	Renew the roof, replacing the existing shingles or installing a temporary sheet metal roof.	High
28	Pull back grade and organic growth from the building perimeter	Medium

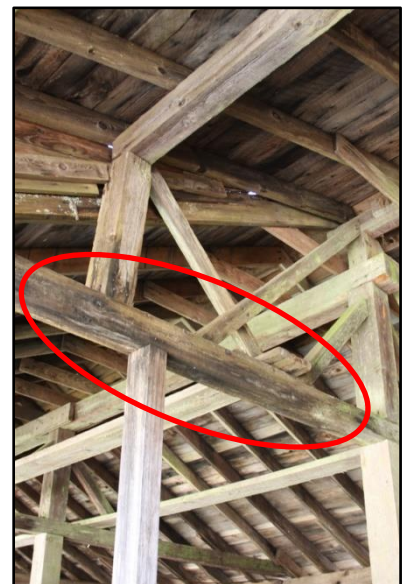
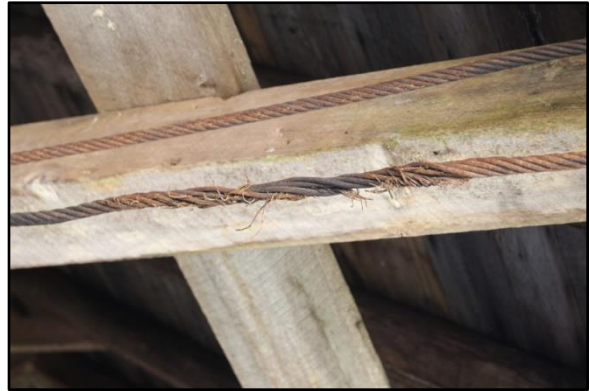
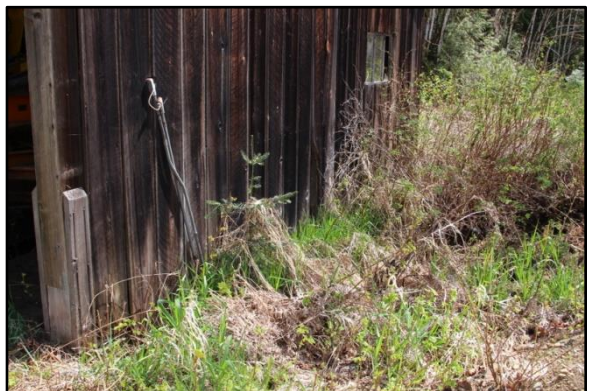
Photographs 61 - 68 –
(clockwise from top left)
failed roof cladding,
frayed tension cable,
unabated growth along
the east elevation,
localized siding failure,
displaced and collapsed
floor planks, post base
failure, overgrown,
braced lean-to
structure

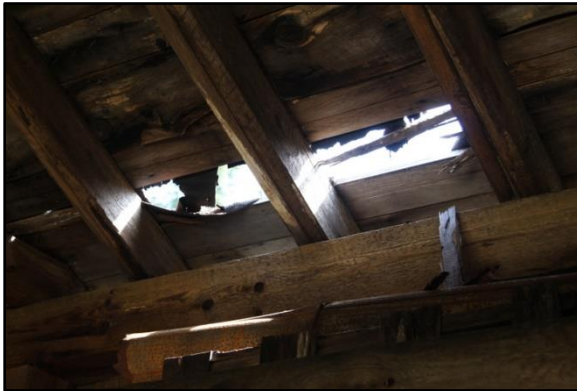
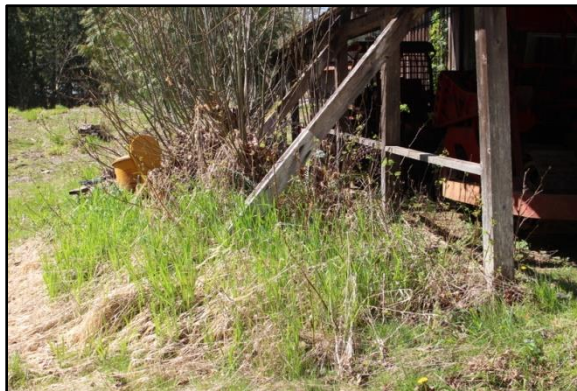
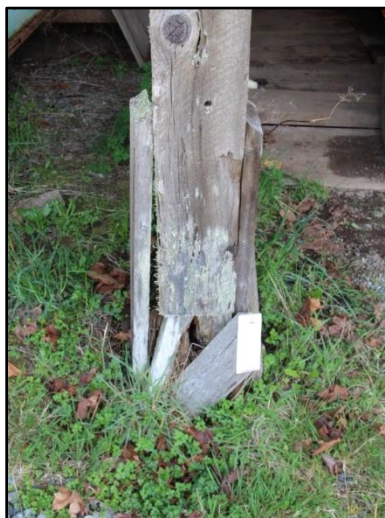
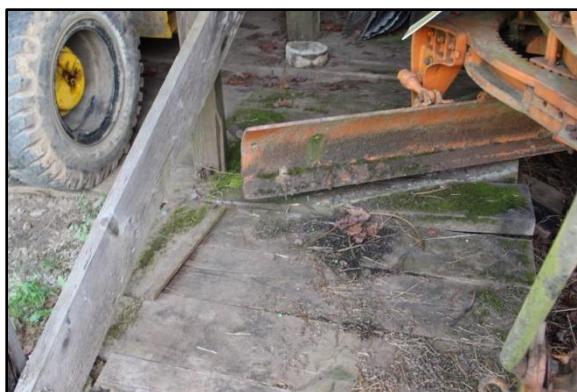
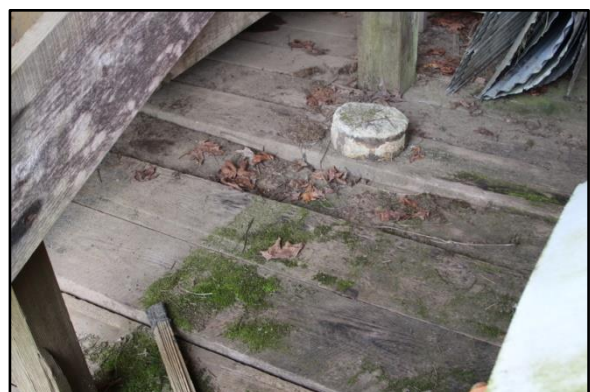
The floor assembly adjacent to and over the pit appears to be failing with loose and displaced floor planks. Further review of the floor could not be completed with the vehicles parked on the assembly. A review of the perimeter grade showed it to be sloping towards the front of the building. This may be contributing the observed post failures.

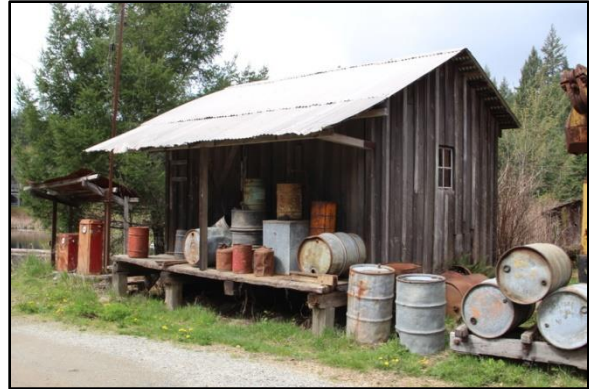
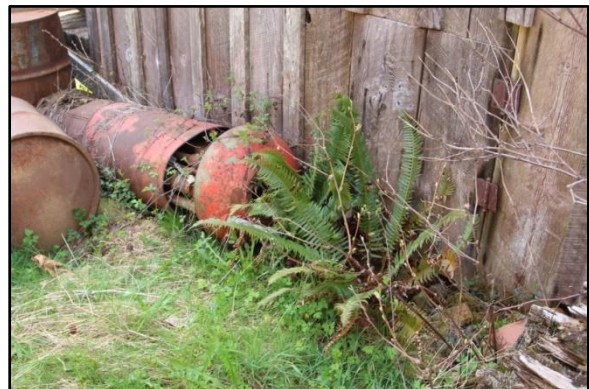
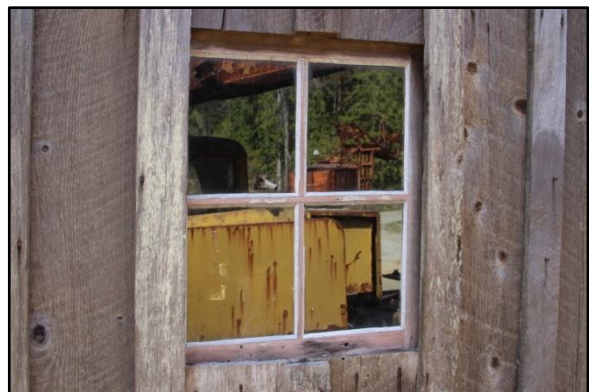
Photographs 70 - 73 – (clockwise from top left) Loose corrugated roofing, encroachment of growth and debris, a window pane set in the wall, the front porch with a missing support post

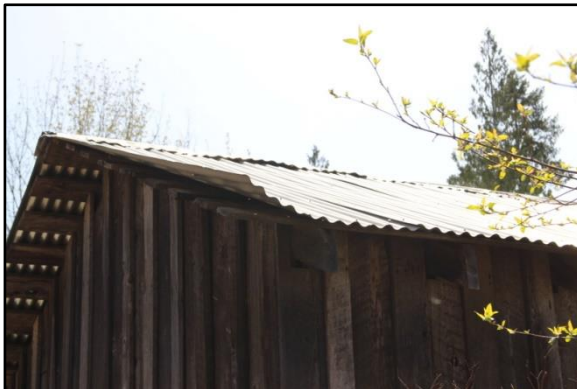
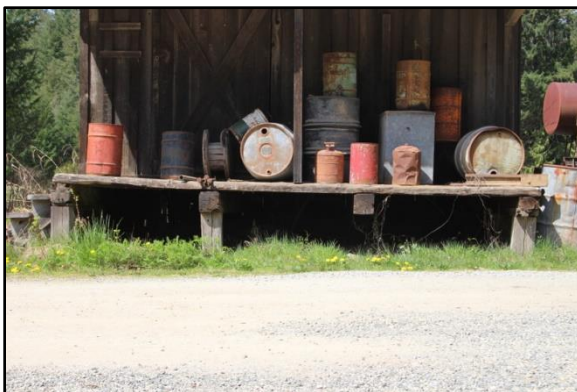
Currently, the corrugated sheet metal roof appeared to be in fair condition with many of the fasteners observed to be lifting, allowing the sheet metal to move in the wind. The edge of the roof over the front porch appears to have sustained impact damage in the past while the structural framing supporting it appears to have been recently renewed.

The south wall is in good condition, protected by the porch roof while the remaining walls, without this protection, are significantly weathered with localized damage and organic growth and debris encroaching at the base. The windows, without sill plates or trim, allow water to pass in between the sash and wall assembly.

The existing post and beam foundation appears to be in fair condition though perimeter deterioration could not be affirmed with the encroachment of growth and grade. The front porch is missing a support post and is subsequently noticeably sagging.

The Gasoline & Oil Shed appears to be in fair condition. The roof, though loose, is in good condition and should simply be refastened down to the roof structure. The deteriorated wall elements could be repaired while the windows, could be discretely trimmed, if historically appropriate, to reduce moisture ingress through the wall assembly. The accumulated debris and organic growth should be removed from the building perimeter to facilitate drying and reduce the rate of deterioration. The support post beneath the front porch should also be reinstated to avoid undue stress on the porch assembly.

Table 13 – Gasoline & Oil Shed - Renewal Recommendations		
29	Refasten the roof to the roof structure	Medium
30	Renew the deteriorated and deficient wall and window assemblies	Low
31	Reinstate the missing porch post	Low

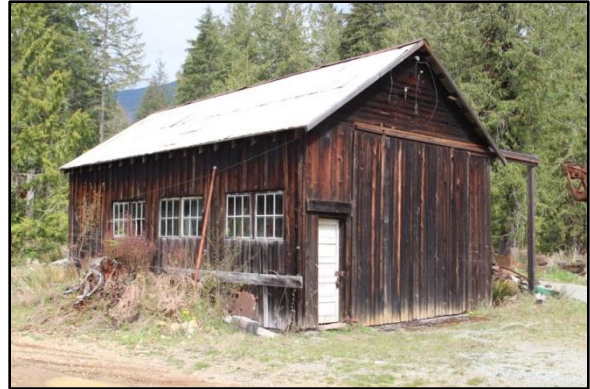
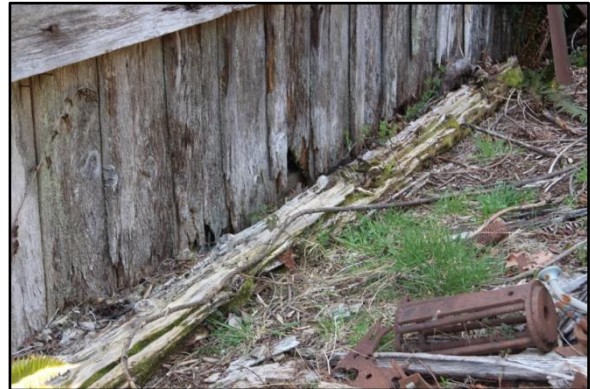
The board and batten wall cladding is in fair condition being largely coated with creosote or other petroleum product. Typical base perimeter deterioration is occurring where organic growth and debris are starting to encroach. A number of battens were observed to be loose or missing while horizontal planks are supporting organic growth and starting to deteriorate. Most of the windows are untrimmed, allowing moisture ingress in between the sash and the wall assembly.

Photographs 75 - 77 – (clockwise from top left) loose corrugated roof sheet, deteriorating cladding at base of wall, untrimmed window opening

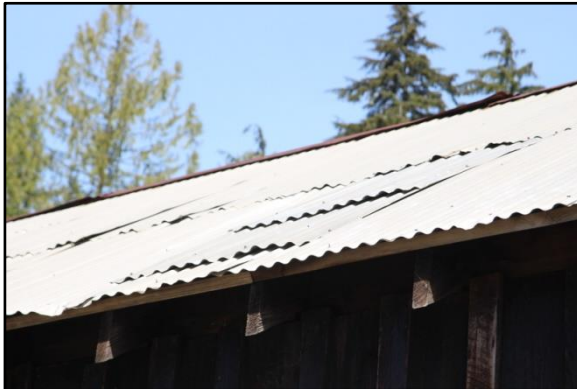
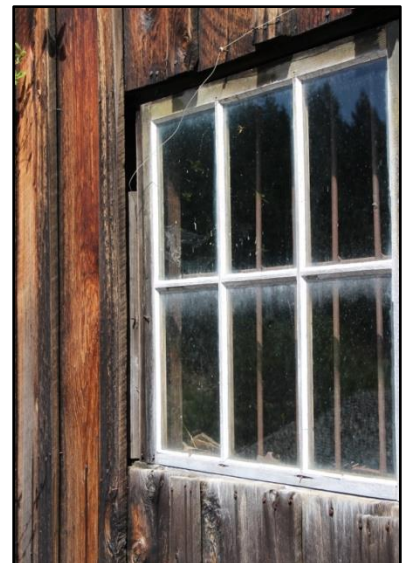
Today, the corrugated metal roof is in good condition though many of the panels are loose with the fasteners either pulling up or punching through the sheet metal. Some of the rafter tails were also observed to be deteriorated.

The Machine Shop is in good condition with no observed deterioration of significance. The corrugated roof should be refastened to the roof structure and the encroaching organic growth and debris should be pulled back from the wall perimeter. Additional conservation work could include the renewal of the wall assembly, reinstating the loose and missing battens.

Table 14 – Machine Shop - Renewal Recommendations		
32	Fasten down the corrugated roof to the roof structure	Medium
33	Renew the wall cladding, reinstating the loose and missing battens	Low

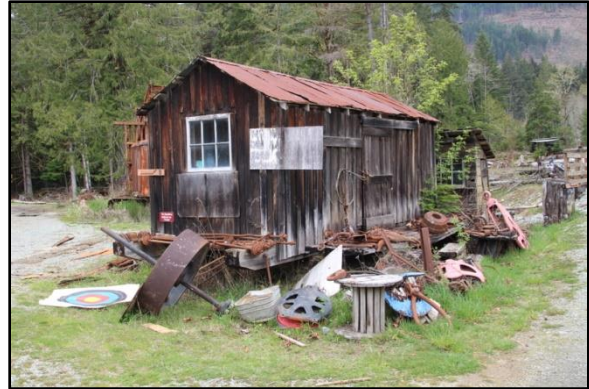
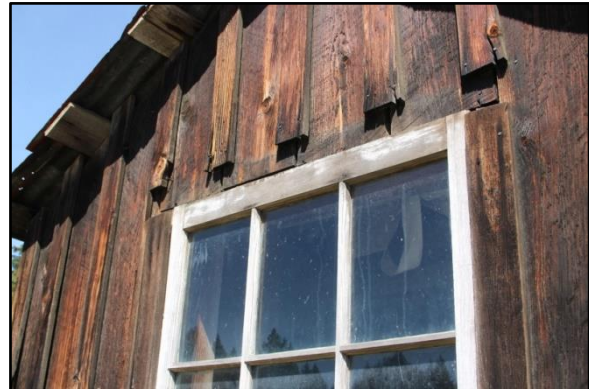
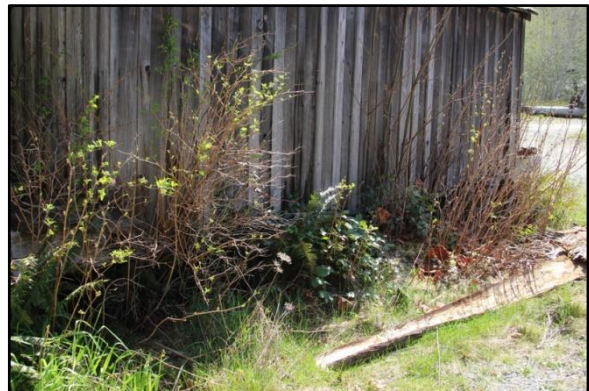
Photographs 79 - 82 – (clockwise from top left) corroded and loose corrugated roofing, missing window trim, organic growth and the building perimeter, misc. parts stored on buckling planks

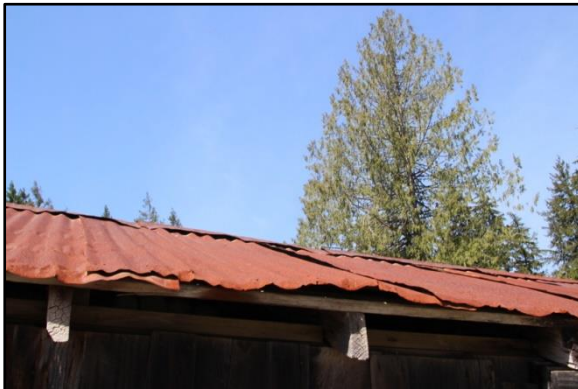
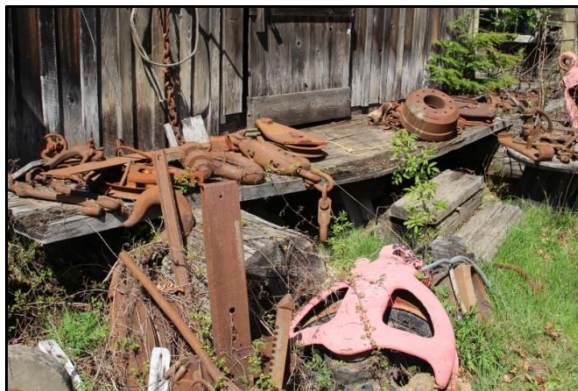
Today, the corrugated metal roof is heavily corroded, loose, and missing a number of fasteners.

The board and batten siding appears to be in fair condition while the west window is missing a trim board at the head.

The skidding timbers on which the shed is set are themselves supported by heavy logs. Both appeared to be in good condition. Planks set in front of the main door to support miscellaneous parts and machinery are starting to buckle under the load with a failed support post. It is not likely that these planks are original to the shed that was designed to be pulled through the forest. Organic growth around the perimeter is persistent with trees growing up against the east end.

The Parts Shed is in fair condition with limited deterioration. It is recommended that the roof cladding be renewed, restoring the original assembly or reinstating the corrugated metal cladding. The existing assembly may have a few serviceable years remaining if it is refastened to the roof structure. The organic growth around the perimeter should also be removed to reduce base deterioration and allow the building assembly to dry more effectively.

Table 15 – Parts Shed - Renewal Recommendations		
34	Renew the roof cladding restoring the original material or reinstating the existing corrugated metal.	Medium

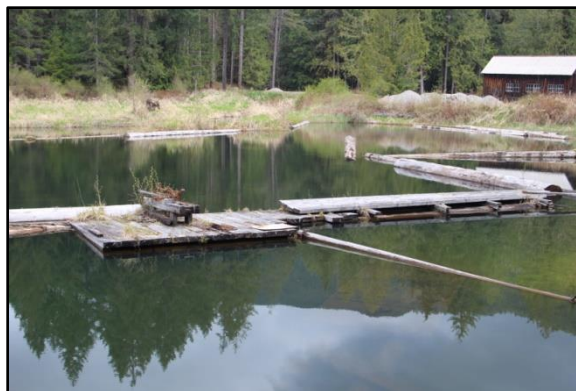
The Boom Shack building no longer exists, with only a piece of mechanical equipment on a floating dock identifying where it was once located. The mechanical equipment and dock are both deteriorating with the onset of corrosion and wood decay.

Photographs 84 & 85 – (left to right) Deteriorating wood planks, corroding piece of mechanical equipment

Given the exposure and position within the pond, what is remaining of the former Boom Shack will continue to deteriorate over time. It is recommended that the planks of the wooden dock be replaced to retain the sense of location of the former building. The deterioration of the mechanical equipment could be addressed by installing a protective cover on the dock or should the opportunity arise, restoring the original Boom Shack.

35	Renew the deteriorating planks on the wood dock	Medium
----	---	--------

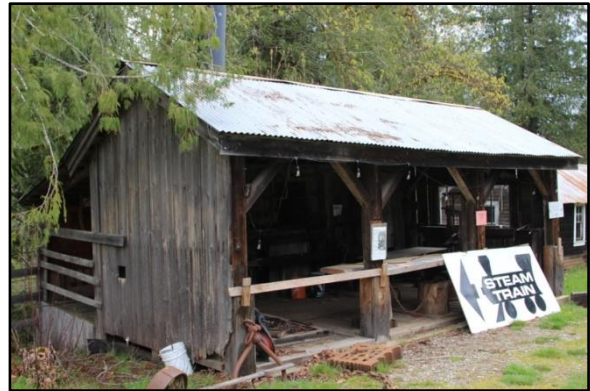
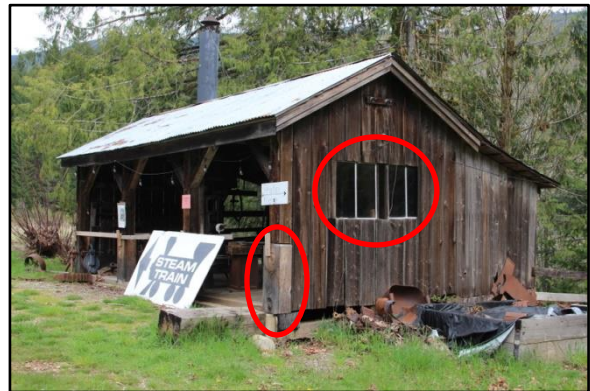
Photographs 87 & 88 – (left to right) organic debris accumulation on the sheet metal roof, unsympathetic post repair and sliding sash
