AGENDA - COMMITTEE OF THE WHOLE

Monday, June 16, 2025 @ 6:00 PM

4850 Argyle Street, Port Alberni, BC

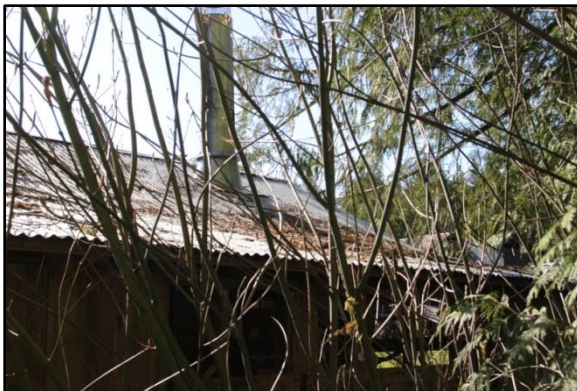
The corrugated sheet metal roof, screwed down to the roof structure, appears to be in good condition with no apparent leaks observed. The lean to roof is still clad with cedar shingles, possibly original, beneath the sheet metal. Given the low-sloped pitch of the lean-to roof, organic debris can and is accumulating on the sheet metal. Due to previous deterioration, a number of rafters over the lean –to have been twinned to provide adequate structural support.

The building is an open air structure with a braced post front wall and a partial height rear wall. The gapped planks on the side and rear walls provides modest protection against the elements. The wall cladding and timber support structure appeared to be in good condition with limited deterioration observed at the north west corner. The unsympathetic repairs to the bases of the front posts suggest that deterioration was an issue in the past. Loosely installed, sliding sash fill in two wall openings on the south elevation.

Photographs 87 & 88 – (left to right) organic debris accumulation on the sheet metal roof, unsympathetic post repair and sliding sash

Having been previously restored and recently in operation, the Blacksmith Shop was observed to be in good condition. It is simply recommended at this time that the roof assembly be regularly maintained removing the accumulating debris and cutting up the adjacent tree branches. Perimeter growth and debris, although modest at this building, should also be constantly maintained. Consideration can also be given to future conservation works, restoring the appearance of the original post structure on the front elevation.

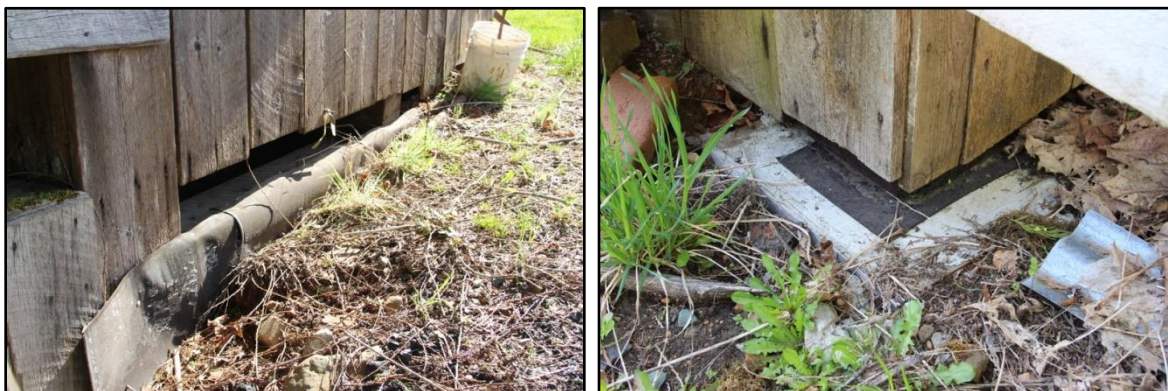
Photographs 89 & 90 – (left to right) protective sheet rubber between the timber structure and concrete footings

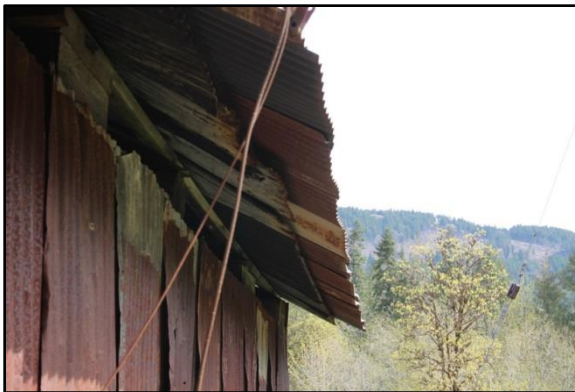
Both buildings are currently protected with a corrugated sheet metal roof assembly, the one on the east building being double layered. The roof assemblies appeared to be in fair condition showing minor surface corrosion. The chimney openings through the roofs are rough cut and unsealed, potentially allowing moisture into the buildings. The roofs rely on sheet rubber lined, wood frame gutters to direct moisture away from the building and prevent it from entering the adjacent Mill.

Photographs 92 - 94 – (clockwise from top left) Double layer roof assembly over the east building, gaps between the roof cladding and chimney, sheet rubber lined, wood frame gutters

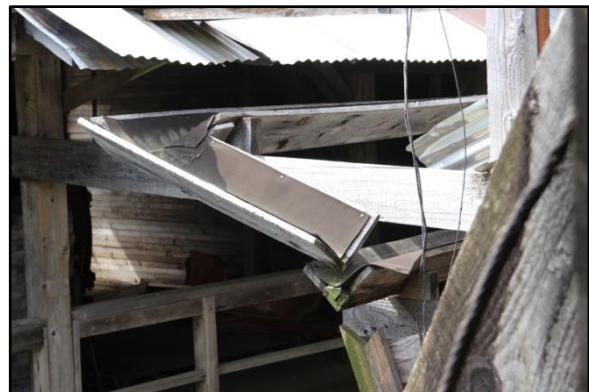
The upper walls of the east building are a braced, round timber assembly extending down to grade and protected with vertical corrugated sheet metal panels while the lower foundation walls, supporting the floor assembly and boiler above, appeared to be a lime or cementitious brick. The vertical, corrugated sheets appeared to be unrestored, looking in similar condition to what was captured on the Canadian Parks Service photographic record. The brick foundation, held in place with corroding structural steel members including rails, is deteriorating with many of the bricks spalling and eroding. This may be associated with the age of the assembly but also likely

exacerbated with the use of cementitious repointing mortar. Despite the condition, the upper walls appear to be largely preventing moisture ingress into the building while access is not possible to the lower level containing the ‘fire pit’.

Photographs 95 - 98 – (clockwise from top left) corroding sheet metal wall cladding, spalling and eroding brick foundation, laminated timber walls

Knowing that the Boiler House has been in operation until last year, generally serviced, and without signs of significant deterioration, it is simply recommended that the brick foundation walls be repointed with a lime mortar and that the corrugated sheet metal wall is maintained in place. Reviewing the roof assembly during a rain event can determine if there is moisture ingress and if the gutter assemblies are performing as expected. Restoring the operation of the Mill would significantly benefit the maintenance and durability of the Boiler House.

37	Repoint the brick foundation	Medium
----	------------------------------	--------

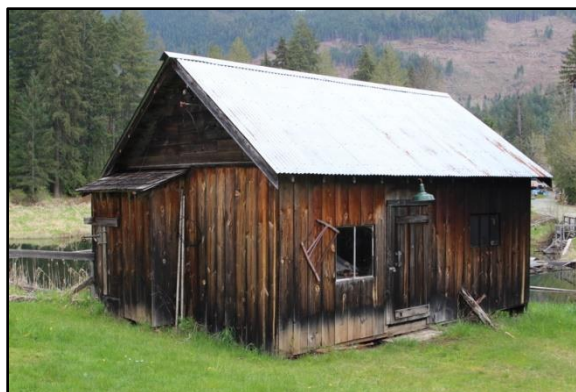
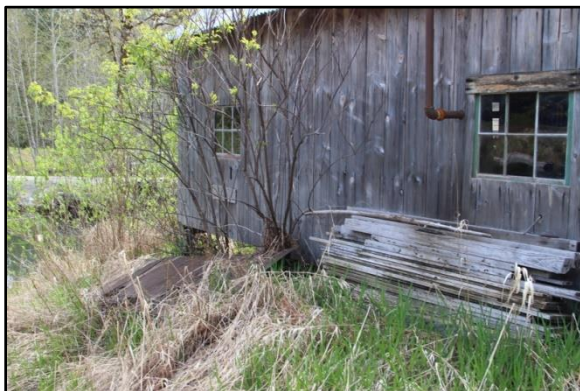
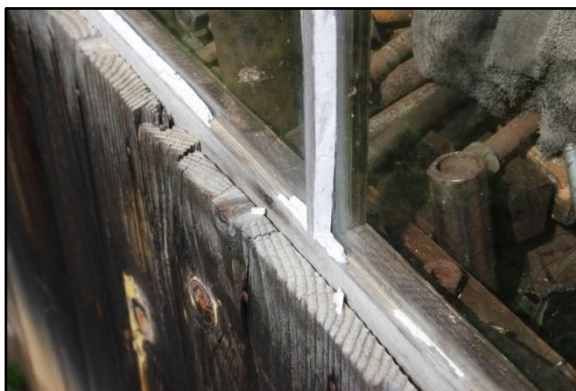
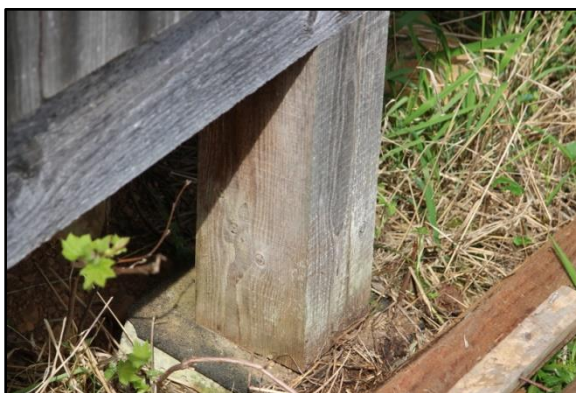
The walls assemblies generally appeared to be in good condition. Some of the shiplap plank siding appeared to be benefitting from the protection of a petroleum stain while a number of planks on the east elevation are starting to curl. The north elevation has material stored against it and organic growth encroaching the base. The windows are without sills and trim which allow moisture to pass in between the sash and wall assembly. The glazing putty on the window sash was also observed to be deteriorating.

Photographs 100 - 102 – (clockwise from top left) material debris and organic growth against the north elevation, deteriorating glazing putty and gap between the sash and cladding, timber post set on rubber pad on concrete footing

The timber foundation is set on rubber pads on concrete footings. Despite the material storage and organic growth on the north elevation, the foundation appeared to be in good condition.

The Millwright's Shed appeared to be in good condition with no observed significant, deterioration. Consideration could be given to installing perimeter trim around the windows, if historically correct, to reduce moisture ingress into the wall assembly and building. Both the material storage and organic growth against the north foundation should be removed.

Table 19 – Millwright's Shed - Renewal Recommendations		
38	Remove material storage and organic growth from north elevation	Low

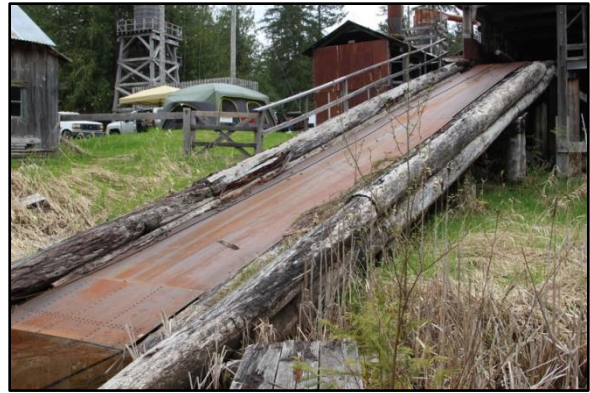
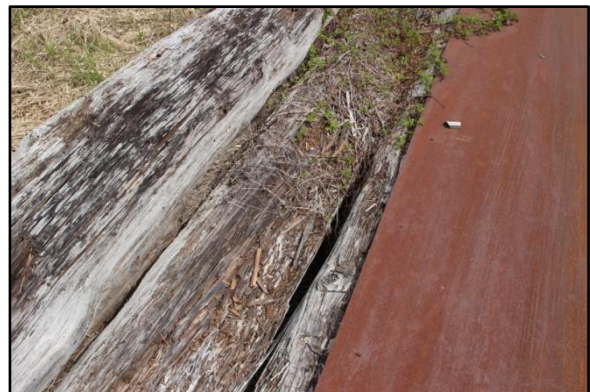
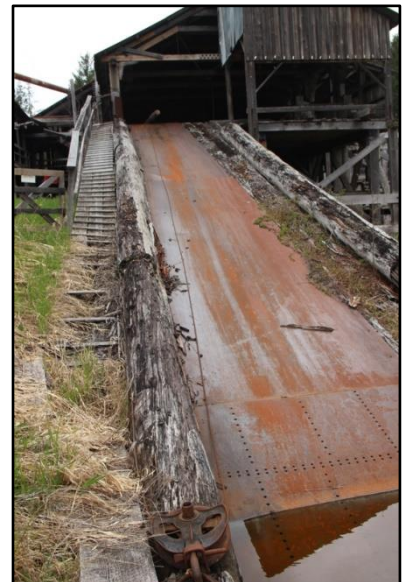
Photographs 104 - 107 – (clockwise from top left) corroding steel plate and deteriorating side timber, deteriorating side timbers with encroaching organic growth, deteriorating side timber and organic growth over walkway, severely deteriorated walkway

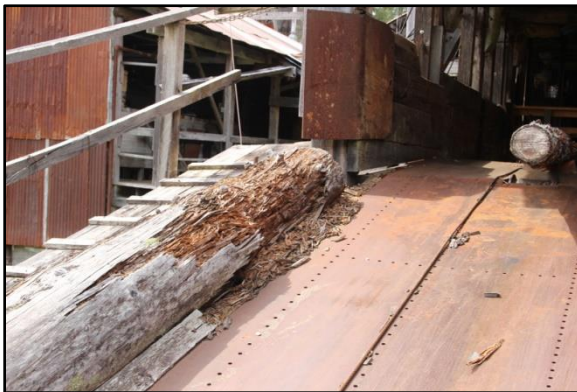
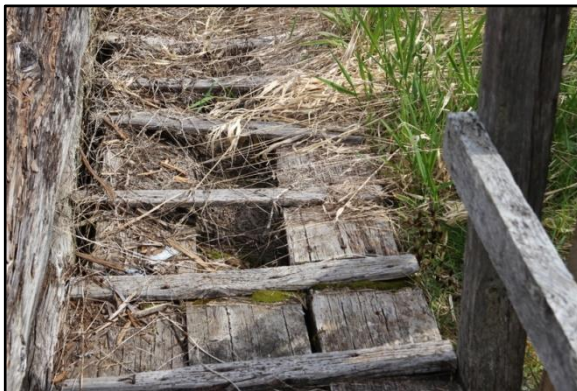
The steel plate is showing signs of surface corrosion. This would be expected given its exposure to the weather. Many of the exposed heavy timbers adjacent to the steel plate and the walking plank up the south side are severely deteriorated with plant growth and the proximity of the pond at the lower end exacerbating this.

Given its exposure and positioning into the edge of the pond, the unchecked organic growth around it, and the ceasing of mill operations, the Log Haul is in fair condition though it will continue to deteriorate over time. This will necessitate the ongoing maintenance of the exposed timbers. Without regular use, the steel plate itself will also start to deteriorate more rapidly. It is recommended that the severely deteriorated heavy timbers and adjacent walkway be renewed immediately to preserve the integrity of the Log Haul and minimize the impact of deterioration on those members less affected. The timber footings should be regularly monitored to ensure structural stability.

Table 20 – Log Haul - Renewal Recommendations		
39	Replaced deteriorated timbers and renew the deteriorated walkway	High

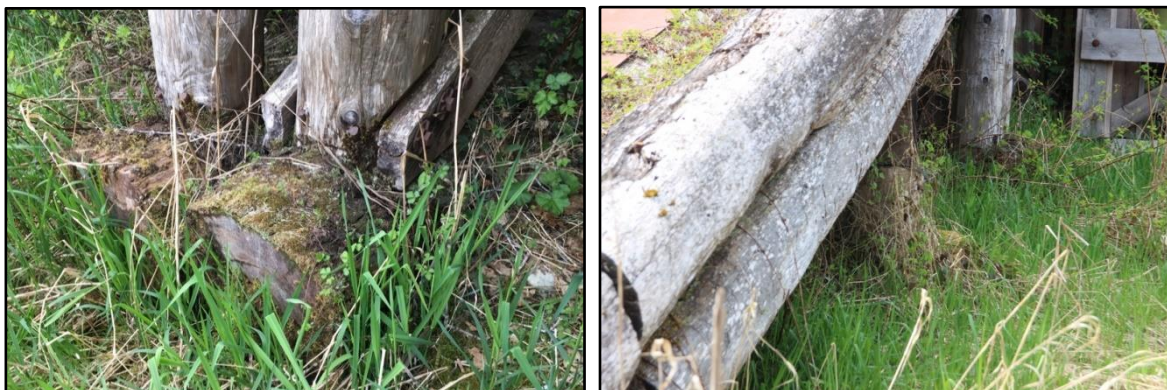
Photographs 108 & 109 – (left to right) timber footings set on grade being overgrown and deteriorating

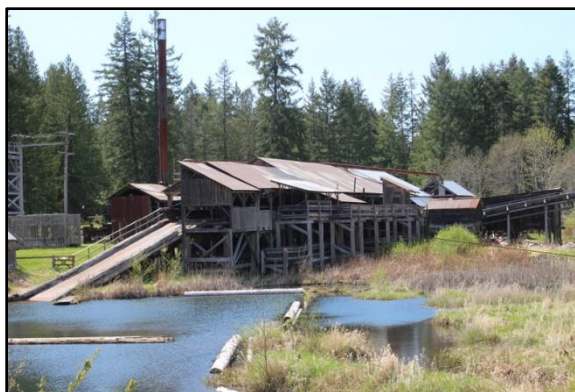
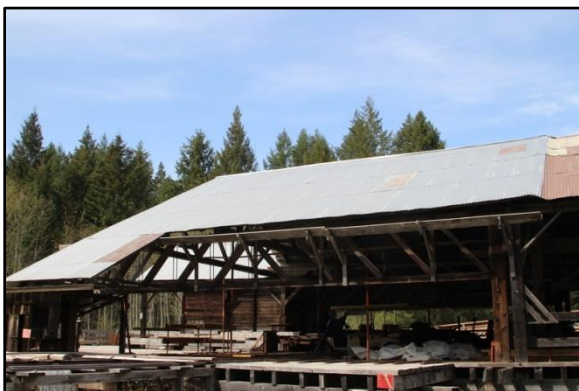
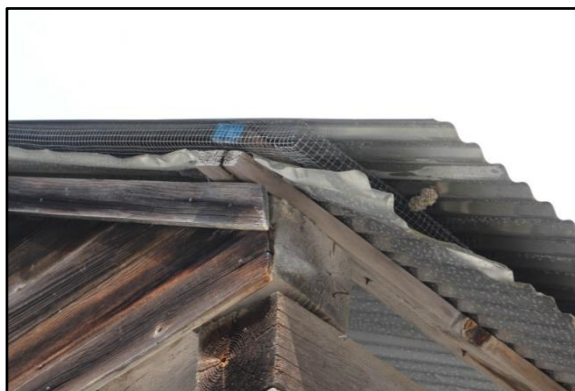
The roof over the Mill comprises corrugated sheet metal panels on a timber frame. The panels were further corroded at the east end of the Mill suggesting the west end was more recently renewed. The roof over the planer building also incorporates corrugated metal panels but utilizes a double layer assembly much like the Boiler House. The purpose of this assembly may be to control rising temperatures in the summer time.

Photographs 111 & 112 – (left to right) renewed west roof, double roof over the planer

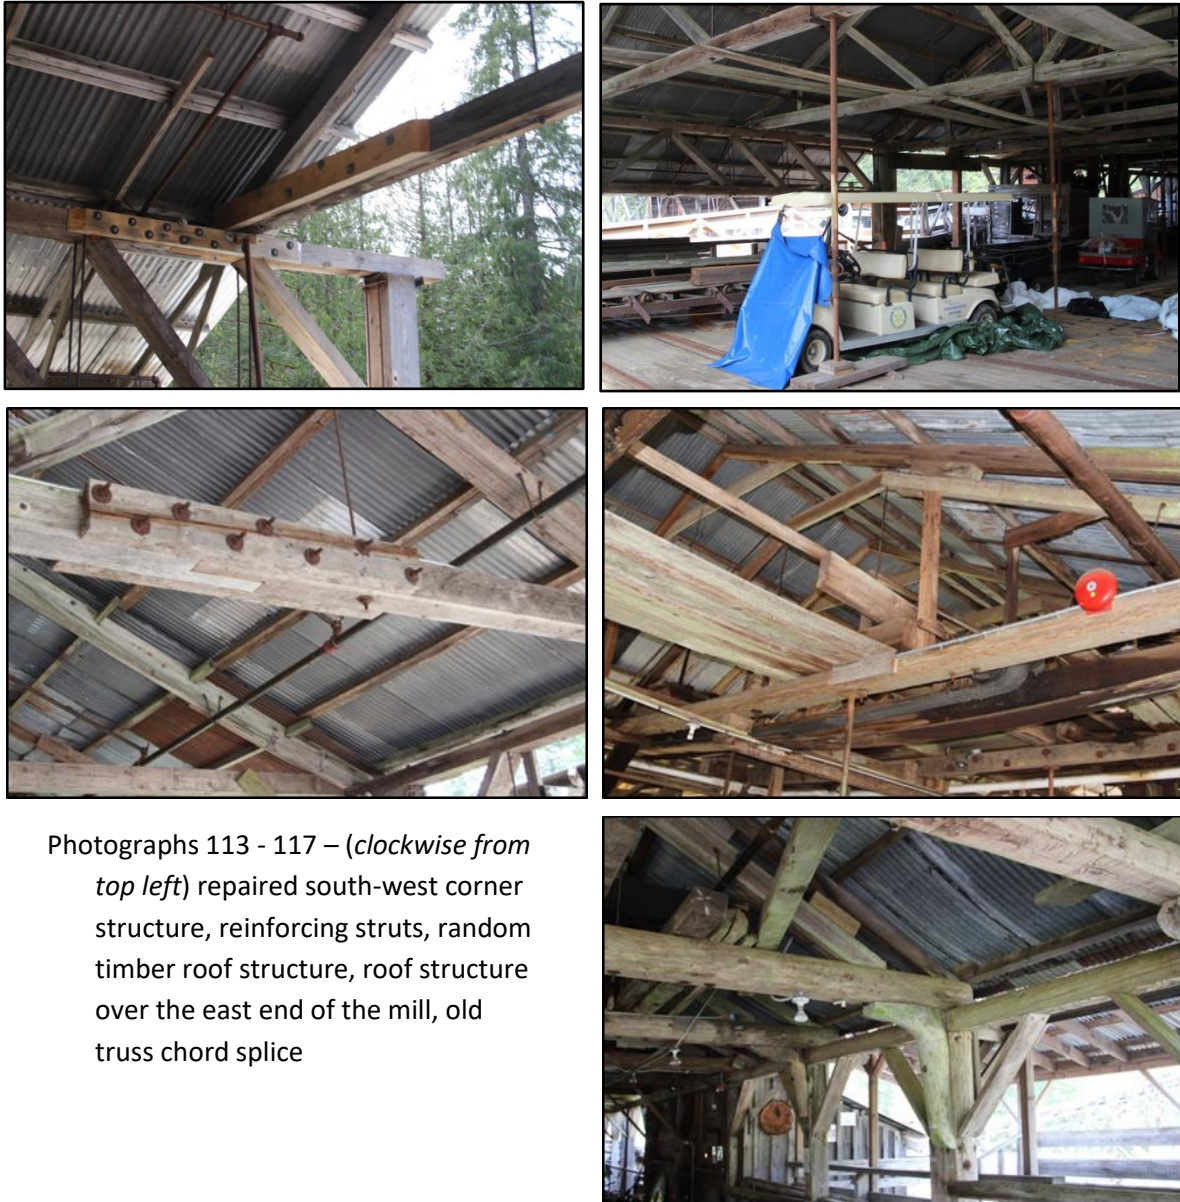
Photographs 113 - 117 – (clockwise from top left) repaired south-west corner structure, reinforcing struts, random timber roof structure, roof structure over the east end of the mill, old truss chord splice

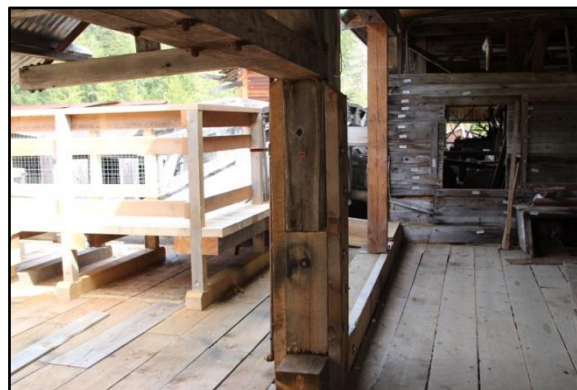
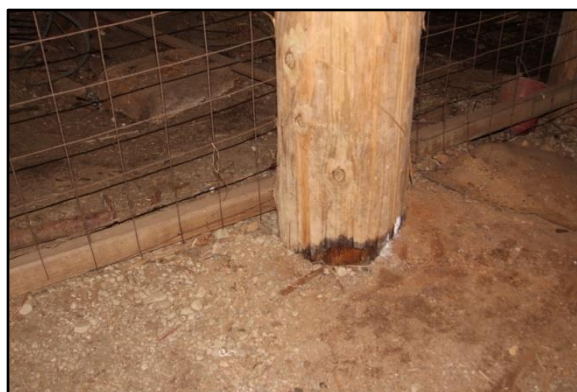
The wall assemblies are simply a series of braced posts with no wall cladding protecting the interior of the mill. A number of supporting posts were observed to not be lining up with the load path of

the roof structure. The posts and beams appeared to be in fair to good condition exhibiting the same frequency of splicing as the roof structure as well as the same indeterminate load capacity.

A heavy timber structure, typically on concrete footings, supports the building below the main floor. Most of the beams appeared to be simple spans with no observed splice repairs. A number of interior members appeared to be stained with a petroleum product, quite likely as a result of being adjacent to machinery. In addition, the interior of the foundation structure exists in a cool and damp environment. Despite the typical concrete footings, a number of posts did appear to be set on grade or have grade encroaching at their bases. It is recommended that the ventilation potential of the Mill foundation be maximized and any debris associated with operations or otherwise be regularly removed from accumulating against the timber members.

Photographs 118 & 119 – (top to bottom)
repaired wall post, deteriorating
foundation post base

It is recommended that consideration be given to complete a structural review of the building to address possible safety/durability concerns and potentially eliminate the need for seasonal reinforcement. The foundation should be cleaned of detrimental debris and ventilated as well as naturally possible. The continued operation and conservation of this building has prevented the onset of significant deterioration in the recent past and it is essential that these circumstances be maintained to ensure the continued existence and long term durability of the Mill.

Table 21 – Mill - Renewal Recommendations		
40	Complete a review of the Mill structure	Medium
41	Remove deleterious debris from the foundation members	Medium
42	Continue the ongoing review and renewal of the building assemblies of the Mill	Medium

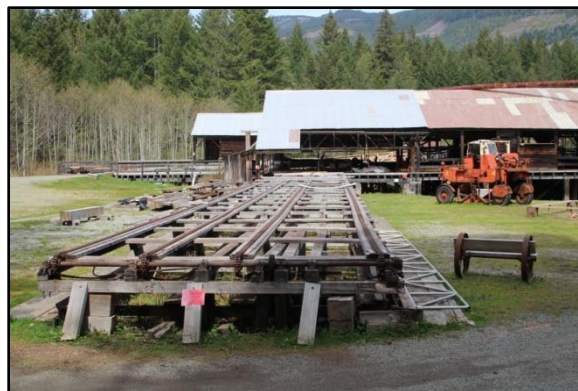
Currently however, the timber structure and steel mechanisms appeared to be in fair to good condition with a limited number of posts and timber joints observed to have decayed and failed. The steel workings of the assembly are starting to deteriorate with the lack of use increasing the rate.

Photographs 122 & 123 – (left to right) failed timber joints

Given the exposure and design of the Green Chain, it is particularly vulnerable to moisture related deterioration and will have to be regularly maintained with the continual replacement of the timber members. It is recommended that the failed members be replaced to prevent collateral decay and progressive structural failure. It would be of significant benefit to the assembly as a whole to renew operations, reducing the rate of deterioration on the mechanical assemblies while continuously maintaining the overall structure.

43	Renew the failed timber joints	High
----	--------------------------------	------

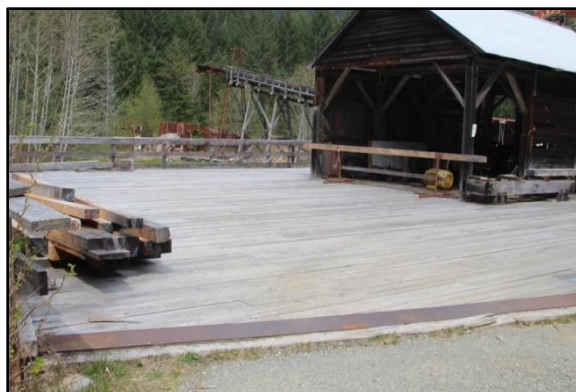
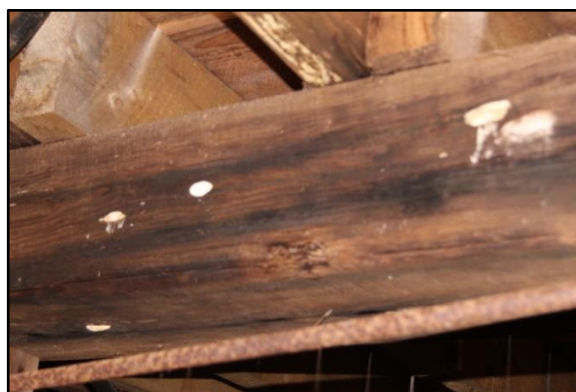
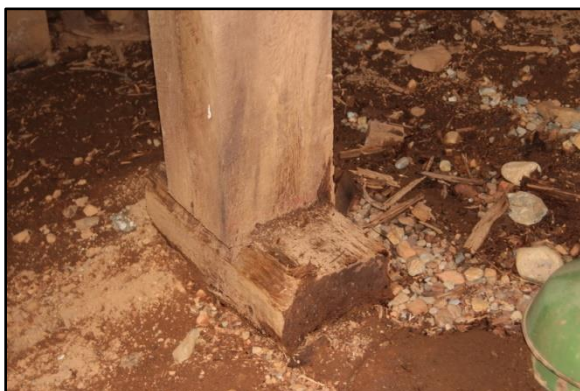
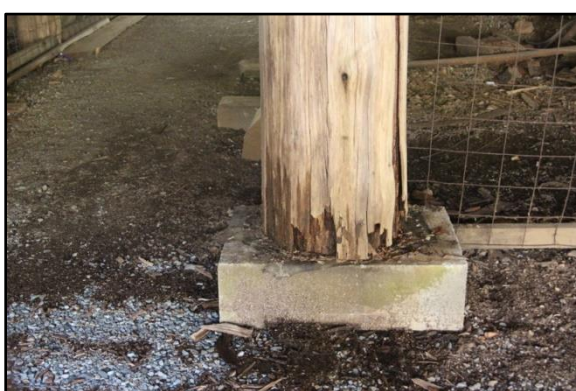
Today, the Lumber Deck was observed to be aging but there were no observed signs of deterioration or failure. The supporting timber structure beneath the deck is set primarily on concrete pad footings though some timber footings were observed. A number of the beam joints were observed to be protected with a sheet membrane while a number of original beams that were retained were observed to be supporting minor organic growth. Some of the timber footings were observed to be decaying at their bases. The environment beneath the deck was noted to be quite cool and damp. This condition, combined with the accumulation of sawdust on the grade and around the footings, exacerbates moisture related deterioration of the timber members

Photographs 125 - 128 – (clockwise from top left) renewed timber deck structure, organic growth on original timber beam, deteriorating post base, , deteriorating timber footing

The Lumber Deck appeared to be in good condition despite some localized deterioration. It is recommended that the deck and support structure be regularly reviewed and that the deteriorating posts and footings be renewed. In addition, accumulating sawdust and grade should be pulled back from any timber members that might be negatively affected by them.

Table 23 – Lumber Deck - Renewal Recommendations		
44	Renew deteriorating timber posts and footings	Medium
45	Pull accumulated sawdust away from vulnerable timber elements	Medium

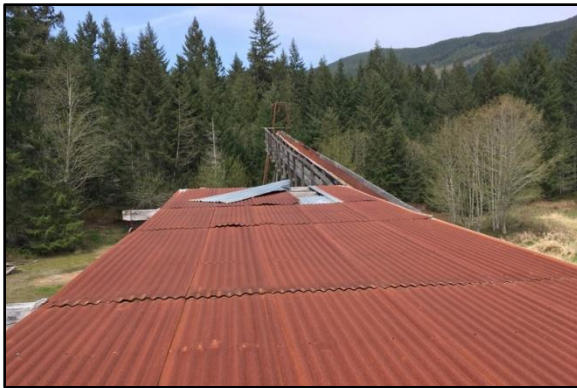
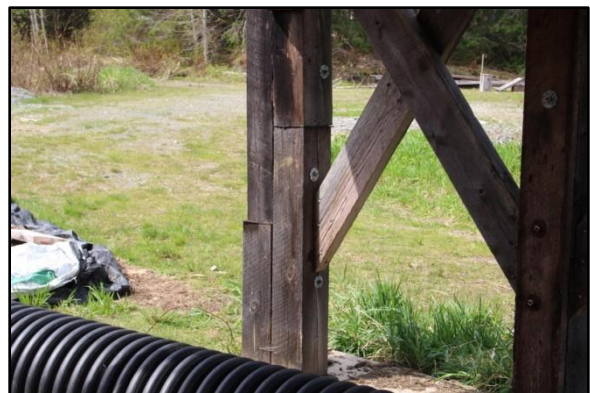
The elevated Waste Sheds appeared to be in good condition with a number of chute gates still operational. The corrugated roof was observed to be in fair condition with general extensive surface corrosion. One panel was however observed to have flipped over exposing the roof structure. The timber support structure of the sheds, now set on concrete footings and protected with membrane pads, had been renewed in the past with new materials simply spliced on the end of the posts. Possibly suitable for gravity loads, the structural repairs appeared vulnerable to lateral loading.

Photographs 130 - 132 – (clockwise from top left) Corroded, corrugated metal roof with flipped panel, spliced posts supporting the Waste Sheds

The Waste Burner is generally in good condition. It is recommended that all of the assemblies be regularly monitored for deterioration and member failure. The posts supporting the Waste Sheds should be renewed with full length members or reviewed to ensure adequate structural capacity while the displaced corrugated roof panel should be reinstated and fastened down. The Conveyor Belt frame posts will require renewal in the near future either splicing on new ends or replacing the entire post. The public should also be prevented from getting within close proximity of the Burn Pile enclosure.

Table 24 – Waste Burner - Renewal Recommendations		
46	Renew Waste Shed post with new, full length posts	Low
47	Reinstate corrugated sheet metal roof	Medium

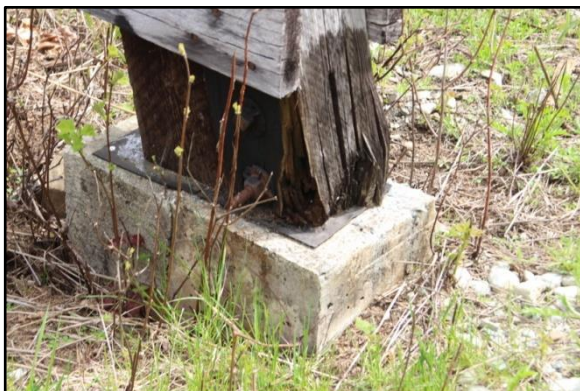
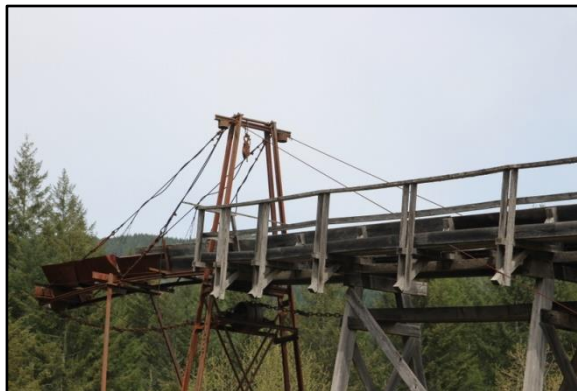
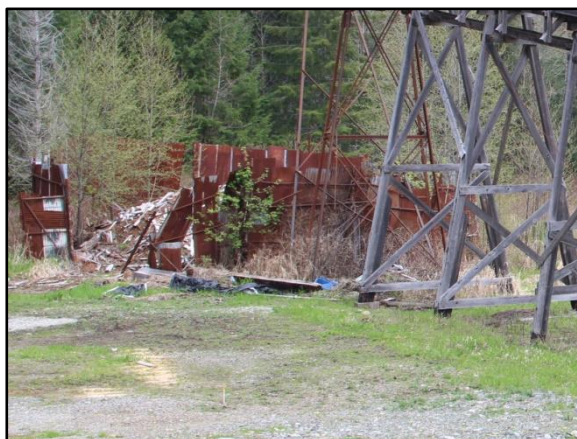
The timber Conveyor Belt frame has also been set on concrete footings. Apart from the deterioration of the frame bases despite the appearance of chemical treatment, the support frames generally appeared to be in good condition. The steel terminus of the frame adjacent to the Burn Pile appeared in fair condition with observed deterioration limited to the surface corrosion.

Photographs 133 - 135 – (clockwise from top left) treated and deteriorated timber post base of a Conveyor Belt frame, corroded steel frame, corroded and dilapidated Burn Pile structure

The Burn Pile is contained with corrugated sheet metal panels set on end and supported by a dilapidated steel post frame. The construction of the enclosure was simply intended to contain the debris and the spread of flame without utilizing design or construction elegance. Many of the corrugated panels and support posts were observed to be displaced. The current condition of the enclosure, aside from the possibility of some unstable members, adequately demonstrates its purpose.

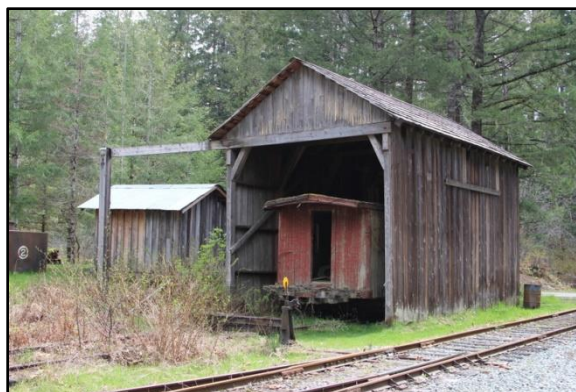
Photographs 137 - 139 – (clockwise from top left) timber roof structure, deteriorated wall planks, organic growth along the east wall

The cedar shingle roof appeared to still be in good condition with no signs of moisture passing through the assembly. The timber frame trusses supporting the shingles also appeared sound with no signs of deterioration observed.

The two cross braced, post and beam walls are protected with vertical planks. Deterioration of these walls appeared to be limited to the ends of the planks where evidence of moisture uptake and associated organic growth was observed.

The Locomotive Shed is in good condition with limited deterioration localized to the base of the walls and the timber footings. It is recommended that the footings be renewed with concrete assemblies and that the perimeter organic growth be pulled back from the walls.

Table 25 – Locomotive Shed - Renewal Recommendations		
48	Renew the timber footings with concrete assemblies	Medium

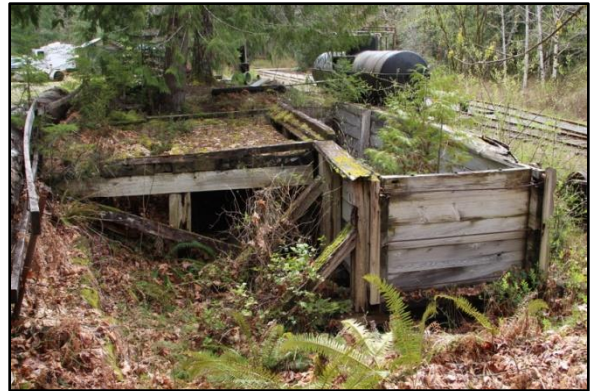
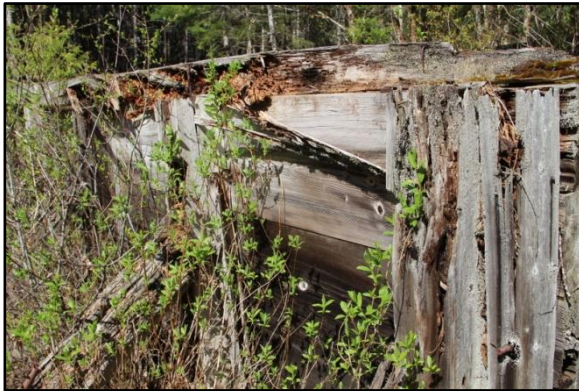
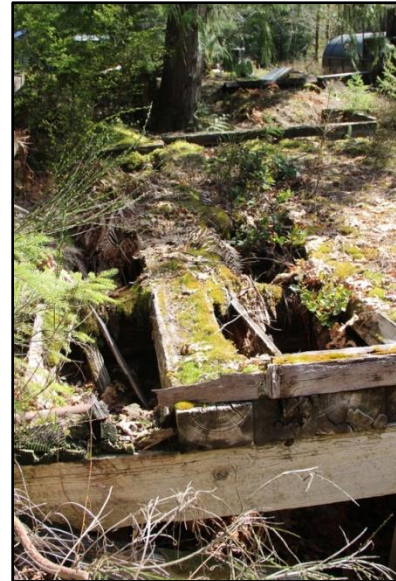
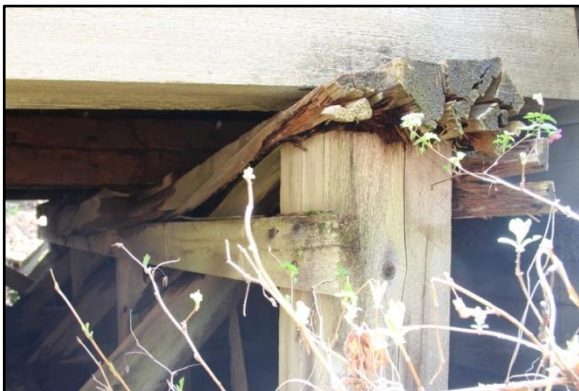
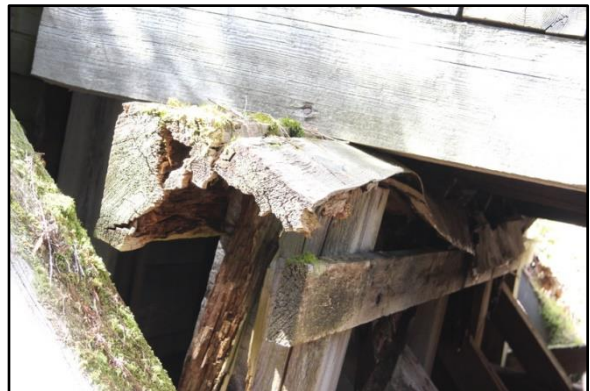
Photographs 141 - 144 – (clockwise from top left)

The Dip Tank is a heavy timber structure set on timber footings adjacent to the railway tracks. The deck leading to the tank and the tank itself are both severely deteriorated with numerous timber failures and extensive organic growth and accumulation in and about the tank. Given the exposure and current condition of this structure, total failure appears imminent.

Overgrown and deteriorated tank wall and adjacent deck, completely deteriorated and failed support beams

It is recommended that if there is an interest to conserve this structure, all organic growth and debris be removed from within and around it, all deteriorated timber elements be replaced with new timbers, and, if necessary, the support structure be set on new concrete footings. Once the conservation work is complete, the deck and tank should be regularly maintained, eliminating organic growth and debris accumulation.

Table 26 – Dip Tank - Renewal Recommendations		
49	Removal of all organic growth and debris and fully restore the entire structure	Critical

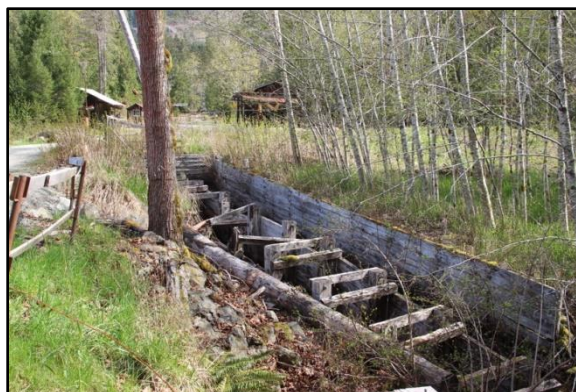
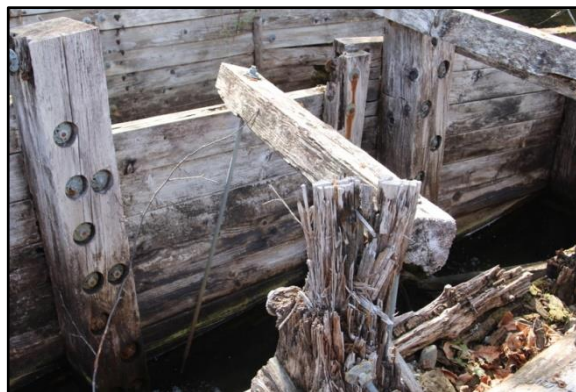
Photographs 146 & 147 – (left to right) structural deterioration of the planks and timbers

As with all of the exposed timber structures, the constant wetting and accumulation of organic debris makes the ladder vulnerable to accelerated decay. Many of the side planks, support posts, and cross beams were observed to be failing. Though not at imminent risk, without conservation work, failure of the side walls and ladder structure could occur over the next few years.

Given its current condition and potential for exponential increase in deterioration, it is recommended that the Fish Ladder be fully restored, replacing all damaged and deteriorating timber members. Regular review of the structure should then be completed, removing all accumulated and encroaching organic debris and growth.

Table 27 – Fish Ladder - Renewal Recommendations

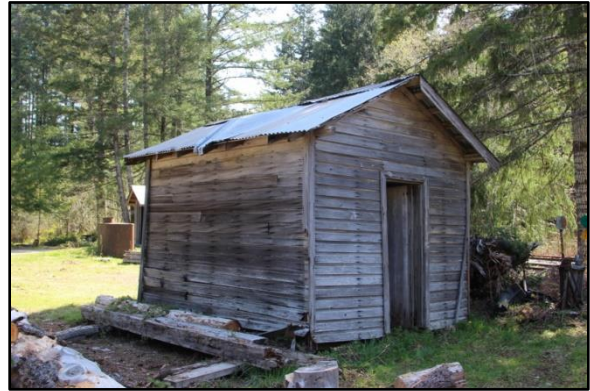
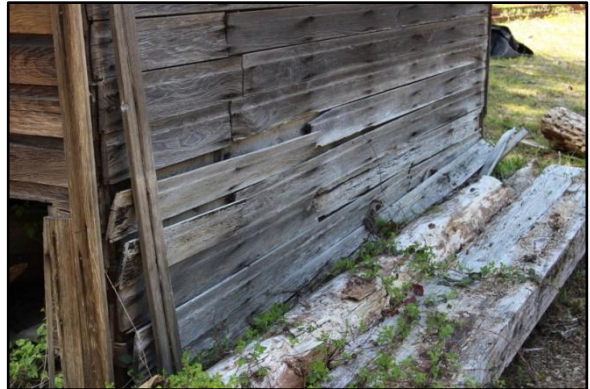
The nailed in place corrugated roof appeared to be in fair condition with a panel bent down at the eaves and buckled mid-span. It would appear that an object fell against the edge of the roof to create this condition. Many of the roofing nails also appeared to be popping leaving a number of the panels loosely held in place. Half of the trim at both roof gables was noted to be missing.

Photographs 149 - 151 – (clockwise from top left) buckled corrugated roof panel, damaged wall siding, missing trim on the north window

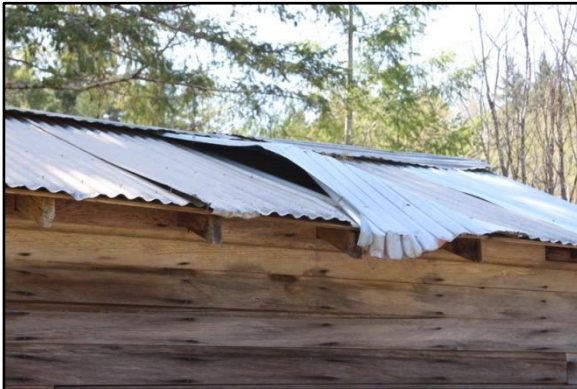
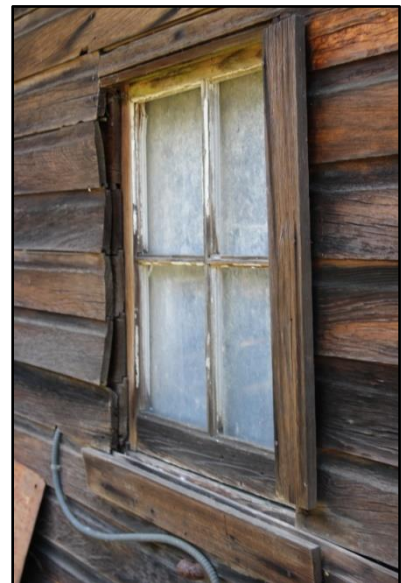
The cove profile, cedar siding protecting the walls generally appeared to be in good condition with some observed damage at the base of the east wall. A number of siding lengths on the north elevation were observed to be curling out of position while a piece at the peak is missing. The door and west window appeared to be in good condition while the north window is missing its perimeter trim. There is also an opening with an unknown purpose at the lower east corner of the north wall.

The First Aid Shack, despite its relocation without a proper foundation or footing, appeared to be in fair condition.¹ Setting the building on a new concrete foundation and floor structure in a suitable location within the context of the site as a whole is the primary recommendation for this building. It is also recommended that the damaged roofing panel and east wall siding be renewed. Consideration could also be given to renewing the fascia and north window trim.

Table 28 – First Aid Shack - Renewal Recommendations		
51	Rebuild the wood frame floor structure and set the building on a sensibly located concrete foundation	Critical
52	Repair the buckled roof panel and reset the fasteners	Medium
53	Renew the east siding	Medium
54	Restore the north window trim	Low

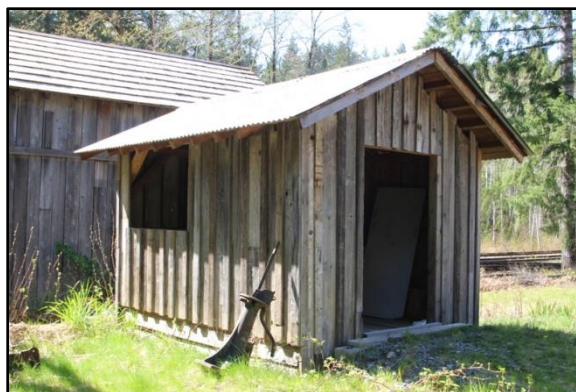
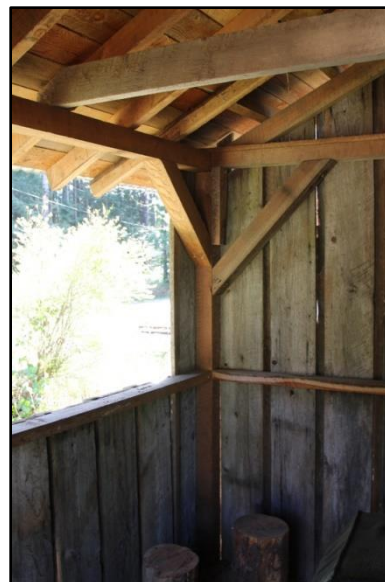
Photographs 153 - 155 – (clockwise from top left) Cracked truss chord, braced frame wall structure, log timber on concrete footings

The corrugated sheet metal roof is set on a rafter assembly supported by a pair of king post timber trusses and the end walls. Excepting a crack in one of the truss cords, the roof appeared to be in good condition.

Board and batten wood siding protects the braced frame wall structure. No damage or deterioration of the siding or structure was observed. A window opening is set in the south elevation while a door opening provides access on the east side. Both openings are without associated assemblies.

The wood frame floor structure supporting the building is set on round logs on concrete 'sonotube' footings. The foundation assembly appeared to be in good

The Sand Shed and its current condition requires no recommendations beyond consideration for a window and door to fill their respective openings (if in the original building), to reduce moisture ingress into the building.
