CITY OF PORT ALBERNI

CLERK'S DEPARTMENT REPORT TO COUNCIL

SUBJECT: McLean Mill and Tourism Rail

Jan. 21, 2019 Committee of the Whole Minutes and Reference Materials

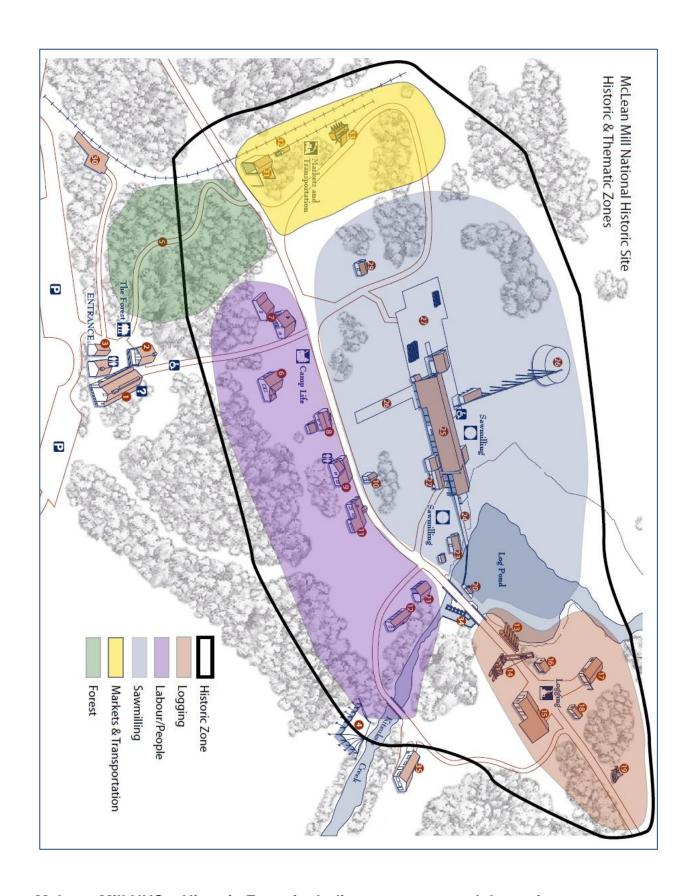
McLean Mill NHS – Historic Zone, including structures and thematic zones.

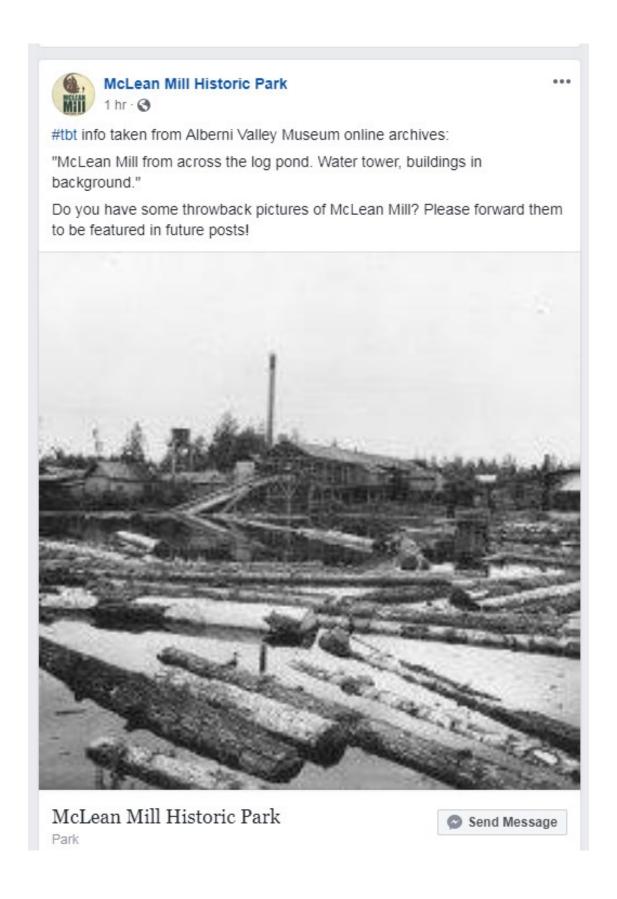
6597 Walker Road Port Alberni, BC V9Y 8W8 T: 250-918-8920 E: sroth61@gmailcom This photograph was posted on Facebook on January 10, 2019. It shows that the contamination issue could easily extend beyond the current mill pond. Look at the size of the pond when the mill was in operation. It was much larger than it is now.

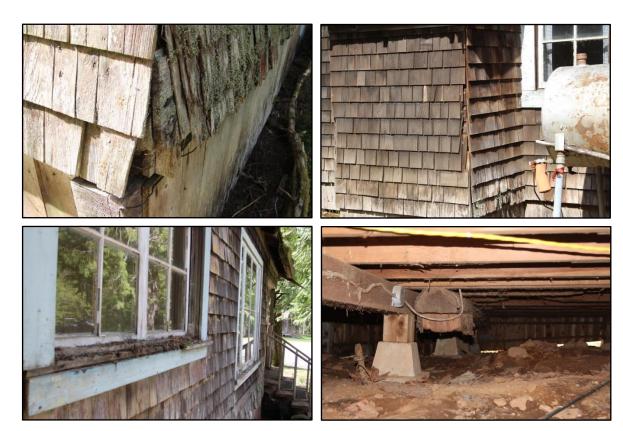
The interior is set up as an exhibit space for visitors to experience as they pass through. Signs of interior moisture ingress and related deterioration were not observed.

Photographs 13 - 16 – (*clockwise from top left*) deteriorated wall cladding, sound building frame and footings, debris on the window sills

Having been formerly used as the site caretakers' house, the A. McLean House is generally in good condition. It is recommended that the roof and gutters be regularly maintained, removing accumulated organic growth and debris, and that the lower hanging tree branches be trimmed up to improve the drying capacity of the cedar shingles. The wall cladding should be repaired where damage and deterioration are exposing the framing assembly behind. The window sills should also be regularly maintained having accumulated debris removed and if necessary, the sills renewed.

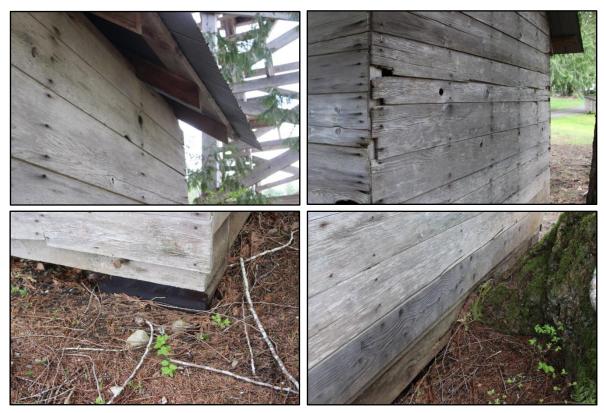
Creosote blocks at the building corners were observed to be providing foundational support. They appeared to be in good condition from what could be seen. Beyond this, little could be observed of the footings. The building appeared level indicating the footings have not failed. It was noted that the building was constructed over a tree root that will likely, over time, impact its slope and stability.

Photographs 33 - 36 – (*clockwise from top left*) sheet metal roof cladding overhang, deteriorated siding, building base constructed over a tree root, a creosote block footing

The interior space with wood shelves holding a few items of historical interest, appeared in good condition with no signs of moisture related deterioration or other damage.

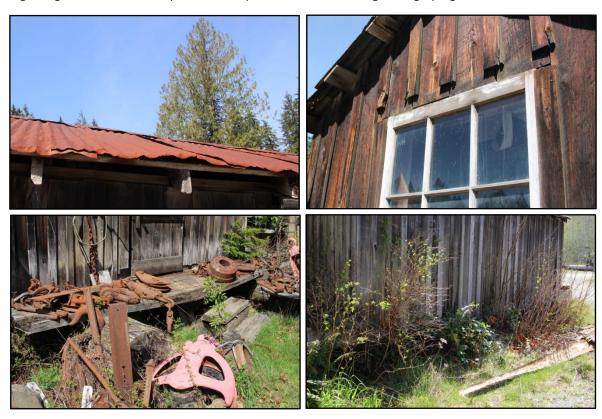
The skidding timbers on which the shed is set are themselves supported by heavy logs. Both appeared to be in good condition. Planks set in front of the main door to support miscellaneous parts and machinery are starting to buckle under the load with a failed support post. It is not likely that these planks are original to the shed that was designed to be pulled through the forest. Organic growth around the perimeter is persistent with trees growing up against the east end.

Photographs 79 - 82 – (*clockwise from top left*) corroded and loose corrugated roofing, missing window trim, organic growth and the building perimeter, misc. parts stored on buckling planks

The interior space, from what could be observed through the windows, appeared to be in good condition with no observed evidence of moisture ingress and associated material deterioration.

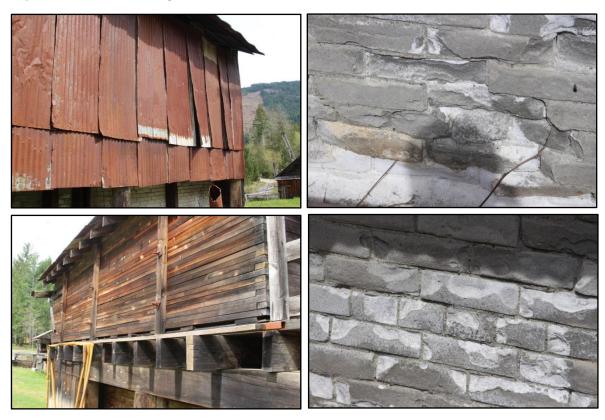
The upper walls of the west building are constructed of stained, laminated timbers set on a heavy timber floor structure that is supported on a concrete foundation and concrete piers. The concrete foundation is partially clad with wood siding to maintain a historic appearance. With no signs of exterior deterioration but having no access to either interior space, it is assumed that the wall assemblies are performing as expected. As a building in active use, it is expected that it would be reported to the site manager if otherwise.

Photographs 95 - 98 – (*clockwise from top left*) corroding sheet metal wall cladding, spalling and eroding brick foundation, laminated timber walls

Knowing that the Boiler House has been in operation until last year, generally serviced, and without signs of significant deterioration, it is simply recommended that the brick foundation walls be repointed with a lime mortar and that the corrugated sheet metal wall is maintained in place. Reviewing the roof assembly during a rain event can determine if there is moisture ingress and if the gutter assemblies are performing as expected. Restoring the operation of the Mill would significantly benefit the maintenance and durability of the Boiler House.

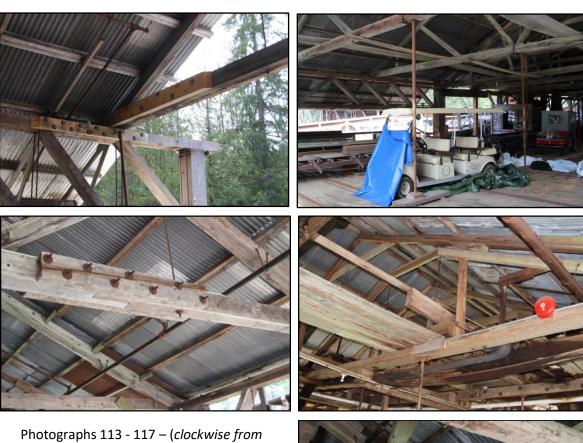
load path through the assemblies. Many of the individual pieces had splice repairs addressing previous deterioration. The structural performance of some of these splices is of concern. A series of heavy trusses and additional shoring posts were noted over the main saw. Other than past repairs including the splicing, there were no signs of significant deterioration or potential failure. However, the random framing and splicing makes the performance of the roof structure indeterminate. It is recommended that a review of the roof be considered to determine where upgrading and additional permanent support would enhance the safety and durability of the structure.

Photographs 113 - 117 – (clockwise from top left) repaired south-west corner structure, reinforcing struts, random timber roof structure, roof structure over the east end of the mill, old truss chord splice

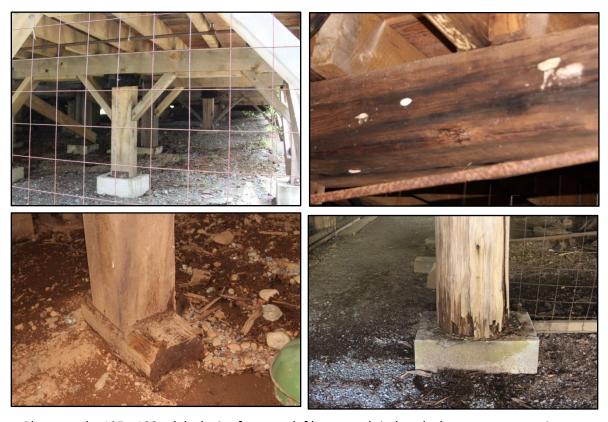
Today, the Lumber Deck was observed to be aging but there were no observed signs of deterioration or failure. The supporting timber structure beneath the deck is set primarily on concrete pad footings though some timber footings were observed. A number of the beam joints were observed to be protected with a sheet membrane while a number of original beams that were retained were observed to be supporting minor organic growth. Some of the timber footings were observed to be decaying at their bases. The environment beneath the deck was noted to be quite cool and damp. This condition, combined with the accumulation of sawdust on the grade and around the footings, exacerbates moisture related deterioration of the timber members

Photographs 125 - 128 – (*clockwise from top left*) renewed timber deck structure, organic growth on original timber beam, deteriorating post base, , deteriorating timber footing

The Lumber Deck appeared to be in good condition despite some localized deterioration. It is recommended that the deck and support structure be regularly reviewed and that the deteriorating posts and footings be renewed. In addition, accumulating sawdust and grade should be pulled back from any timber members that might be negatively affected by them.
