AGENDA

COMMITTEE OF THE WHOLE MEETING OF COUNCIL

MONDAY, JANUARY 21, 2019 AT 3:30 PM
IN THE CITY HALL COUNCIL CHAMBERS

- Cost Sharing Agreement for McLean Mill National Historic Site (outlining City's obligations) dated July 23, 1996 - Page 10
- McLean Mill Society (MMS) Constitution dated December 8, 2016 - Page 22
- Operation and Management Agreement between City and MMS dated January 1, 2017 - Page 23
- McLean Mill Site Assessment prepared by John Dam & Associates Inc. dated July 3, 2018 - Page 36

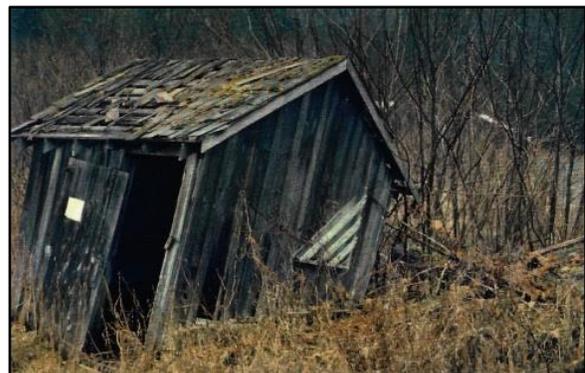
Photograph 2 – Building deterioration

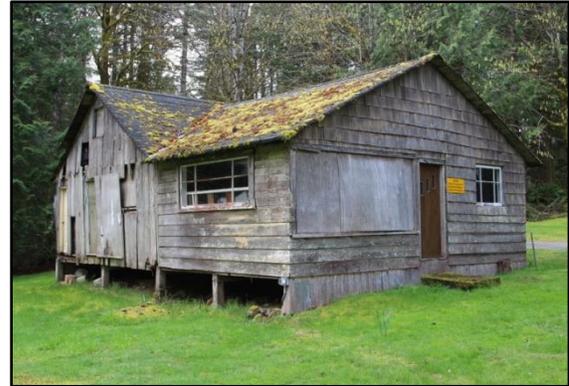
Currently, the asphalt shingle roof is supporting significant moss growth on both the north and east elevations while moisture ingress through the attic has occurred, deteriorating the ceiling finishes. The discontinuous roof line at the south-east corner would suggest a previous addition on the east elevation has been removed.

The Workers House was generally found to be in fair condition though in need of remediation work. It is recommended that if the roof is found to be currently leaking, it be addressed with the installation of temporary sheet metal or the renewal of the asphalt shingles to eliminate persistent moisture ingress and related deterioration. The east elevation should be repaired to close up the damaged and exposed wall assembly and prevent moisture ingress into the building. The window sills should be restored where signs of moisture ingress into the wall assembly are evident. The damaged floor joists should also be replaced to prevent further building displacement and the possibility of progressive failure. If material is to be stored in this building, it is important that it be organized and well-spaced to facilitate airflow, reduced moisture storage, and allow for the onset of assembly deterioration and displacement to be readily observed.

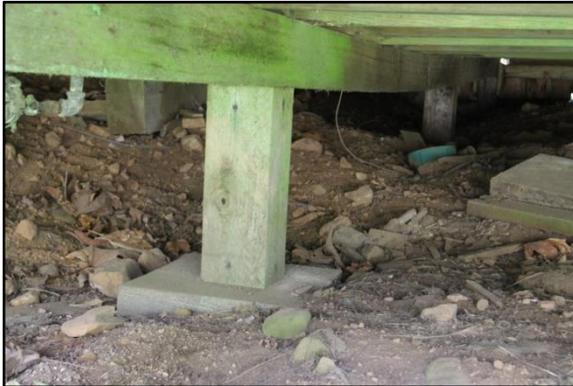
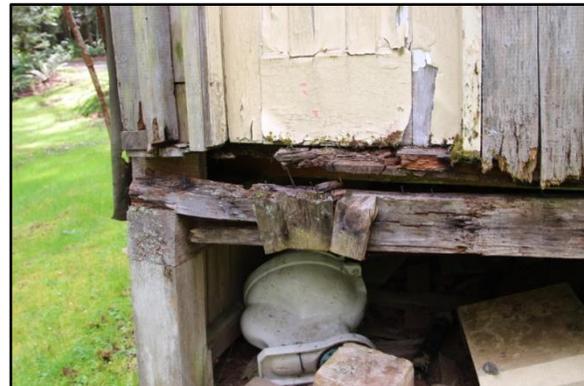
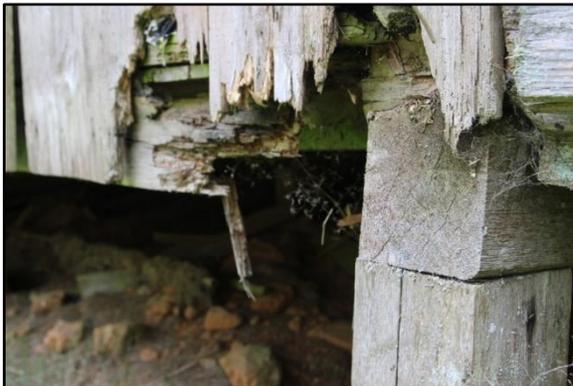
The supporting timber structure appears in good condition except at the south end of the east elevation where the outer joist has failed, resulting in differential settlement.

Photographs 8 - 10 – (clockwise from top left) renewed timber foundation structure on concrete pad footings, deteriorated exterior joists resulting in building displacement

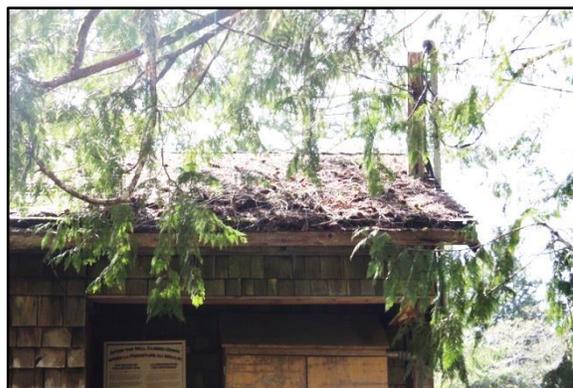
Built adjacent to a couple of large trees, Organic debris and growth is accumulating on the cedar shingle roof and filling the gutter over the front door. At least one branch was observed to be resting on the roof. Despite this, the roof appeared to be performing as required with no observed interior moisture ingress and related deterioration.

Photograph 12 – debris accumulation on the roof and in the gutter

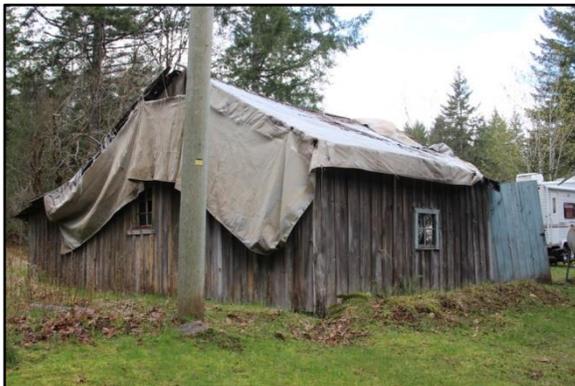
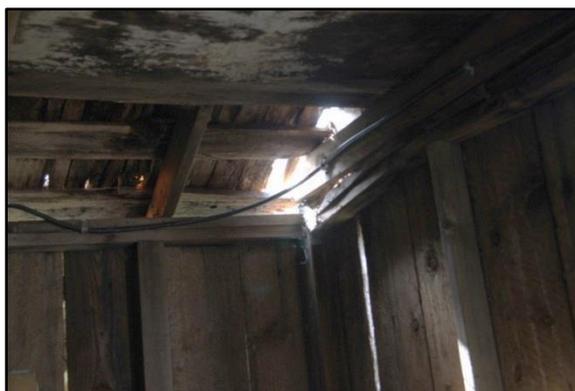
The cedar shingle roof over the main garage has been protected with a tarp that is loosely held in place and heavily damaged. With the severe deterioration of the shingles and the damaged tarp, the roof structure is exposed to moisture ingress and the associated deterioration. The lean-to on the west side is protected with sheet metal cladding held down with timber scraps and debris. Given the low-slop and accumulation of debris, the onset of deterioration of the sheet metal is unavoidable with a number of holes already observed.

Photograph 18 - 20 – (clockwise from top left) damaged roof tarp, holes through the main, cedar shingle roof and the lean-to, sheet metal roof

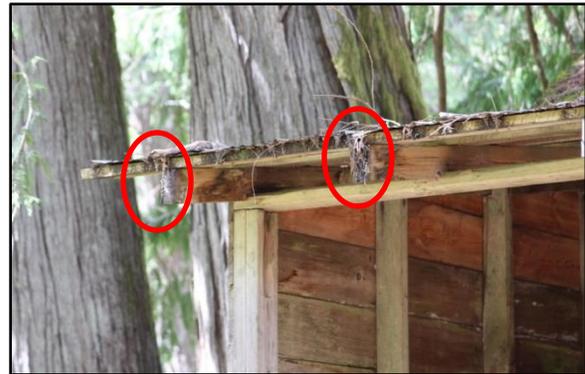
The main and entrance porch roofs are currently protected with a modified bitumen sheet membrane while the rear addition is covered with sheet metal. Both roofs are supporting organic growth and debris but otherwise appear to be performing as expected. The exposed rafter ends were observed to be deteriorating suggesting that the overhang of the roof is not sufficient to prevent moisture drainage onto them. The chimney appears in fair condition but could be cleaned and repointed to reduced accumulating organic growth and associated deterioration.

Photograph 24 – debris runoff on the rafter tails

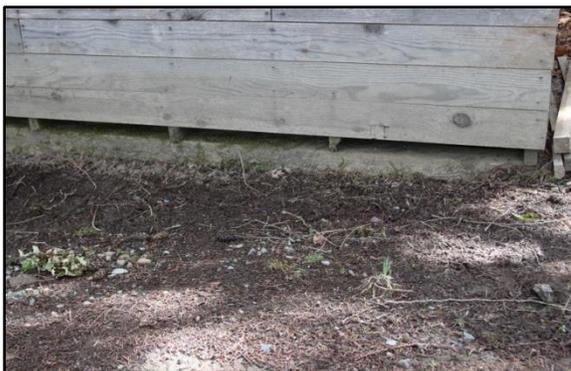
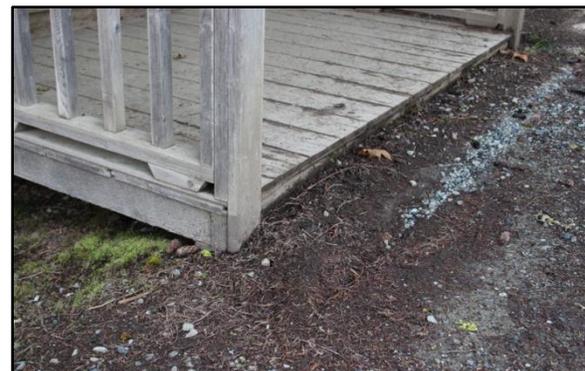
Lacking the perimeter skirting, there is positive ventilation beneath the building. Grade is however starting to accumulate at the north-west corner and along the west and north edges of the entrance porch putting the base timber at risk of moisture related deterioration. A large tree is also growing in close proximity to the west elevation, exacerbating the impact of the accumulating grade. Material debris was also observed to be stored beneath the building.

Photograph 25 & 26 – (left to right) grade accumulation along the north elevation

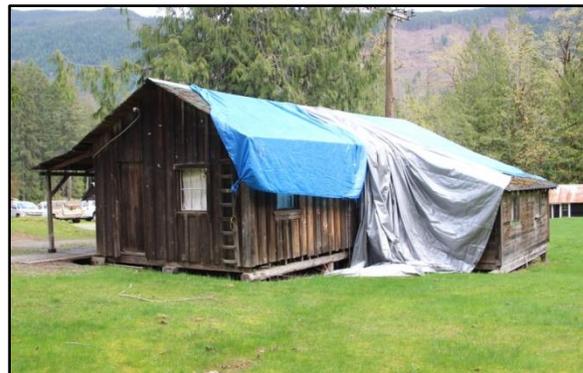
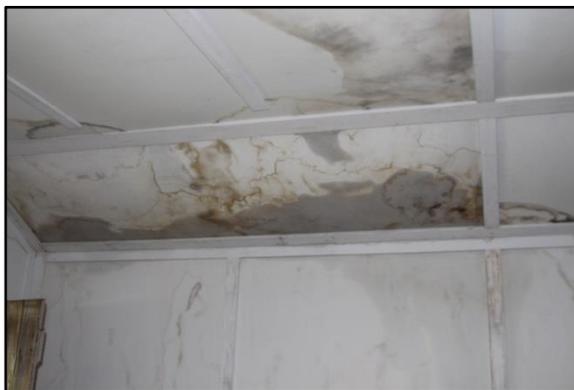
Currently, the asphalt shingle roof is notably deteriorated and protected with haphazardly secured tarps. A large tree remains in close proximity with its lower branches resting on the roof. Roof plank deterioration was observed at the south-east corner while the donna conna ceiling finish of the dining room, and the wood ceiling of the bedroom are supporting organic growth and failing.

Photographs 38 - 40 – (clockwise from top right) loose roof tarps, deteriorated wood and donna conna ceilings

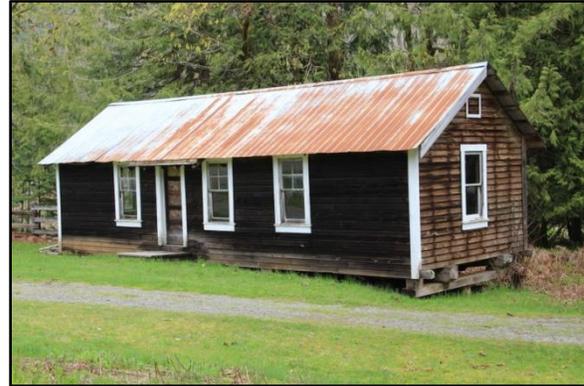
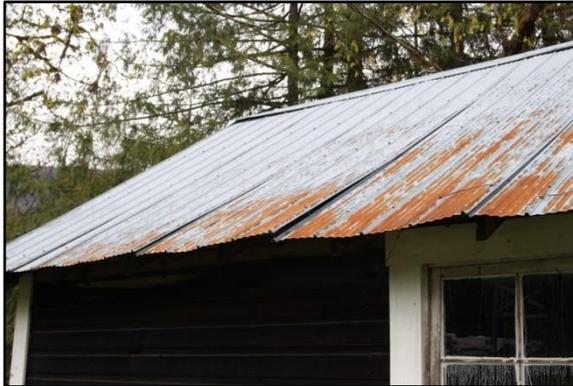
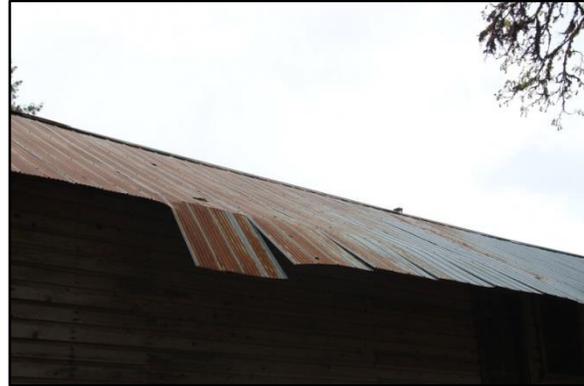
The ‘temporary’ sheet metal roof is now starting to corrode and a number of panels were observed to be loose. Along the back elevation, the sheet metal was installed with excessive overhang and one panel has buckled. An abridged gutter, determined to not be original to the building, has been installed over the front door.

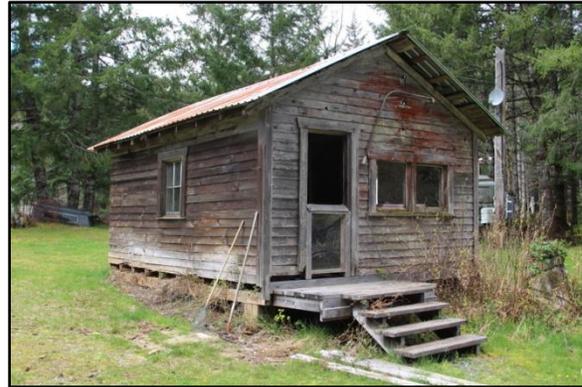
The sheet metal roof appeared to be in fair condition with the onset of surface corrosion and some flashing repairs completed along the ridge. The wood structure supporting the roof had some noteworthy deterioration but the interior of the building appeared to be dry and free of moisture related deterioration.

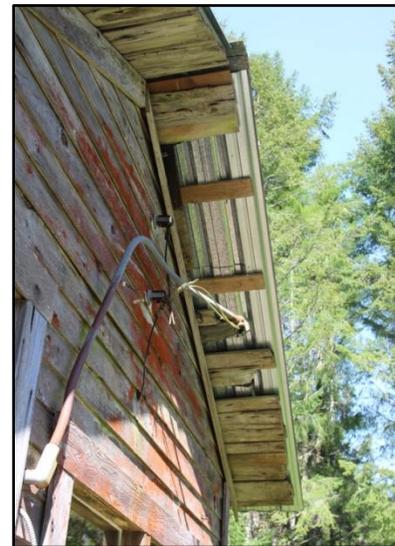
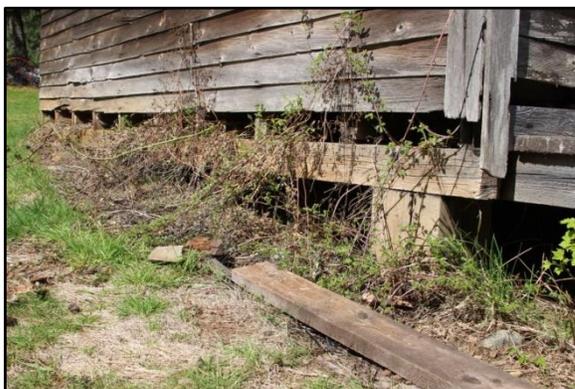
The wood siding appeared to be in good condition accepting along the base of the building, particularly adjacent to the north porch, where deterioration was evident. The window is missing in the west elevation while the east window is supporting moss growth. The east door was found to be off its hinges, inside the building while the north door, adjacent to the porch, is significantly deteriorated along the base.

The building is supported by a timber foundation and treated timber and concrete blocks. The foundation structure appeared to be in good condition though organic growth is not managed along the perimeter. The front porch is in good condition but the side porch appears to be sloping towards the building, exacerbating the deterioration of the adjacent door and siding.

Photographs 48 - 50 – (clockwise from top right) deteriorated timber roof structure, north porch with adjacent door and cladding deterioration, perimeter growth

Having been relocated at least once, the Teacherage currently appears to be in good condition on a sound foundation with limited, observed deterioration. It is recommended that the north porch be addressed, sloping it away from the building to reduce backsplash against the base of the building. Organic growth around the perimeter should be cut back to allow the base of the building to vent and dry while the east window sill should be cleaned of organic growth to prevent deterioration. Consideration for future conservation works would include the renewal of the doors and windows to reduce moisture ingress into the building, and a further investigation of the roof structure.

Table 9 – Teacherage - Renewal Recommendations		
23	Slope north porch away from building	Medium

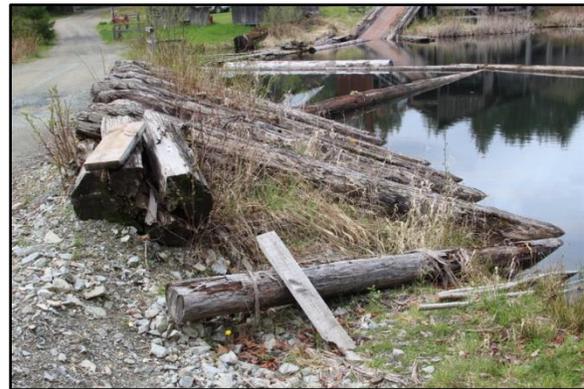
There are currently 6 sloping logs set on a notched base log. The sloping logs, despite the accumulation of debris between them, are in fair condition with the expected level of exposure related deterioration. The base log is significantly decayed at the ends and splitting apart.

Given its exposure and positioning into the edge of the pond, the Log Dump is a feature that will continue to deteriorate over time. This will necessitate the eventual and continual, replacement of the timber members. When it was last restored, the slope was reduced to accommodate current concerns pertaining to the fish in the pond. If possible, consideration should be given to restore the original geometry of the structure.

24	Monitor the timber members, removing debris and growth between them to reduce the rate of decay and replacing them when they become unstable	Low
----	--	-----

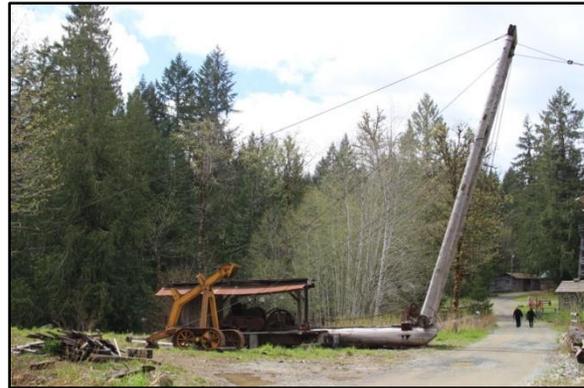
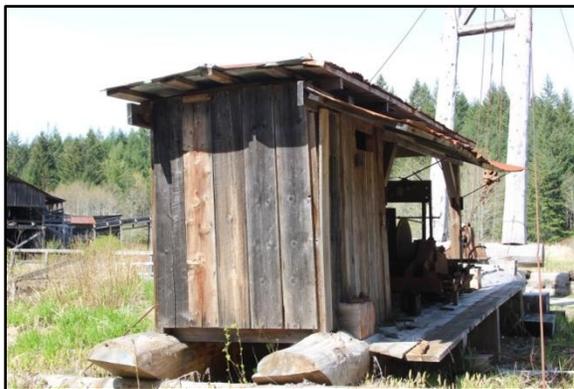
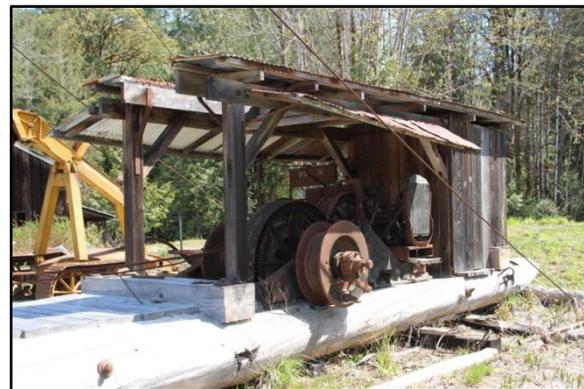
The assembly, set on treated timbers, appeared to generally be in good condition with no significant deterioration observed beyond the ongoing corrosion of the mechanical equipment. The two side roofs, providing protective cover for the operators, are sagging under their own dead load suggesting inadequate structural support. This is likely exacerbated under snow loads conditions.

Photographs 55 & 56 – (left to right) The cabin of the A-Frame with the wing roofs

Ongoing use and maintenance of the A-Frame would enhance the durability and life expectancy of this structure. Alternatively, a contemporary roof structure could be erected over the mechanical end to protect it from exposure to the weather and associated corrosion. It is likely that the structure of the wing roofs is original and that the angled position is what they originally looked like. Regular monitoring and maintenance of these roofs will keep them in place while modest structural upgrades would reduce maintenance requirements and possible failure.

Table 11 – A-Frame - Renewal Recommendations		
25	Monitor the mechanical assembly and protective structure, completing maintenance and renewal work when necessary.	Low

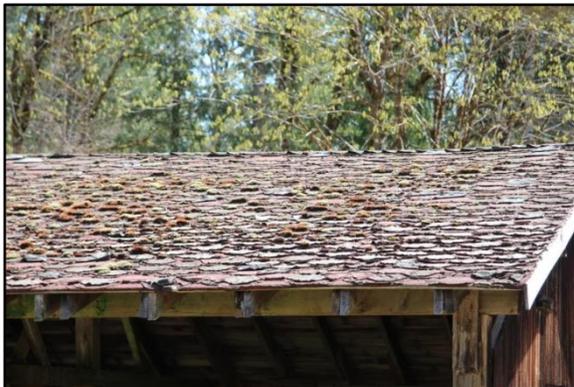
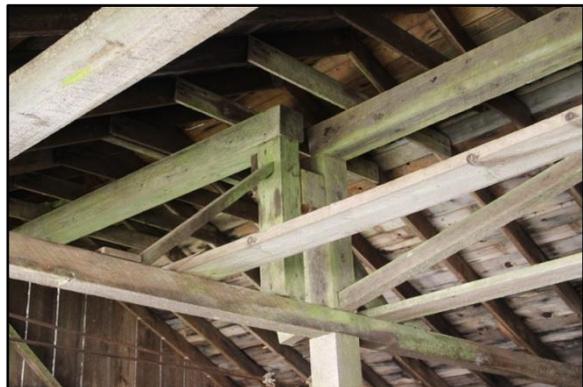
The renewed asphalt shingles are now beyond their expected service life with extensive deterioration and organic growth observed.

The cedar shingles on the rear lean-to roof are also covered with moss and organic debris. The main roof structure is unconventionally framed with discontinuous members and seemingly random bracing. Moisture ingress is occurring in a number of locations, most notably where the raised roof transitions to the main roof. A number of material and assembly failures were observed including a significant hole in the roof, fraying tension cables, and deteriorating post bases.

Photographs 58 - 60 – (clockwise from top left) deteriorated asphalt shingles, unconventional roof framing, moisture staining on the structural assembly

Table 12 – Garage - Renewal Recommendations		
26	Complete a structural review of the building to determine any necessary renewal and reinforcing works that may be required	High
27	Renew the roof, replacing the existing shingles or installing a temporary sheet metal roof.	High
28	Pull back grade and organic growth from the building perimeter	Medium

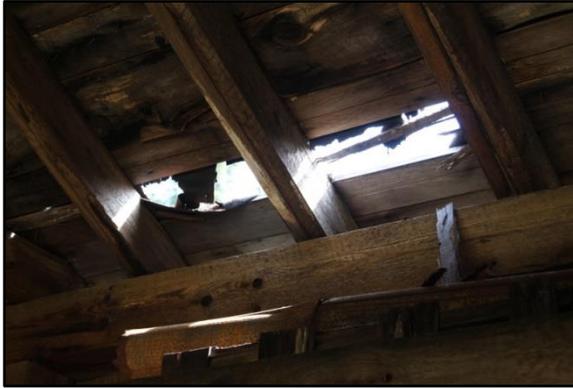
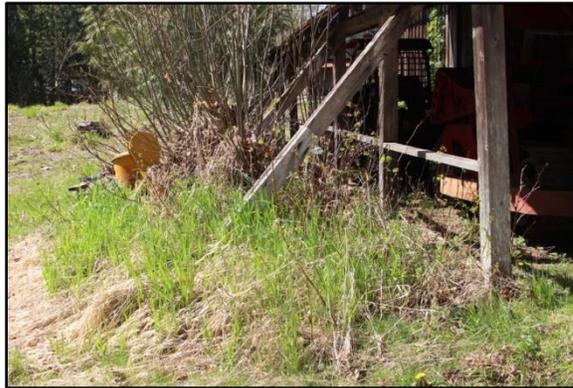
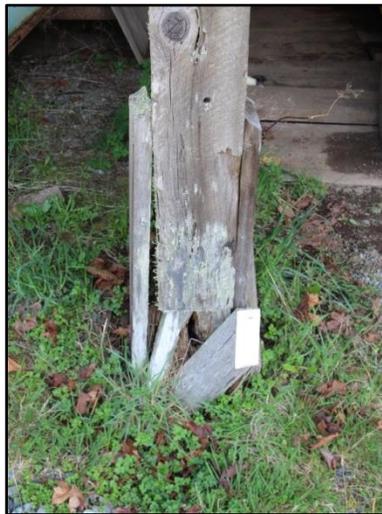
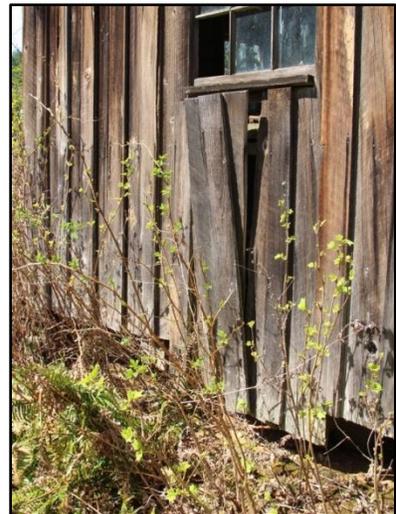
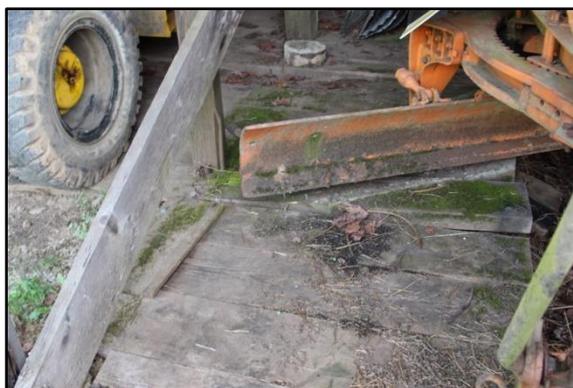
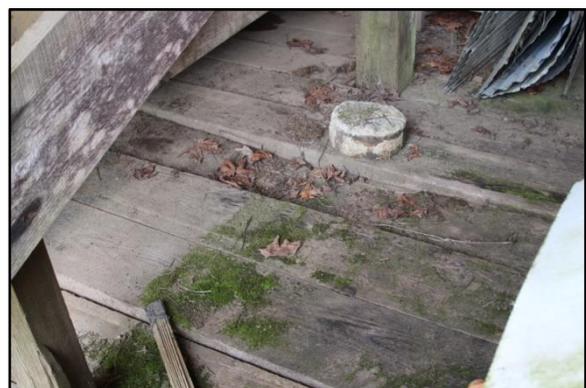
The floor assembly adjacent to and over the pit appears to be failing with loose and displaced floor planks. Further review of the floor could not be completed with the vehicles parked on the assembly. A review of the perimeter grade showed it to be sloping towards the front of the building. This may be contributing the observed post failures.

Photographs 61 - 68 –
(clockwise from top left)
failed roof cladding,
frayed tension cable,
unabated growth along
the east elevation,
localized siding failure,
displaced and collapsed
floor planks, post base
failure, overgrown,
braced lean-to
structure

Despite the renewal work completed in the 90’s when the building was found to be near collapse, the Garage is once again in very poor condition with signs of structural settlement, moisture ingress and related deterioration. The unconventional framing and bracing along with the settlement indicates that the building may not be stable. It is recommended that a comprehensive structural review of the building be undertaken to ensure its safety and stability and to determine what structural renewal work may be required. In addition, the roof should be replaced to eliminate moisture ingress into the building and reduce further member deterioration while the surround grade and organic growth should be pulled back from the building to allow the base assemblies to dry out and reduce their rate of deterioration.

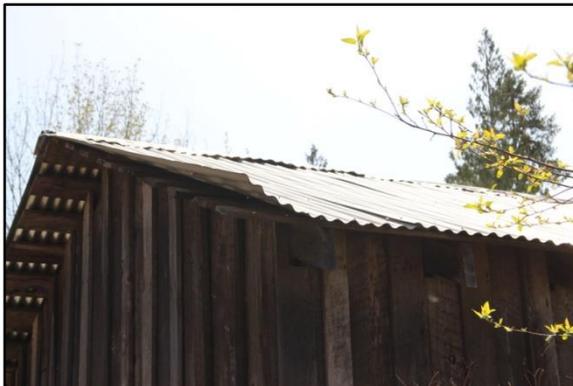
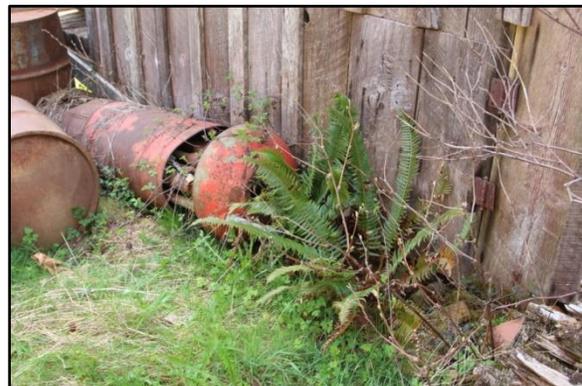
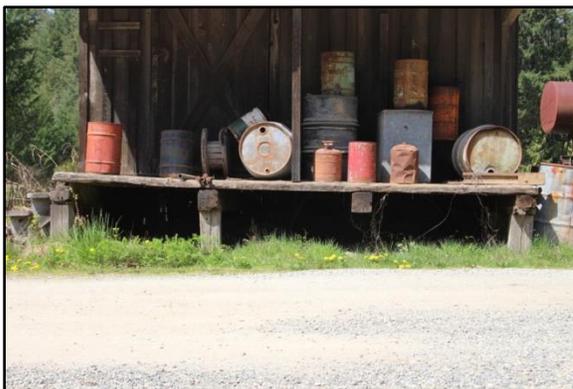
Currently, the corrugated sheet metal roof appeared to be in fair condition with many of the fasteners observed to be lifting, allowing the sheet metal to move in the wind. The edge of the roof over the front porch appears to have sustained impact damage in the past while the structural framing supporting it appears to have been recently renewed.

The south wall is in good condition, protected by the porch roof while the remaining walls, without this protection, are significantly weathered with localized damage and organic growth and debris encroaching at the base. The windows, without sill plates or trim, allow water to pass in between the sash and wall assembly.

Photographs 70 - 73 – (clockwise from top left) Loose corrugated roofing, encroachment of growth and debris, a window pane set in the wall, the front porch with a missing support post

The existing post and beam foundation appears to be in fair condition though perimeter deterioration could not be affirmed with the encroachment of growth and grade. The front porch is missing a support post and is subsequently noticeably sagging.

The Gasoline & Oil Shed appears to be in fair condition. The roof, though loose, is in good condition and should simply be refastened down to the roof structure. The deteriorated wall elements could be repaired while the windows, could be discretely trimmed, if historically appropriate, to reduce moisture ingress through the wall assembly. The accumulated debris and organic growth should be removed from the building perimeter to facilitate drying and reduce the rate of deterioration. The support post beneath the front porch should also be reinstated to avoid undue stress on the porch assembly.

Table 13 – Gasoline & Oil Shed - Renewal Recommendations		
29	Refasten the roof to the roof structure	Medium
30	Renew the deteriorated and deficient wall and window assemblies	Low
31	Reinstate the missing porch post	Low

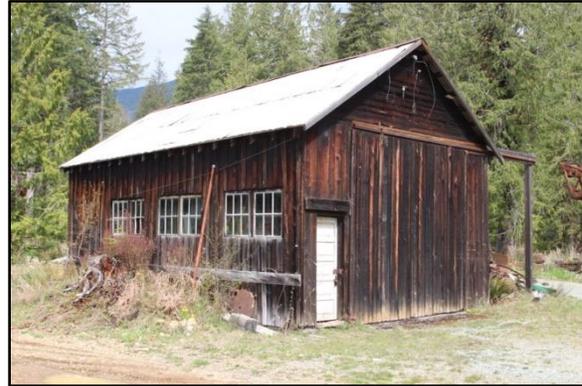
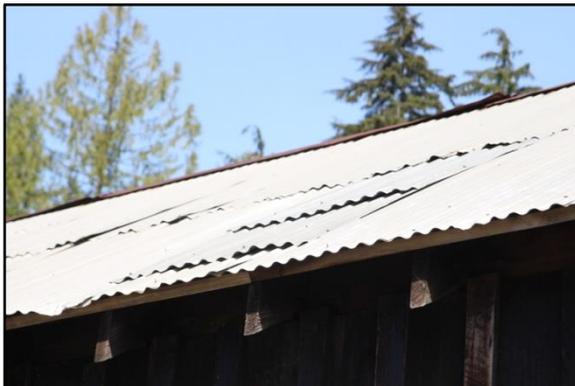
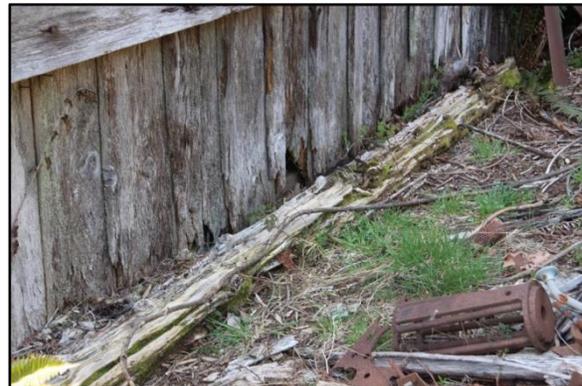
Today, the corrugated metal roof is in good condition though many of the panels are loose with the fasteners either pulling up or punching through the sheet metal. Some of the rafter tails were also observed to be deteriorated.

The board and batten wall cladding is in fair condition being largely coated with creosote or other petroleum product. Typical base perimeter deterioration is occurring where organic growth and debris are starting to encroach. A number of battens were observed to be loose or missing while horizontal planks are supporting organic growth and starting to deteriorate. Most of the windows are untrimmed, allowing moisture ingress in between the sash and the wall assembly.

Photographs 75 - 77 – (clockwise from top left) loose corrugated roof sheet, deteriorating cladding at base of wall, untrimmed window opening

The Machine Shop is in good condition with no observed deterioration of significance. The corrugated roof should be refastened to the roof structure and the encroaching organic growth and debris should be pulled back from the wall perimeter. Additional conservation work could include the renewal of the wall assembly, reinstating the loose and missing battens.

Table 14 – Machine Shop - Renewal Recommendations		
32	Fasten down the corrugated roof to the roof structure	Medium
33	Renew the wall cladding, reinstating the loose and missing battens	Low

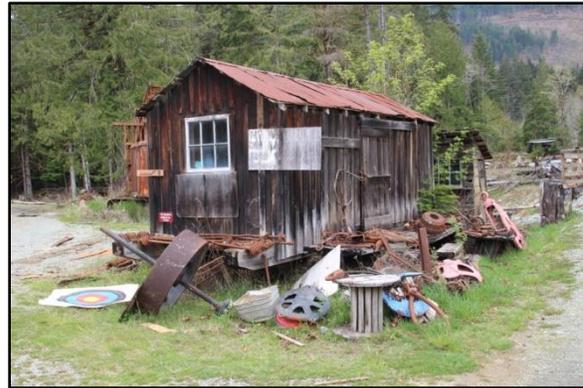
Today, the corrugated metal roof is heavily corroded, loose, and missing a number of fasteners.

The board and batten siding appears to be in fair condition while the west window is missing a trim board at the head.

The skidding timbers on which the shed is set are themselves supported by heavy logs. Both appeared to be in good condition. Planks set in front of the main door to support miscellaneous parts and machinery are starting to buckle under the load with a failed support post. It is not likely that these planks are original to the shed that was designed to be pulled through the forest. Organic growth around the perimeter is persistent with trees growing up against the east end.

Photographs 79 - 82 – (clockwise from top left) corroded and loose corrugated roofing, missing window trim, organic growth and the building perimeter, misc. parts stored on buckling planks

The Parts Shed is in fair condition with limited deterioration. It is recommended that the roof cladding be renewed, restoring the original assembly or reinstating the corrugated metal cladding. The existing assembly may have a few serviceable years remaining if it is refastened to the roof structure. The organic growth around the perimeter should also be removed to reduce base deterioration and allow the building assembly to dry more effectively.

Table 15 – Parts Shed - Renewal Recommendations		
34	Renew the roof cladding restoring the original material or reinstating the existing corrugated metal.	Medium

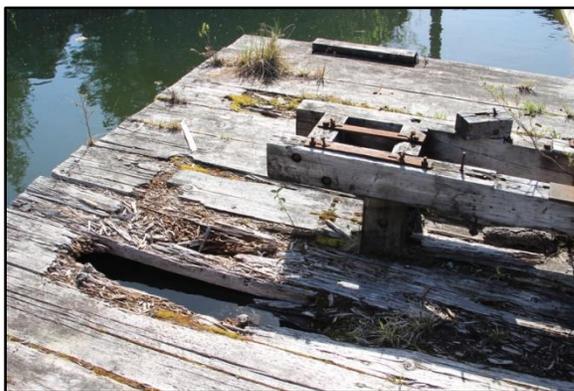
The Boom Shack building no longer exists, with only a piece of mechanical equipment on a floating dock identifying where it was once located. The mechanical equipment and dock are both deteriorating with the onset of corrosion and wood decay.

Photographs 84 & 85 – (left to right) Deteriorating wood planks, corroding piece of mechanical equipment

Given the exposure and position within the pond, what is remaining of the former Boom Shack will continue to deteriorate over time. It is recommended that the planks of the wooden dock be replaced to retain the sense of location of the former building. The deterioration of the mechanical equipment could be addressed by installing a protective cover on the dock or should the opportunity arise, restoring the original Boom Shack.

Table 16 – Boom Shack - Renewal Recommendations		
35	Renew the deteriorating planks on the wood dock	Medium

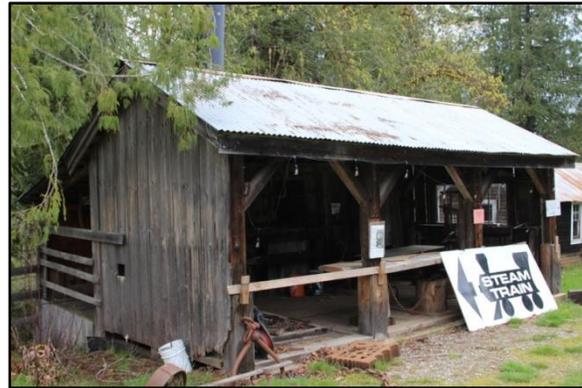
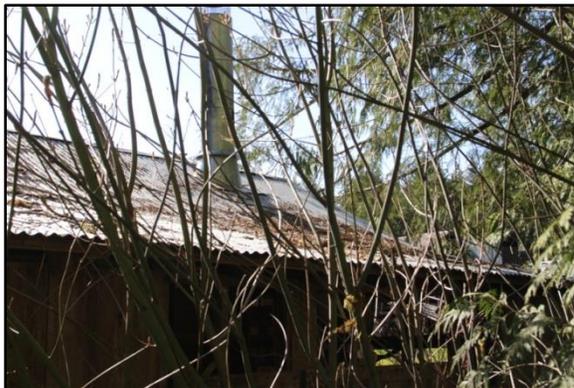
The corrugated sheet metal roof, screwed down to the roof structure, appears to be in good condition with no apparent leaks observed. The lean to roof is still clad with cedar shingles, possibly original, beneath the sheet metal. Given the low-sloped pitch of the lean-to roof, organic debris can and is accumulating on the sheet metal. Due to previous deterioration, a number of rafters over the lean –to have been twinned to provide adequate structural support.

The building is an open air structure with a braced post front wall and a partial height rear wall. The gapped planks on the side and rear walls provides modest protection against the elements. The wall cladding and timber support structure appeared to be in good condition with limited deterioration observed at the north west corner. The unsympathetic repairs to the bases of the front posts suggest that deterioration was an issue in the past. Loosely installed, sliding sash fill in two wall openings on the south elevation.

Photographs 87 & 88 – (left to right) organic debris accumulation on the sheet metal roof, unsympathetic post repair and sliding sash

Having been previously restored and recently in operation, the Blacksmith Shop was observed to be in good condition. It is simply recommended at this time that the roof assembly be regularly maintained removing the accumulating debris and cutting up the adjacent tree branches. Perimeter growth and debris, although modest at this building, should also be constantly maintained. Consideration can also be given to future conservation works, restoring the appearance of the original post structure on the front elevation.

Table 17 – Blacksmith Shop - Renewal Recommendations		
36	Maintain the roof assembly removing debris and low hanging branches	Low

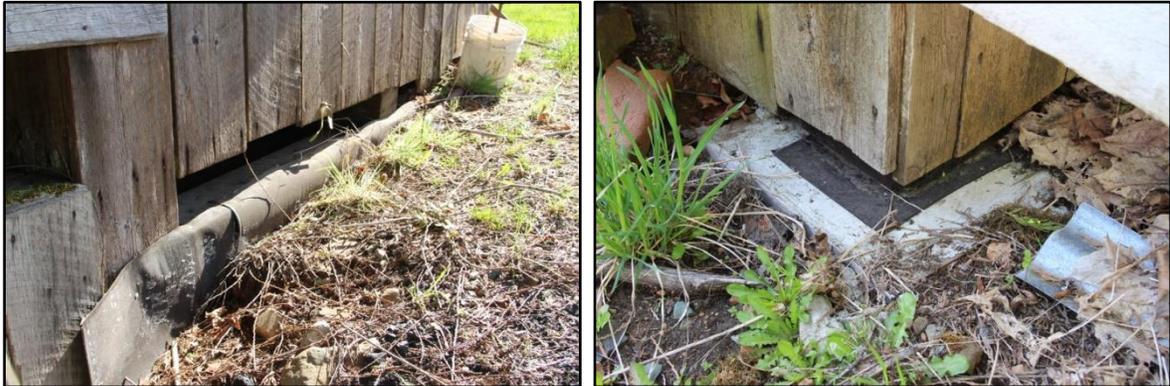
The beams and posts supporting the structure are set on concrete pads and protected with sheet rubber to reduce moisture migration and associated decay. Wood skirting protects the foundation supporting the lean-to. Debris accumulation and organic growth around the building was observed to be limited.

Photographs 89 & 90 – (left to right) protective sheet rubber between the timber structure and concrete footings

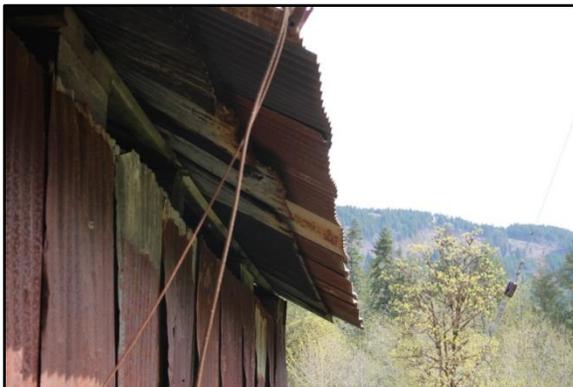
Both buildings are currently protected with a corrugated sheet metal roof assembly, the one on the east building being double layered. The roof assemblies appeared to be in fair condition showing minor surface corrosion. The chimney openings through the roofs are rough cut and unsealed, potentially allowing moisture into the buildings. The roofs rely on sheet rubber lined, wood frame gutters to direct moisture away from the building and prevent it from entering the adjacent Mill.

Photographs 92 - 94 – (clockwise from top left) Double layer roof assembly over the east building, gaps between the roof cladding and chimney, sheet rubber lined, wood frame gutters

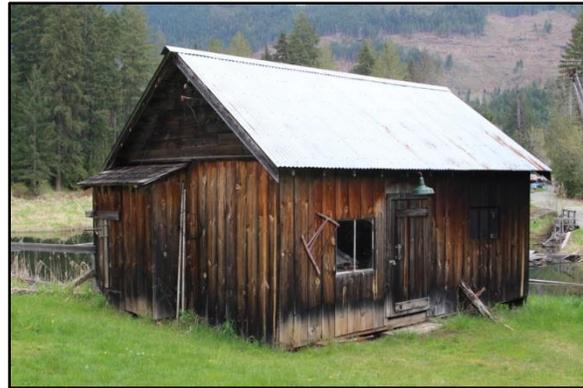
The corrugated roof, screwed down to the roof structure, appeared to be in good condition with limited surface corrosion. Without access to the interior, it was not possible to determine if there were signs of moisture ingress or related deterioration but from what could be observed through the windows, the roof appeared to be performing as expected.

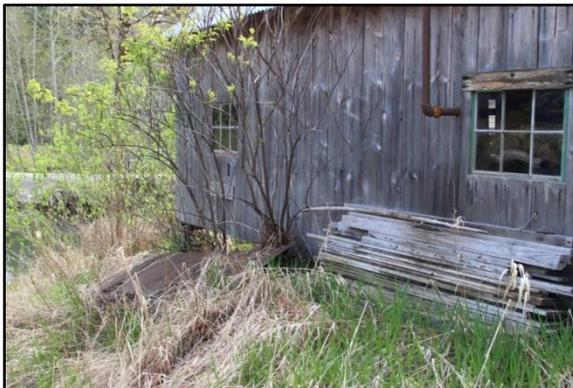
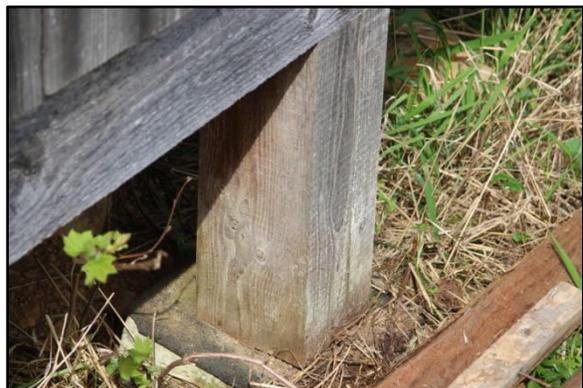
The walls assemblies generally appeared to be in good condition. Some of the shiplap plank siding appeared to be benefitting from the protection of a petroleum stain while a number of planks on the east elevation are starting to curl. The north elevation has material stored against it and organic growth encroaching the base. The windows are without sills and trim which allow moisture to pass in between the sash and wall assembly. The glazing putty on the window sash was also observed to be deteriorating.

Photographs 100 - 102 – (clockwise from top left) material debris and organic growth against the north elevation, deteriorating glazing putty and gap between the sash and cladding, timber post set on rubber pad on concrete footing

The timber foundation is set on rubber pads on concrete footings. Despite the material storage and organic growth on the north elevation, the foundation appeared to be in good condition.

The Millwright’s Shed appeared to be in good condition with no observed significant, deterioration. Consideration could be given to installing perimeter trim around the windows, if historically correct, to reduce moisture ingress into the wall assembly and building. Both the material storage and organic growth against the north foundation should be removed.

Table 19 – Millwright’s Shed - Renewal Recommendations		
38	Remove material storage and organic growth from north elevation	Low

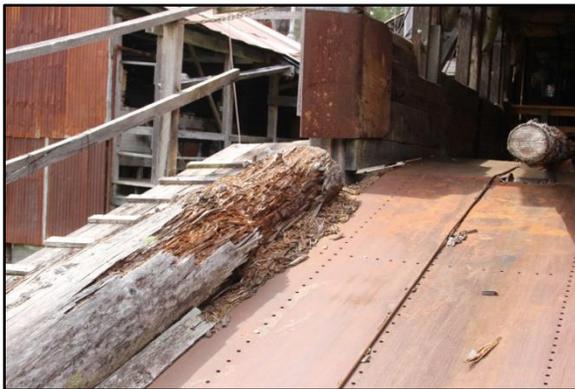
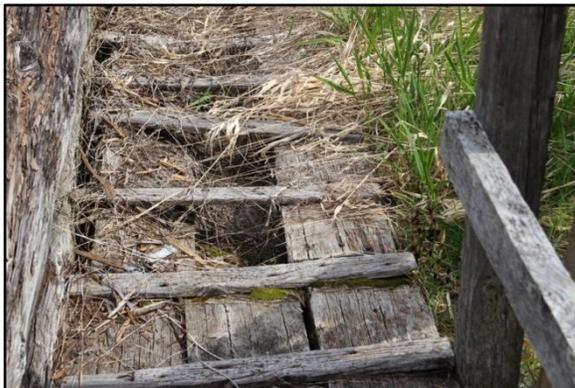
The steel plate is showing signs of surface corrosion. This would be expected given its exposure to the weather. Many of the exposed heavy timbers adjacent to the steel plate and the walking plank up the south side are severely deteriorated with plant growth and the proximity of the pond at the lower end exacerbating this.

Photographs 104 - 107 – (clockwise from top left) corroding steel plate and deteriorating side timber, deteriorating side timbers with encroaching organic growth, deteriorating side timber and organic growth over walkway, severely deteriorated walkway

Given its exposure and positioning into the edge of the pond, the unchecked organic growth around it, and the ceasing of mill operations, the Log Haul is in fair condition though it will continue to deteriorate over time. This will necessitate the ongoing maintenance of the exposed timbers. Without regular use, the steel plate itself will also start to deteriorate more rapidly. It is recommended that the severely deteriorated heavy timbers and adjacent walkway be renewed immediately to preserve the integrity of the Log Haul and minimize the impact of deterioration on those members less affected. The timber footings should be regularly monitored to ensure structural stability.

Table 20 – Log Haul - Renewal Recommendations		
39	Replaced deteriorated timbers and renew the deteriorated walkway	High

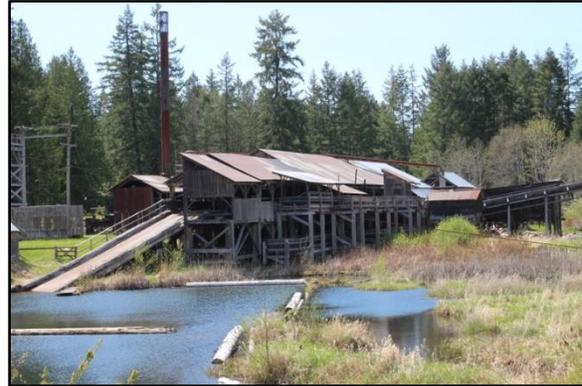
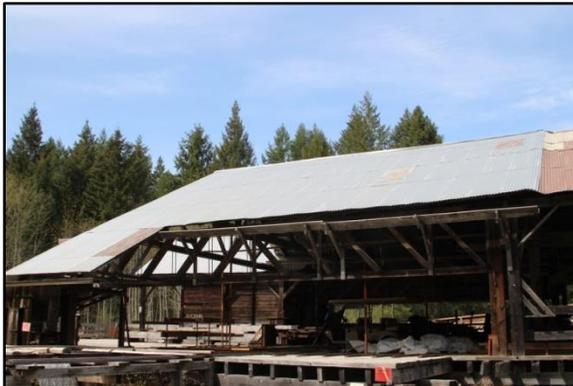
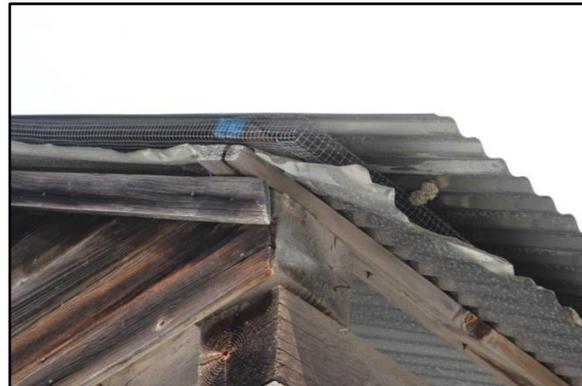
The roof over the Mill comprises corrugated sheet metal panels on a timber frame. The panels were further corroded at the east end of the Mill suggesting the west end was more recently renewed. The roof over the planer building also incorporates corrugated metal panels but utilizes a double layer assembly much like the Boiler House. The purpose of this assembly may be to control rising temperatures in the summer time.

Photographs 111 & 112 – (left to right) renewed west roof, double roof over the planer

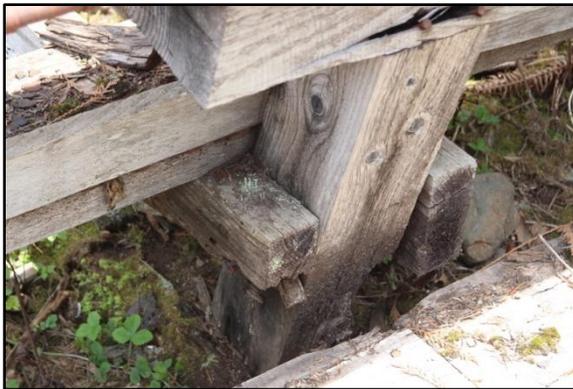
Currently however, the timber structure and steel mechanisms appeared to be in fair to good condition with a limited number of posts and timber joints observed to have decayed and failed. The steel workings of the assembly are starting to deteriorate with the lack of use increasing the rate.

Photographs 122 & 123 – (left to right) failed timber joints

Given the exposure and design of the Green Chain, it is particularly vulnerable to moisture related deterioration and will have to be regularly maintained with the continual replacement of the timber members. It is recommended that the failed members be replaced to prevent collateral decay and progressive structural failure. It would be of significant benefit to the assembly as a whole to renew operations, reducing the rate of deterioration on the mechanical assemblies while continuously maintaining the overall structure.

Table 22 – Green Chain - Renewal Recommendations		
43	Renew the failed timber joints	High

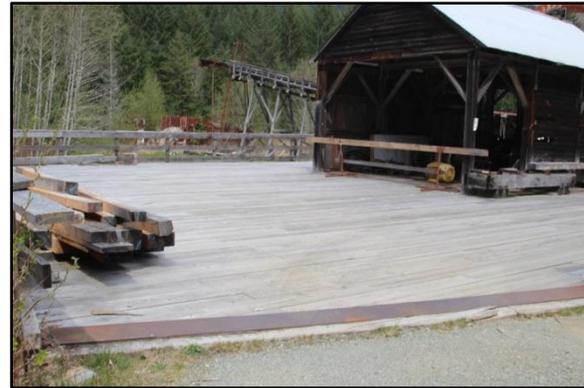
Today, the Lumber Deck was observed to be aging but there were no observed signs of deterioration or failure. The supporting timber structure beneath the deck is set primarily on concrete pad footings though some timber footings were observed. A number of the beam joints were observed to be protected with a sheet membrane while a number of original beams that were retained were observed to be supporting minor organic growth. Some of the timber footings were observed to be decaying at their bases. The environment beneath the deck was noted to be quite cool and damp. This condition, combined with the accumulation of sawdust on the grade and around the footings, exacerbates moisture related deterioration of the timber members

Photographs 125 - 128 – (clockwise from top left) renewed timber deck structure, organic growth on original timber beam, deteriorating post base, , deteriorating timber footing

The Lumber Deck appeared to be in good condition despite some localized deterioration. It is recommended that the deck and support structure be regularly reviewed and that the deteriorating posts and footings be renewed. In addition, accumulating sawdust and grade should be pulled back from any timber members that might be negatively affected by them.

Table 23 – Lumber Deck - Renewal Recommendations		
44	Renew deteriorating timber posts and footings	Medium
45	Pull accumulated sawdust away from vulnerable timber elements	Medium

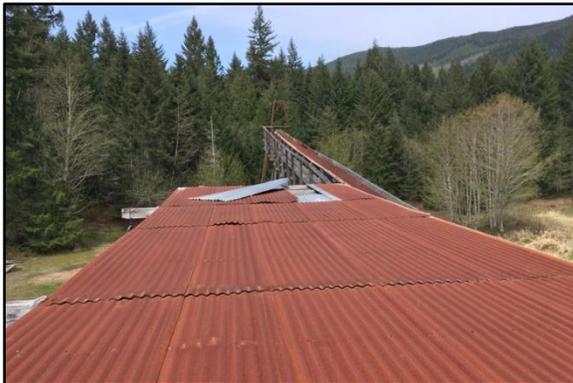
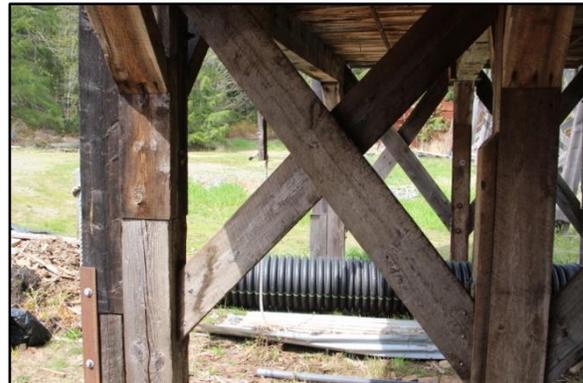
The elevated Waste Sheds appeared to be in good condition with a number of chute gates still operational. The corrugated roof was observed to be in fair condition with general extensive surface corrosion. One panel was however observed to have flipped over exposing the roof structure. The timber support structure of the sheds, now set on concrete footings and protected with membrane pads, had been renewed in the past with new materials simply spliced on the end of the posts. Possibly suitable for gravity loads, the structural repairs appeared vulnerable to lateral loading.

Photographs 130 - 132 – (clockwise from top left) Corroded, corrugated metal roof with flipped panel, spliced posts supporting the Waste Sheds

The Waste Burner is generally in good condition. It is recommended that all of the assemblies be regularly monitored for deterioration and member failure. The posts supporting the Waste Sheds should be renewed with full length members or reviewed to ensure adequate structural capacity while the displaced corrugated roof panel should be reinstated and fastened down. The Conveyor Belt frame posts will require renewal in the near future either splicing on new ends or replacing the entire post. The public should also be prevented from getting within close proximity of the Burn Pile enclosure.

Table 24 – Waste Burner - Renewal Recommendations		
46	Renew Waste Shed post with new, full length posts	Low
47	Reinstate corrugated sheet metal roof	Medium

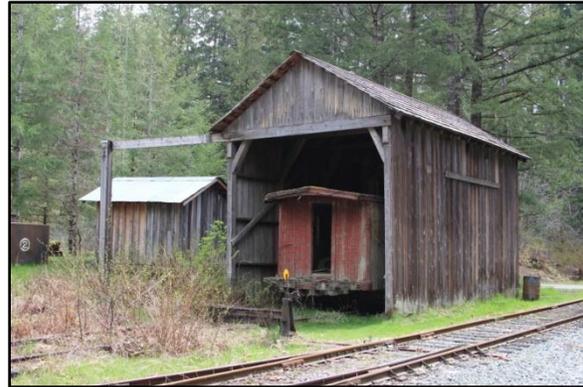
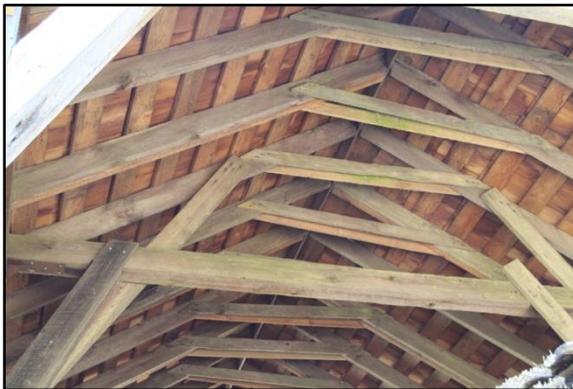
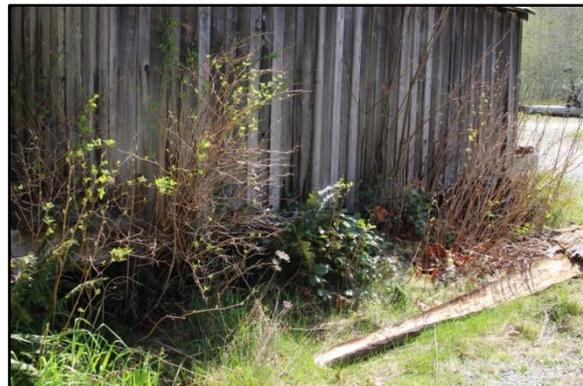
The two cross braced, post and beam walls are protected with vertical planks. Deterioration of these walls appeared to be limited to the ends of the planks where evidence of moisture uptake and associated organic growth was observed.

Photographs 137 - 139 – (clockwise from top left) timber roof structure, deteriorated wall planks, organic growth along the east wall

Timber beams set on grade comprise the existing wall footings. Aside from the onset of minor rotation, the beams appeared to be fine at the time of review. However, being set on grade and covered with organic growth, they are vulnerable to moisture related deterioration.

The Locomotive Shed is in good condition with limited deterioration localized to the base of the walls and the timber footings. It is recommended that the footings be renewed with concrete assemblies and that the perimeter organic growth be pulled back from the walls.

Table 25 – Locomotive Shed - Renewal Recommendations		
48	Renew the timber footings with concrete assemblies	Medium

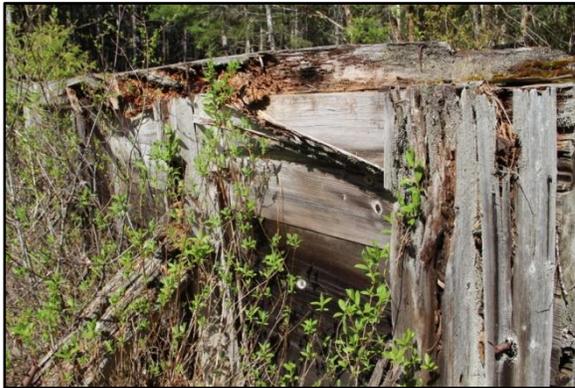
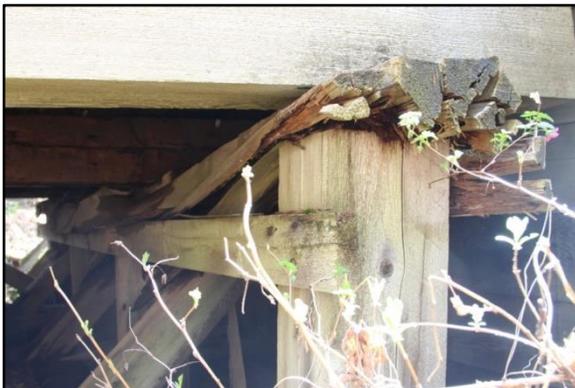
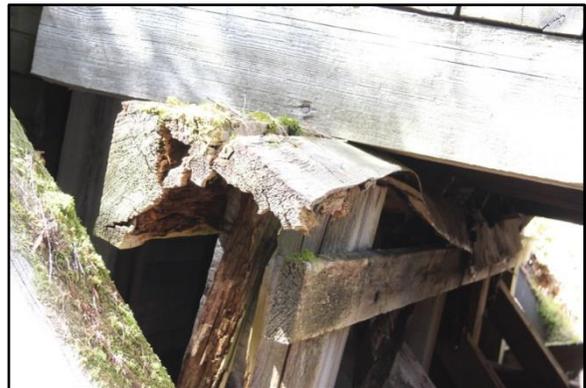
The Dip Tank is a heavy timber structure set on timber footings adjacent to the railway tracks. The deck leading to the tank and the tank itself are both severely deteriorated with numerous timber failures and extensive organic growth and accumulation in and about the tank. Given the exposure and current condition of this structure, total failure appears imminent.

Photographs 141 - 144 – (clockwise from top left)
Overgrown and deteriorated tank wall and adjacent deck, completely deteriorated and failed support beams

It is recommended that if there is an interest to conserve this structure, all organic growth and debris be removed from within and around it, all deteriorated timber elements be replaced with new timbers, and, if necessary, the support structure be set on new concrete footings. Once the conservation work is complete, the deck and tank should be regularly maintained, eliminating organic growth and debris accumulation.

Table 26 – Dip Tank - Renewal Recommendations		
49	Removal of all organic growth and debris and fully restore the entire structure	Critical
