AGENDA

COMMITTEE OF THE WHOLE MEETING OF COUNCIL

MONDAY, JANUARY 21, 2019 AT 3:30 PM
IN THE CITY HALL COUNCIL CHAMBERS

- Cost Sharing Agreement for McLean Mill National Historic Site (outlining City's obligations) dated July 23, 1996 - Page 10
- McLean Mill Society (MMS) Constitution dated December 8, 2016 - Page 22
- Operation and Management Agreement between City and MMS dated January 1, 2017 - Page 23
- McLean Mill Site Assessment prepared by John Dam & Associates Inc. dated July 3, 2018 - Page 36

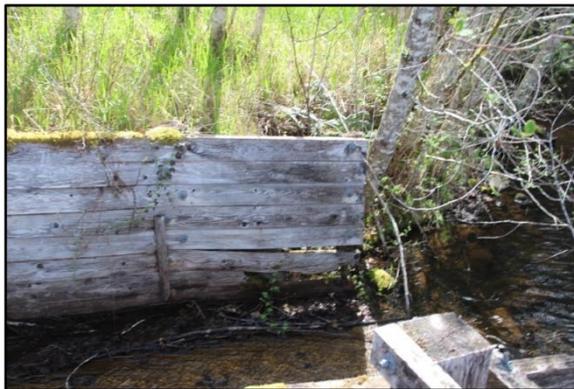
accelerated decay. Many of the side planks, support posts, and cross beams were observed to be failing. Though not at imminent risk, without conservation work, failure of the side walls and ladder structure could occur over the next few years.

Photographs 146 & 147 – (left to right) structural deterioration of the planks and timbers

Given its current condition and potential for exponential increase in deterioration, it is recommended that the Fish Ladder be fully restored, replacing all damaged and deteriorating timber members. Regular review of the structure should then be completed, removing all accumulated and encroaching organic debris and growth.

Table 27 – Fish Ladder - Renewal Recommendations		
50	Removal of all organic growth and debris and fully restore the entire structure	High

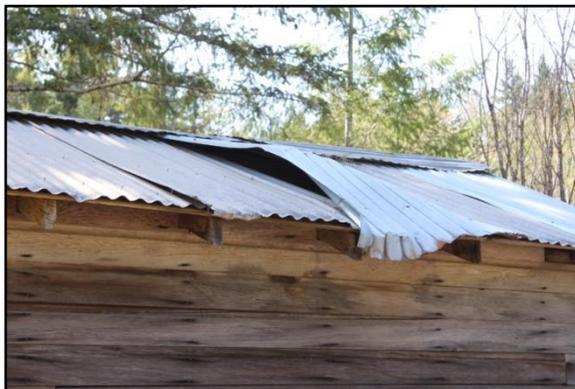
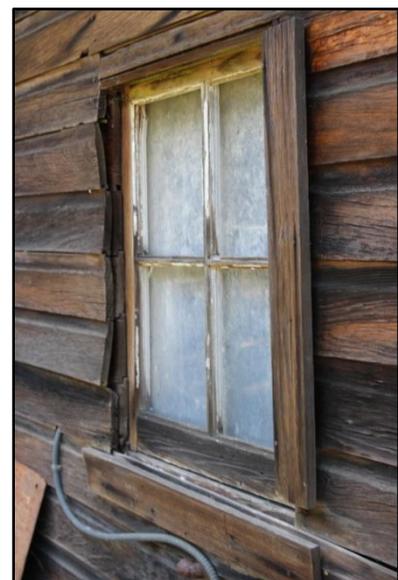
The nailed in place corrugated roof appeared to be in fair condition with a panel bent down at the eaves and buckled mid-span. It would appear that an object fell against the edge of the roof to create this condition. Many of the roofing nails also appeared to be popping leaving a number of the panels loosely held in place. Half of the trim at both roof gables was noted to be missing.

Photographs 149 - 151 – (clockwise from top left) buckled corrugated roof panel, damaged wall siding, missing trim on the north window

The cove profile, cedar siding protecting the walls generally appeared to be in good condition with some observed damage at the base of the east wall. A number of siding lengths on the north elevation were observed to be curling out of position while a piece at the peak is missing. The door and west window appeared to be in good condition while the north window is missing its perimeter trim. There is also an opening with an unknown purpose at the lower east corner of the north wall.

The First Aid Shack, despite its relocation without a proper foundation or footing, appeared to be in fair condition.¹ Setting the building on a new concrete foundation and floor structure in a suitable location within the context of the site as a whole is the primary recommendation for this building. It is also recommended that the damaged roofing panel and east wall siding be renewed. Consideration could also be given to renewing the fascia and north window trim.

Table 28 – First Aid Shack - Renewal Recommendations		
51	Rebuild the wood frame floor structure and set the building on a sensibly located concrete foundation	Critical
52	Repair the buckled roof panel and reset the fasteners	Medium
53	Renew the east siding	Medium
54	Restore the north window trim	Low
